# North Dakota Office of the State Fire Marshal (ND)

## INCIDENT REPORT

Investigation Title: RUGBY DECOTEAU FIRE

**North Dakota State Fire Marshals Office (ND)**  
**INCIDENT ORIGIN & CAUSE NARRATIVE**  
**Official Law Enforcement Report – Unauthorized Dissemination is Prohibited**

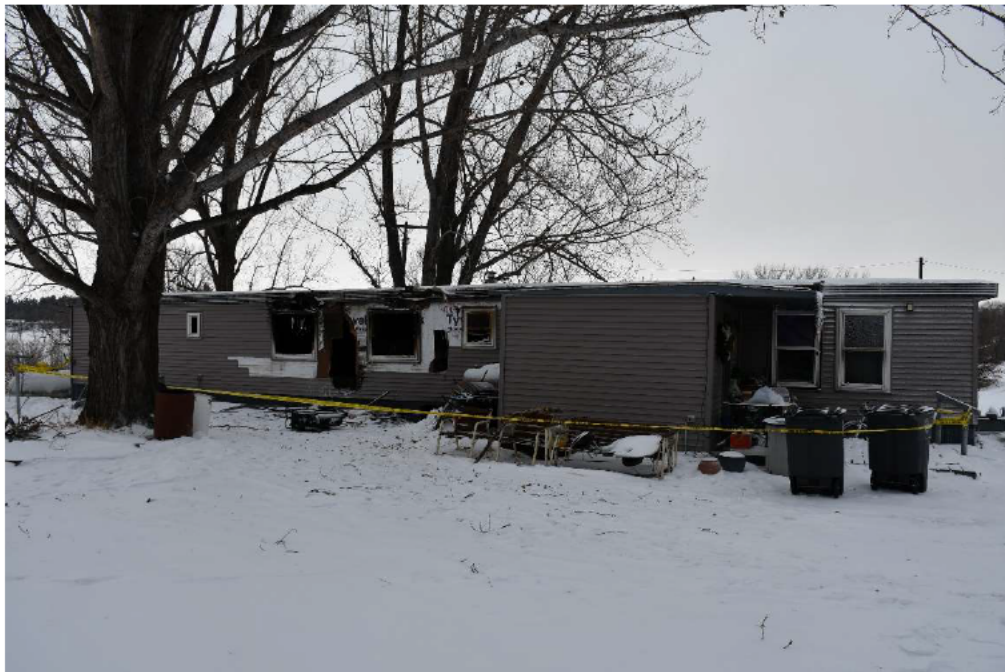
On January 23, 2025, at 4:36pm the Rugby Fire Department was dispatched to a residential mobile home fire at 663 Parkland Dr. SW, Rugby, ND. The fire occurred in an occupied residential mobile home. No injuries or fatalities were reported. (See Figure 1)

*Figure 1 Photograph DSC\_0001.JPG South Exterior Wall Facing North*

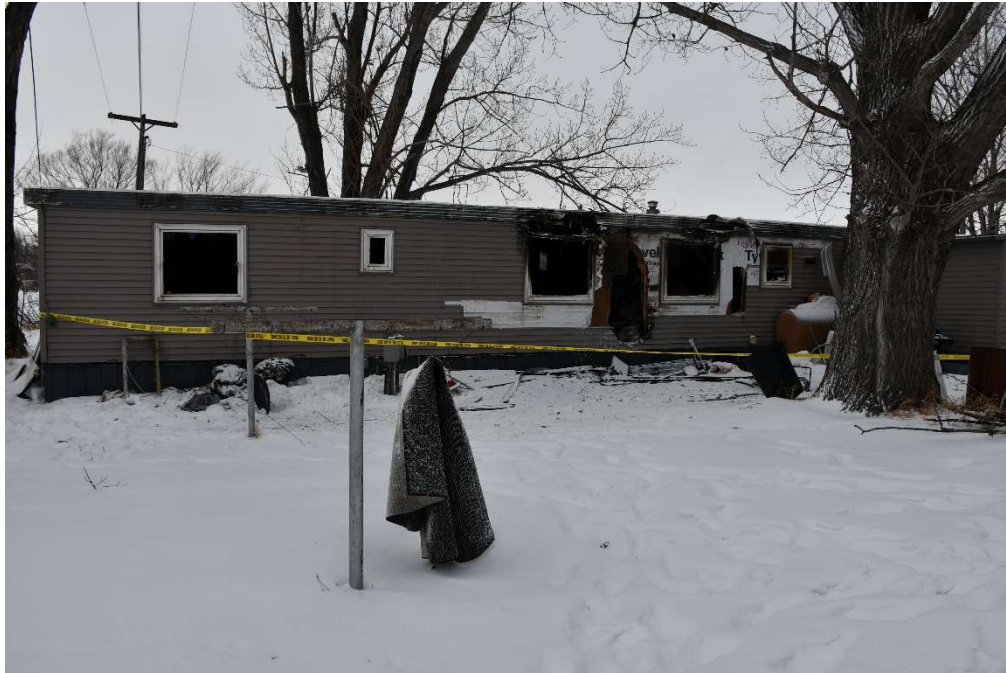
The south exterior wall had eight windows and vinyl siding. The five westerly most window were damaged, and most of the glass was broken and no longer in place. Above two large windows approximately in the middle of the south wall was charring on both sides of the window frames extending upward to the top portion of both window frames. Above the window frames was melted and charred vinyl fascia. (See Figure 2)

Figure 2 Photograph DSC\_0004.JPG South Exterior Wall Facing Northeast

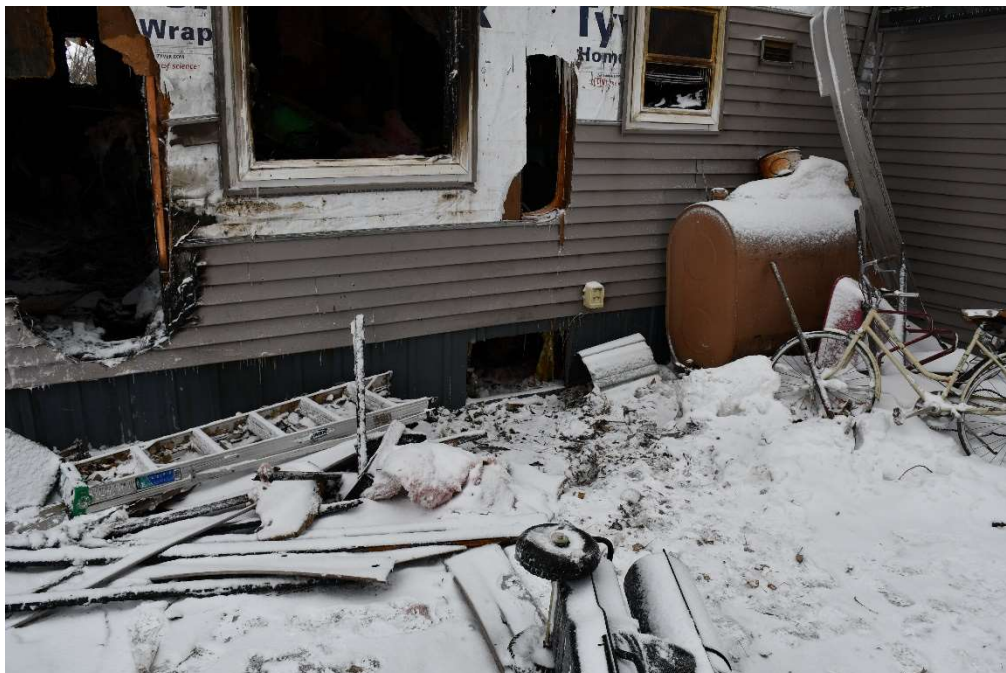
To the west of the addition the metal mobile home skirting was removed on the south side. Where the skirting was removed was a water main pipe and meter that entered the structure through an underground lateral. The water pipe and meter were intact. To the west of the addition were two holes cut in the mobile home wall, consistent with firefighting operations. (See Figure 3)

Figure 3 DSC\_0026.JPG South Exterior Wall Skirt Opening Facing North

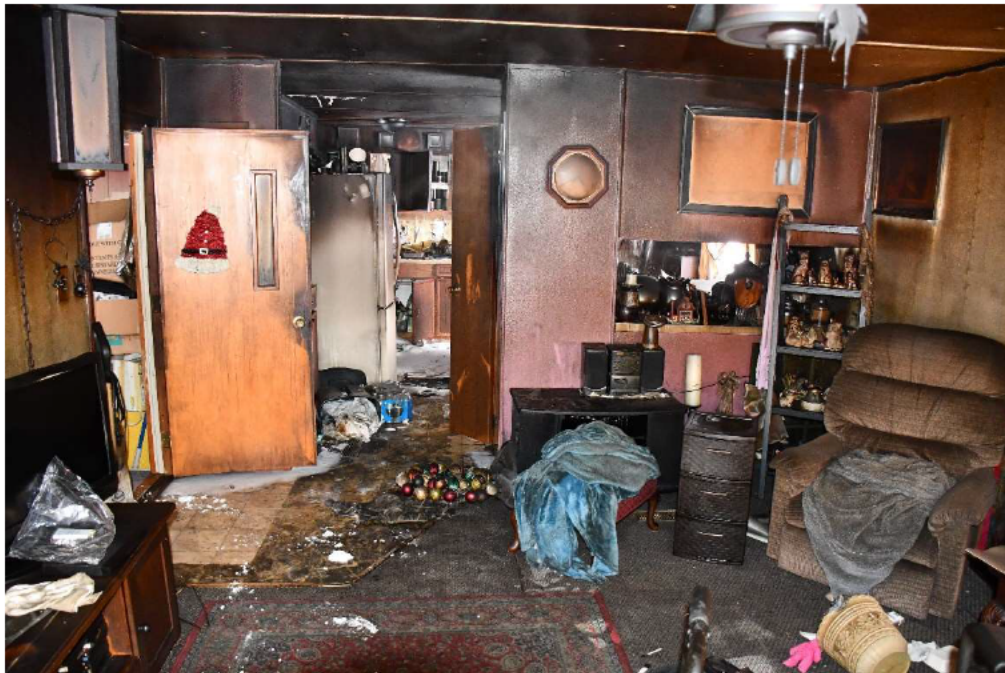
I continued north from the addition into a living room. Along the south wall was a television and entertainment center. The east wall had a couch, wood décor shelves, and a coffee table. The north wall had two reclining chairs and a table. The west wall had a coat closet and opening leading into the kitchen. Most of the combustible and noncombustible materials were intact. The westmost side of the television was melted. There were soot deposits throughout with greatest amount along the west wall and ceiling and decreased going east. (See Figure 4)

*Figure 4 Photograph DSC\_0044.JPG Livingroom Facing West Towards Kitchen*

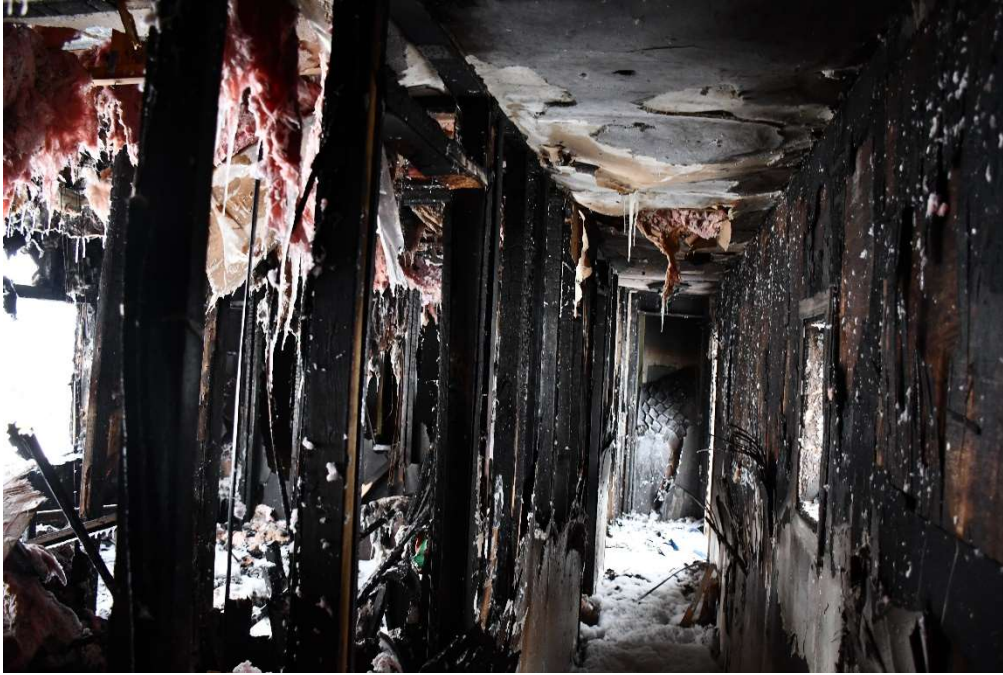
The south wall sustained most of the wood wall panels were consumed along the west end of the hallway and decreased in damage towards the east. The ceiling had peeling and cracking of the paperback drywall on the east end and increased in damage along the westernmost portion of the hallway with the drywall mostly consumed revealing the insulation. The hallway sustained more damage on the west end compared to the east end. (See Figure 5)

Figure 5 Photograph DSC\_0056.JPG Hallway Westernmost Portion Facing West

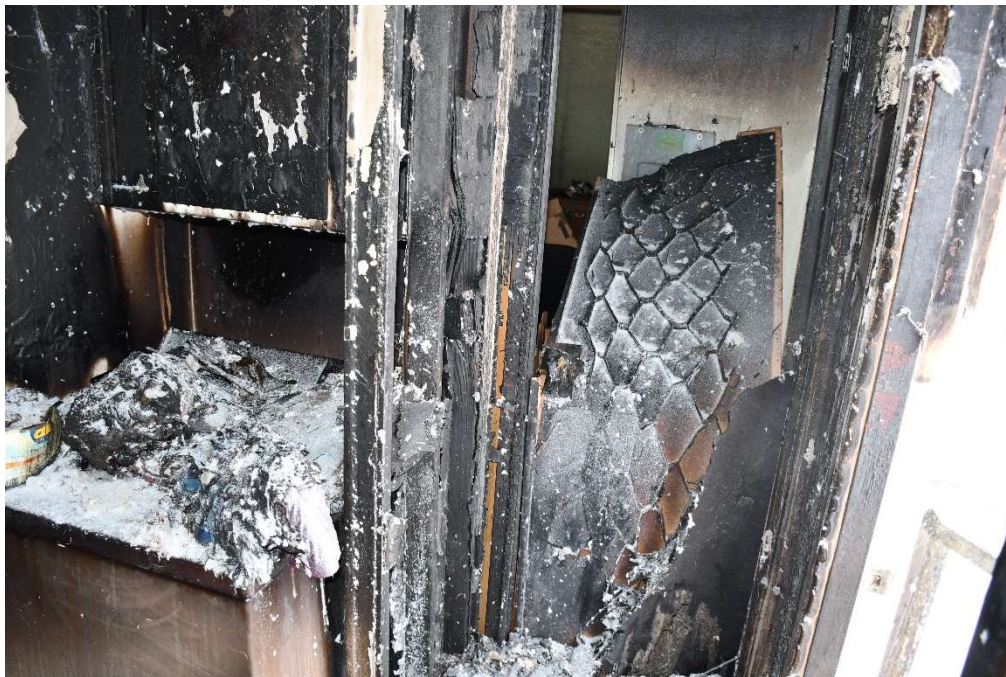
Continuing to the west end of the hallway was a bedroom along the west wall of the mobile home. The door leading to the bedroom sustained damage on the east side of the door facing the hallway with charring and peeling of the laminated protective coating of the wood door. The bedroom was used for storage with an abundance of cardboard boxes, plastic totes, and assorted household items there were scattered throughout the room. Most the combustible and noncombustible materials were intact. There were soot deposits throughout the wall and ceiling and gradually decreased towards the west. (See Figure 6)

Figure 6 Photograph DSC\_0058.JPG Westernmost Portion Of Hallway Facing West Towards West Bedroom Door

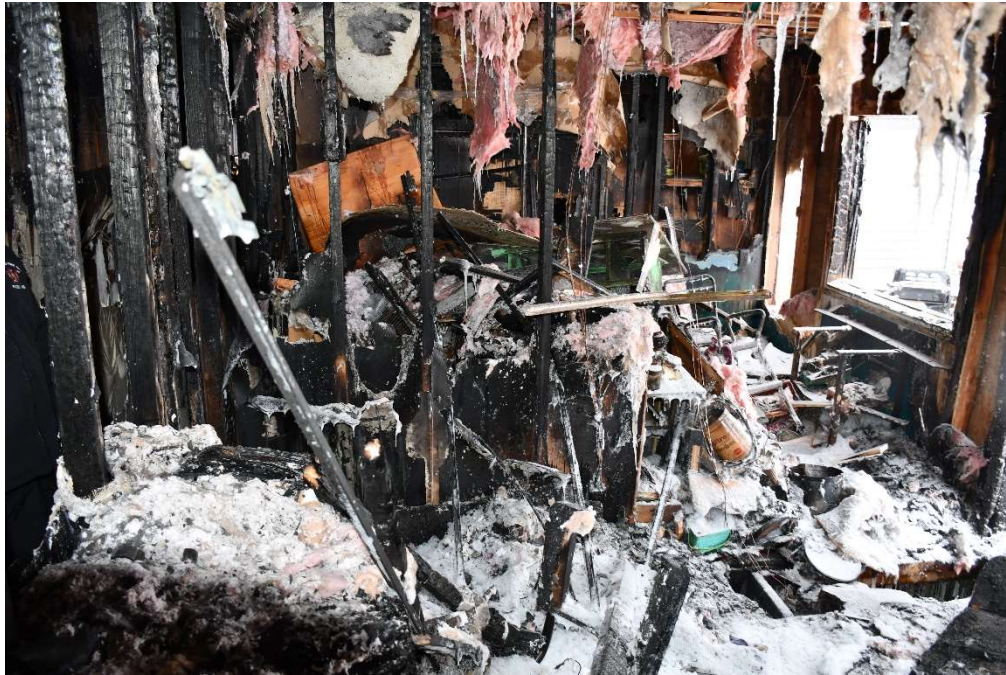
To the east of the bathroom along the south wall was a bedroom. This room was identified as the area of most damage compared to the rest of the rooms in the structure. Along the west, north, and east wall the wood wall panels were mostly consumed. The ceiling drywall was consumed with the insulation melted and dropping down. The wall studs along all the four wall within the room were charred. There was more mass loss on the wall studs on the south wall and north wall in approximately in the middle of the room. In the bedroom were wood truss that ran north/south. (See Figure 7)

*Figure 7 Photograph DSC\_0073.JPG South Bedroom Facing East*

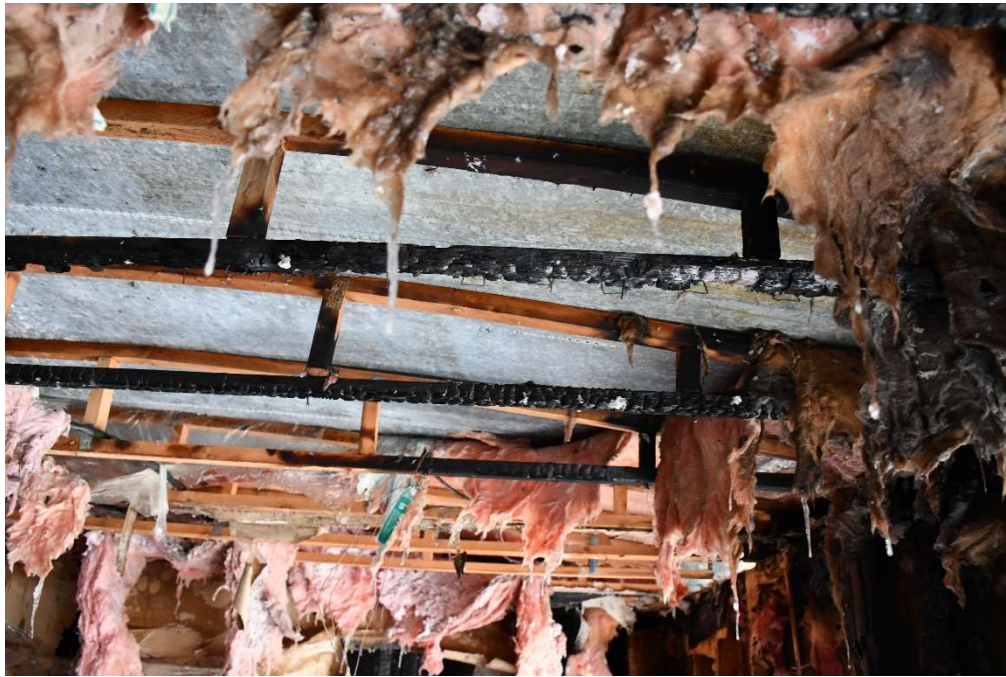
In approximately the middle of the room there were four truss that sustained damaged. The two most middle truss had more mass loss compared to the other two that were located west and east of the two with more damage. In the middle of the two truss that sustained the most damage the metal ceiling was oxidized and discolored. This area of oxidation and discoloration was the only area noted on the metal ceiling. (See Figure 8)

*Figure 8 Photograph DSC\_0091.JPG Truss Above South Bedroom Floor Door Opening*

- Charring to the lower portion of the wood floor joists that burned upward.
  - Mass loss to the wood floor door on the northern end of the door.
  - Mass loss to the wood truss directly above the wood floor door opening.

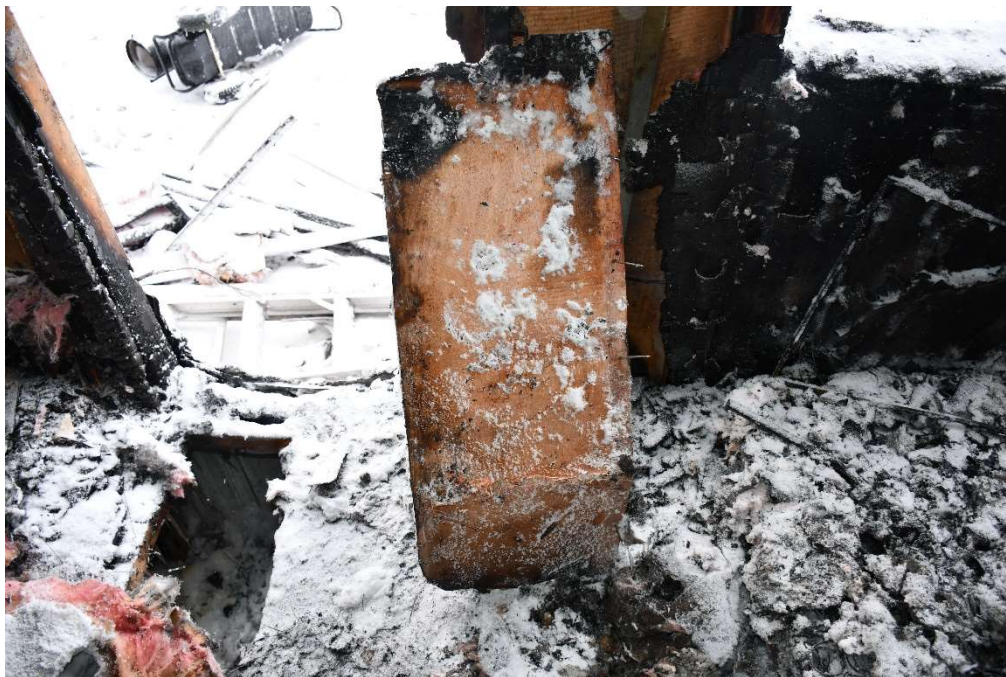
Directly below the two truss that sustained the most damage and the oxidized and discolored metal ceiling was a floor door hatch leading to the exterior under portion of the mobile home. The door was fixed to the opening with nails and was found opened. Fire department told me that during firefighting operations the door was removed. The top portion of the wood door was charred with more mass loss on the northern portion of the door. The bottom portion of the door that was exposed to the exterior under portion of the mobile home sustained charring and mass loss along the northernmost portion of the door. The remaining portion of the door had soot deposits and was intact. (See Figure 9)

*Figure 9 Photograph DSC\_0098.JPG Bottom Side Of The Door For Floor Opening*

- The mass loss on the northern end of the wood floor door was consistent with damage found directly above the wood floor joists that sustained damage.

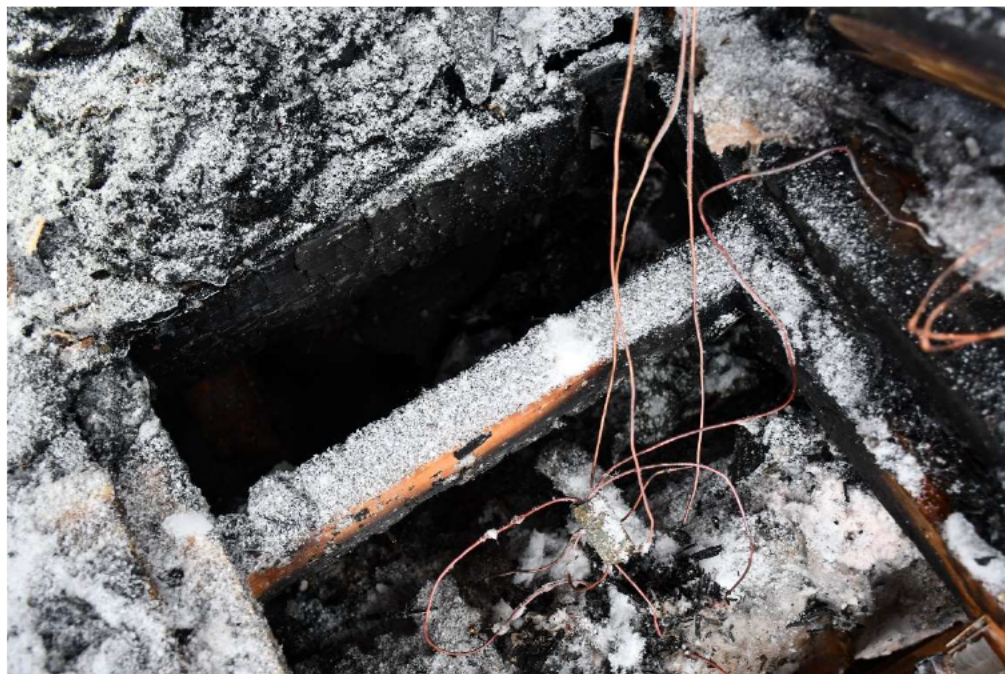
Reconstructing of the door was done by placing the door in the condition it was found prior to being removed during firefighting operations. In the opening the northernmost two wooden support beams that ran west/east were charred. The charring on the second most beam from the north had charring that extending from the bottom up. The north/south support

beam had charring along the northernmost portion of the beam extending from the bottom up and decrease in damage towards the south. Below the charred support beams was remains of charred insulation. (See Figure 10)

Figure 10 Photograph DSC\_0103.JPG North Portion Of Floor Opening

- Charring to the lower portion of the wood floor joists was more charred on the north end of the door opening in the floor. The damage decreased outward to the floor joists away from the floor door opening.
