# North Dakota Office of the State Fire Marshal (ND)

## INCIDENT REPORT

Investigation Title: STANLEY KANNIENEN FIRE

**North Dakota State Fire Marshals Office (ND)**  
**INCIDENT ORIGIN & CAUSE NARRATIVE**  
**Official Law Enforcement Report – Unauthorized Dissemination is Prohibited**

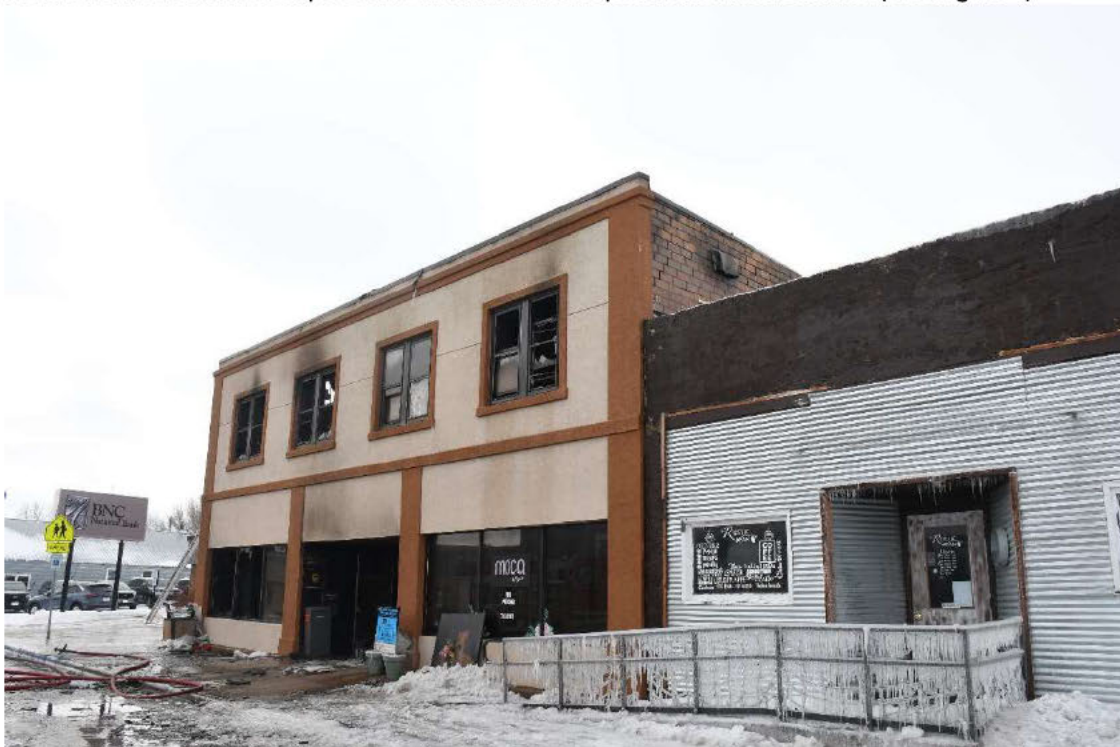
On Saturday, February 22, 2025, at approximately 1:15 AM a fire was reported at 208 S Main St. Stanley, ND. Officer Joseph Rivers of the Stanley Police Department noticed the fire during patrol and reported it. Upon the fire department’s arrival, all occupants had exited the building. The Stanley Fire Department began extinguishment efforts. The fire extended throughout the structure. Most of the structure had collapsed into the interior except for the exterior walls. (See Figure 1)

*Figure 1 Photograph DSC\_0045.JPG Exterior East Side*

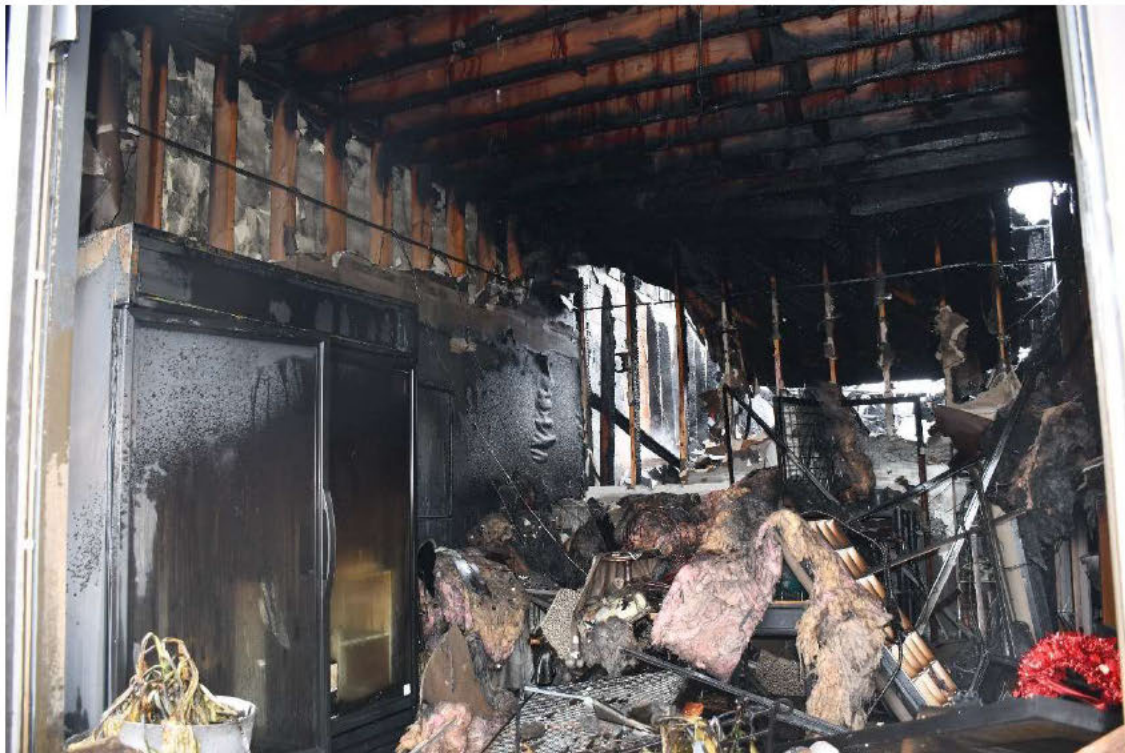
Observation from the east side damaged windows showed the wall studs on the south and west wall. The south wall studs had charring in the area closest to the ceiling joist. As extension went to the east toward the windows the charring decreased. The ceiling joists were exposed. As extension went to the east towards the windows the charring on the ceiling joists decreased. The charring on the wall studs and ceiling joists were on the room facing side. The visible contents were covered with fire debris. The structural members west of the room had collapsed. The north wall had an entry door into the room. The north wall was comparable to the south wall. (See Figure 5)

*Figure 5 Photograph DSC\_0061.JPG Interior Southeast Room*

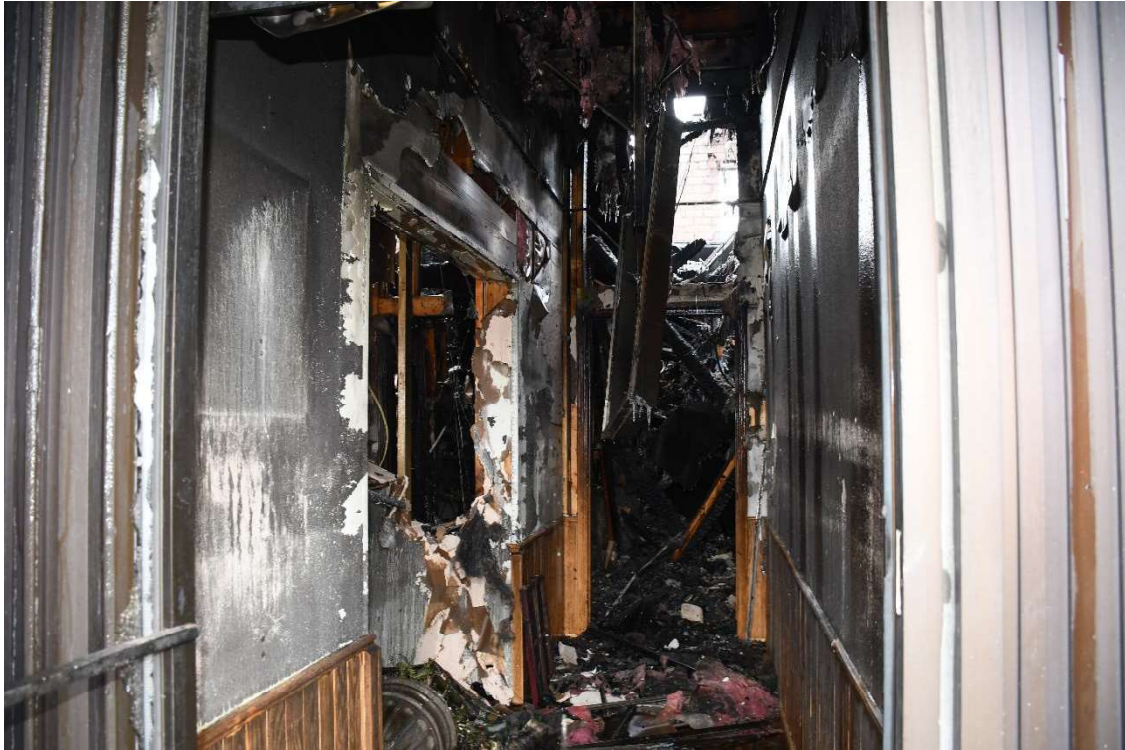
The entryway had three glass pane doors. The door to the south entered a hallway that led to the businesses along the south half of the structure. Photographs were taken from the exterior. The ceiling had collapsed, and fire debris covered the hallway floor. At the west end there was a door opening. Past the door was collapsed fire debris. The south wall and north wall had wood paneling extending up approximately three feet from the floor. The drywall on the south wall was calcinated and had areas of collapse. The north wall had soot deposits and discoloration throughout. (See Figure 6)

*Figure 6 DSC\_0076.JPG Interior of South Hallway, Collapse, Soot Deposits*

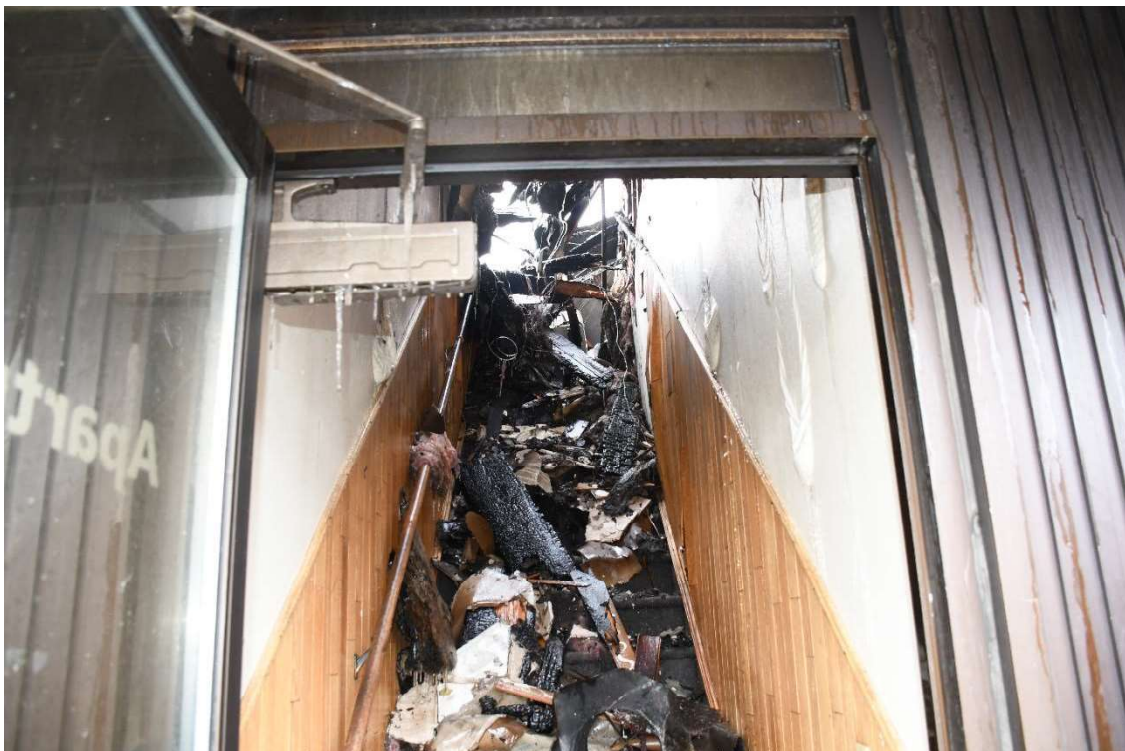
The center door had a staircase that led to the second-story apartments. The stairs were covered in fire debris. The south and north wall had drywall with wood paneling comparable to the hallway. A wood handrail was mounted along the wood paneling on the south wall. The railing extended east/west with the stairs. (See Figure 7)

*Figure 7 Photograph DSC\_0078.JPG Staircase, Fire Debris*

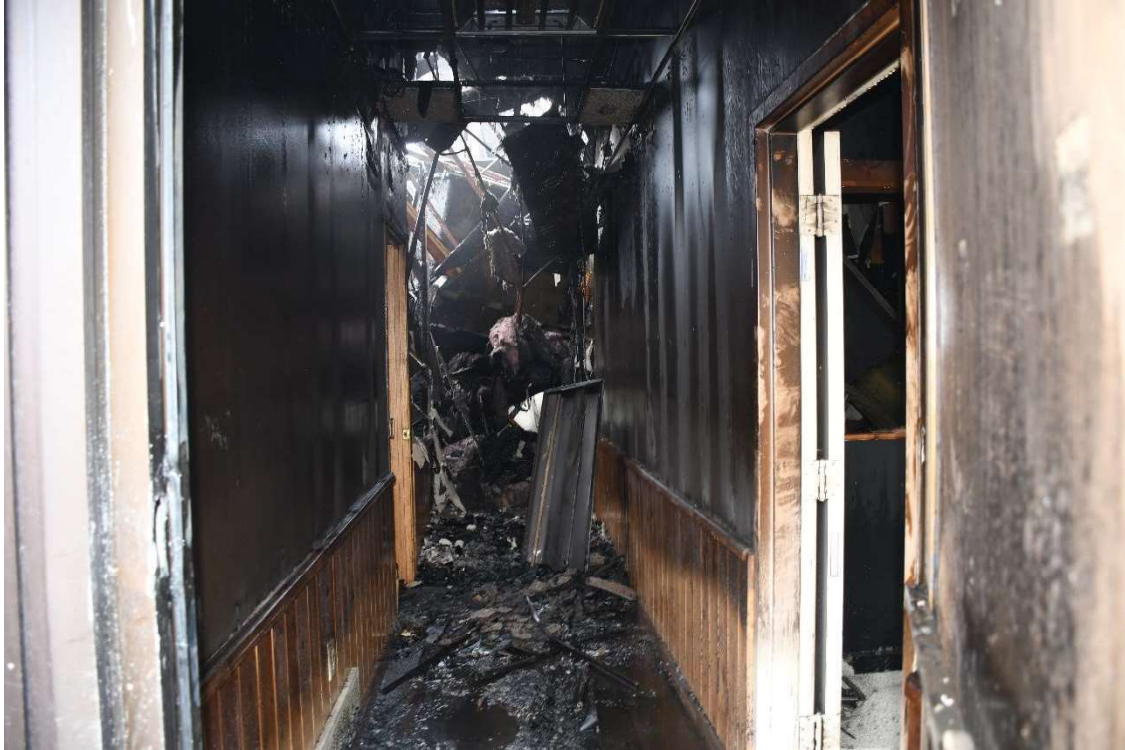
The door on the north entered a hallway that led to the business in the northeast corner. Photographs and observations were taken from the exterior. Most of the drop-down ceiling in the north hallway had collapsed or was consumed. The metal railing to the drop-down ceiling was visible and discolored. The south and north wall had soot staining and discoloration from the ceiling level to approximately a foot from the floor. The north hallway was comparable to the south hallway. Less calcination was noticed throughout the hallway compared to the south hallway. The hallway had a door on the south wall and a door on the north wall. The door on the north wall entered a business in the northeast corner of the structure. (See Figure 8)

*Figure 8 Photograph DSC\_0084 Interior North Hallway*

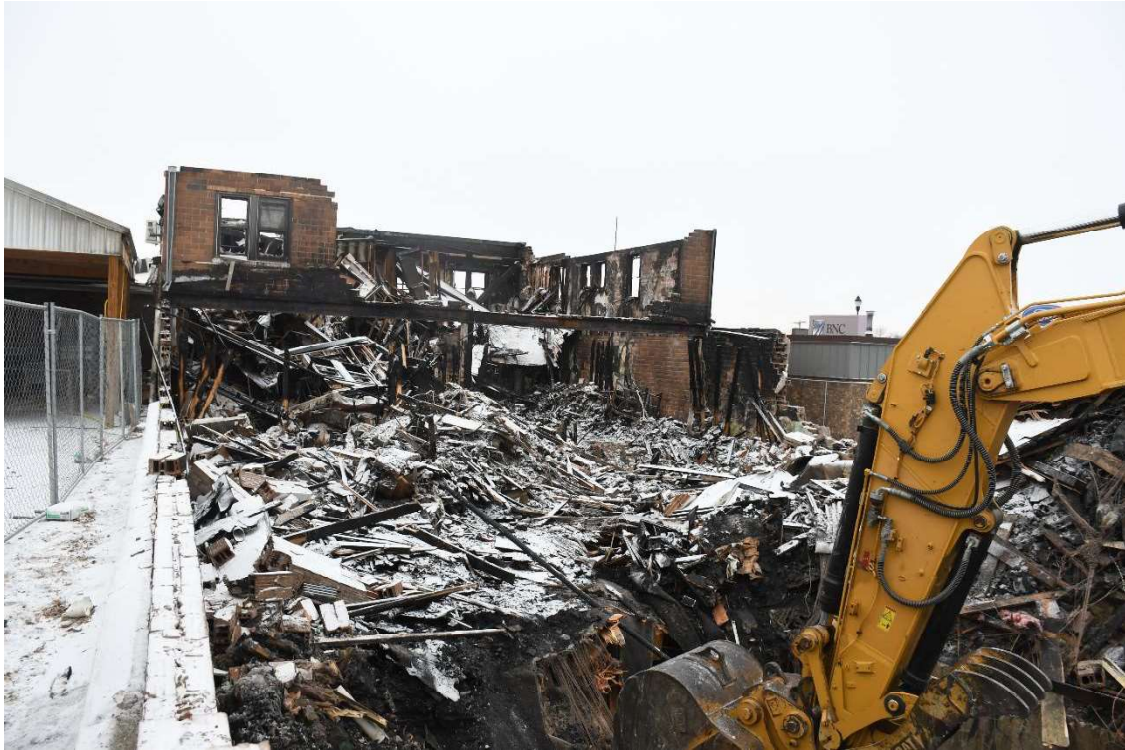
Active demolition continued on the exterior west side. (See Figure 9)

*Figure 9 Photograph DSC\_0008.JPG Exterior West Side*

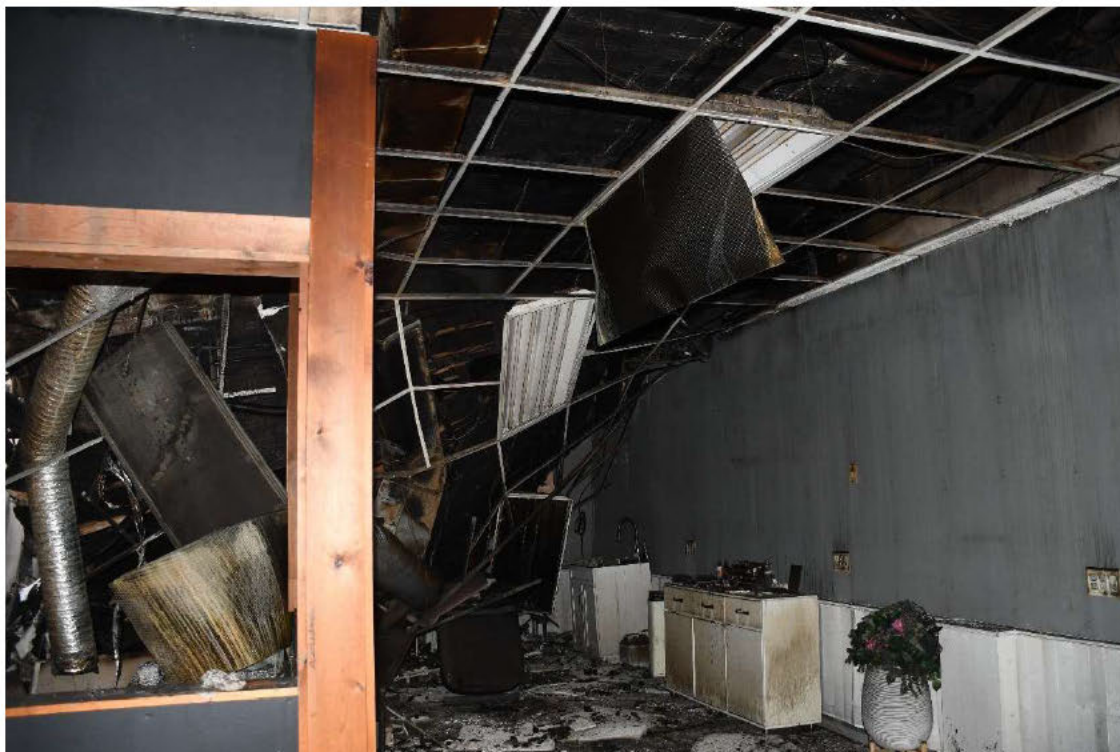
Entry into the north hallway was made, a door on the south wall accessed the basement. No entry was made into the basement. At the west end of the hallway, structural collapse was visible. A door on the north wall entered the northeast business. Entry into the business was made, access was limited to the eastern end of the business due to uncertain structural integrity. Most of the drop-down ceiling within the business had collapsed. Light fixtures were discolored and collapsing. The metal railing to the drop-down ceiling was visible. Soot deposits were throughout the room. The glass windows on the east wall were discolored but remained intact. (See Figure 10)

Figure 10 Photograph DSC\_0019.JPG Interior of Northeast Business, Interior West Area, North Wall, Ceiling Collapse
