INCIDENT REPORT

Investigation Title: SAWYER RICHARDSON FIRE

INCIDENT ORIGIN & CAUSE NARRATIVE

A fire occurred in a two-story residential structure with a basement at 120 Central Ave E in Sawyer, ND. The fire was reported on February 26, 2025, at approximately 8:53 AM. The Sawyer Fire Protection District responded and extinguished the fire. The property tenant was not home at the time of the fire and a passerby called 911. (See Figure 1)

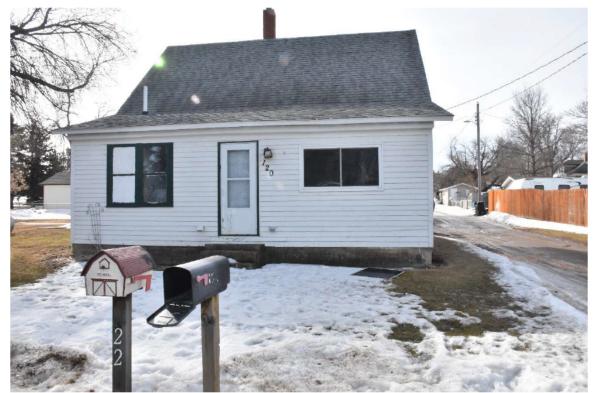
Figure 1 Photograph NJF_0009 North side of the structure with no fire or smoke damage.

The north side of the structure did not have any signs of fire or heat damage.

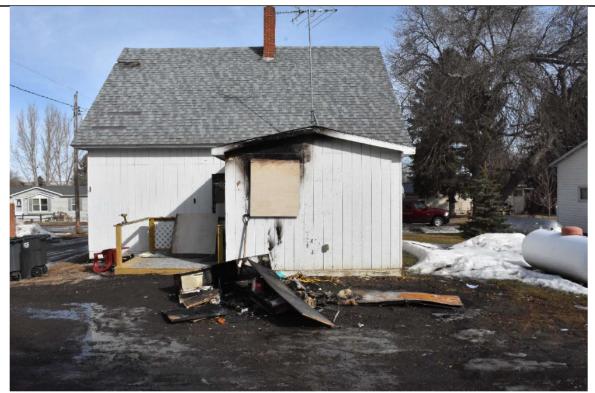
The south side of the structure received smoke staining to the top of the mud room door and mount of the exterior porch light. The door for the mudroom received discoloration and deformation from bottom up. A ring doorbell camera was observed on the south side of the structure by the mudroom door. The window for the mudroom was broken and was boarded up prior to arrival to scene. Above the window on the siding going up to peak of the roof received charring and smoke staining to the structure. Located in the parking area of the structure household materials such as a filing cabinet, door, kitchen cabinet and wood panel that had received charring smoke staining and discoloration. (See Figure 2)

Figure 2 Photograph NJF_0001 South side of structure

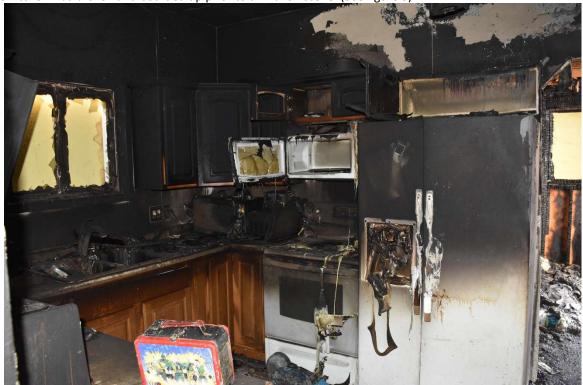
The kitchen received smoke staining to the walls and counter tops. Plastic melting and deformation was observed on the microwave and refrigerator. Charring and smoke staining to the upper cabinets. The window in the kitchen was broken and boarded up prior to arrival on scene. (See figure 3)

Figure 3 Photograph NJF_0066 Kitchen, south wall with charring to cabinets and deformation and melting of plastics.

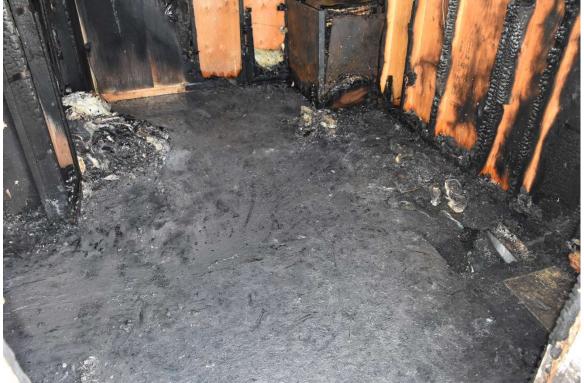
The layering process was performed in the mudroom and Items found through the process was to include, lithium-ion batteries, small electrical motors, electrical wiring with mass loss of electrical wiring insulation,

paper, cardboard, clothing and plastic materials. (See figure 4)

Figure 4 NJF_0106 Mudroom layering process completed

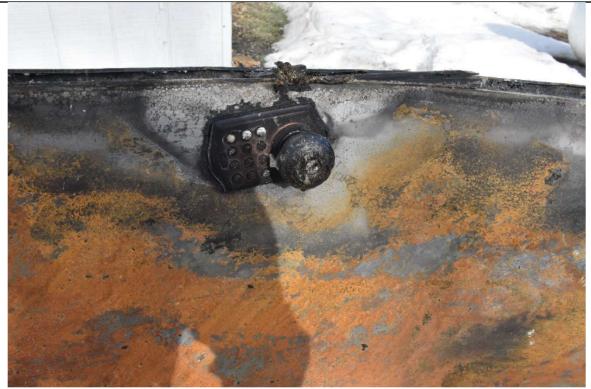
A search was conducted to the materials outside of the structure that fire crews reported had been removed during firefighting operations. The door to the structure was examined and found that the latching mechanism had received mass loss to the latch and discoloration and deformation to the door to both sides. (See figure 5)

Figure 5 Photograph NJF_0123 Exterior door with mass loss of the latch mechanism

- •The exterior door to the mudroom received mass loss to the latch mechanism and was unable to verify if the door was locked
- Calico Richardson stated to not being home at the time of the fire.

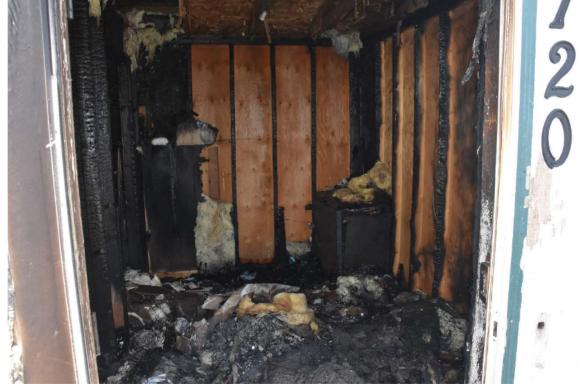
Based on the fire scene examination, witness statements, and other data reviewed, the area of origin was determined to be in the mudroom. (See figure 6)

Figure 6 NJF_0019 Mudroom

- This area sustained the most consumption compared to the rest of the structure.
- The wood framing sustained more charring and consumption compared to the rest of the structure.
- More wood paneling and insulation were collapsed and consumed in the mudroom compared to the rest of the structure.
- Fire Dynamics
- Charring full length of wall studs compared to no wall studs exposed in the rest of the structure.
- Charring and mass loss to common household items in the mudroom.
- Charring and mass loss to interior wood paneling in mudroom.
- Witness Statement
- Assistant Fire Chief Andy Weigel stated fire crews seen flames coming out of the mudroom window.
- 911 caller stated seen flames shooting out of the window of the shed behind the structure. No sheds or outbuildings were observed on the property.

Based on the fire scene examination, witness statements, and other data reviewed, the area of origin was determined to be in the mudroom entryway.

This fire cause remains undetermined.
