INCIDENT REPORT

Agency Incident ID: NDSFM25-030

Investigation Title: BISMARCK DAVEY FIRE

North Dakota State Fire Marshals Office (ND)
 INCIDENT ORIGIN & CAUSE NARRATIVE
 Official Law Enforcement Report – Unauthorized Dissemination is Prohibited

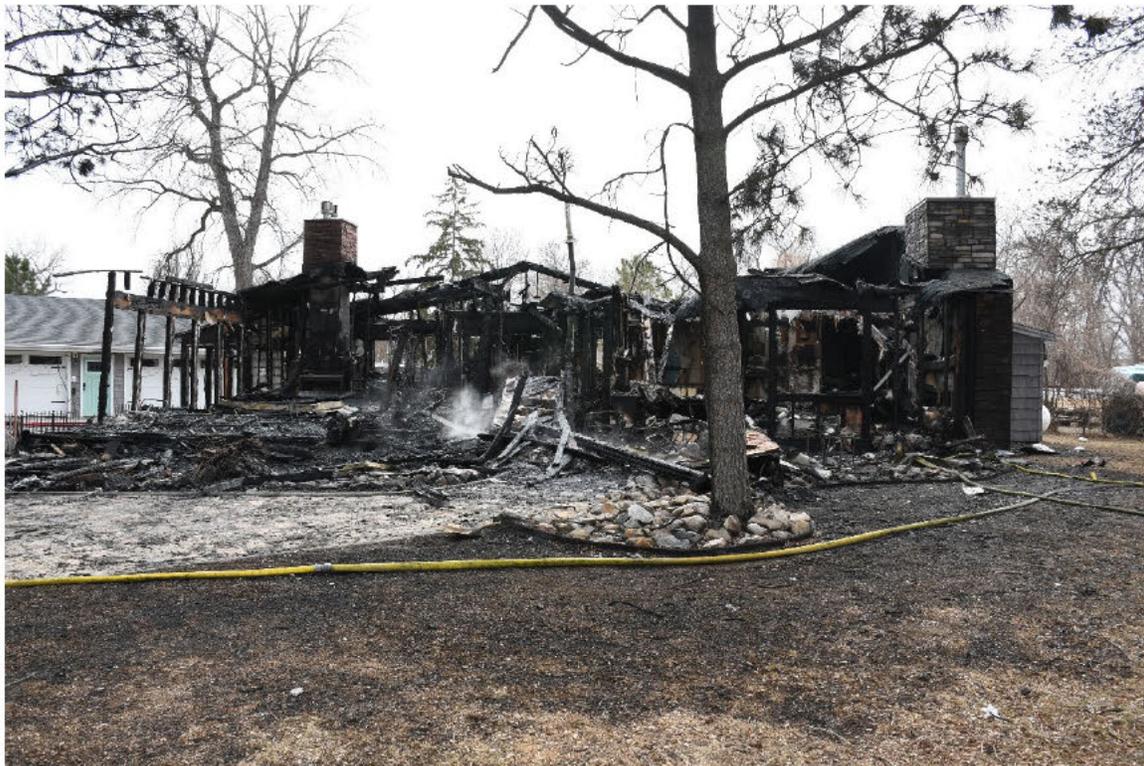
The southeast part of the house sustained mass loss. The west portion of the southeast wall was no longer standing, with portions of it falling forward away from the house. The covered front porch located roughly in the middle of the home was entirely consumed. A portion of the north side of the southeast wall remained standing, but it sustained mass loss and charring.

Figure 2. The front of the home, particularly the southeast portion, shows the extent of the damage on this portion of the house.

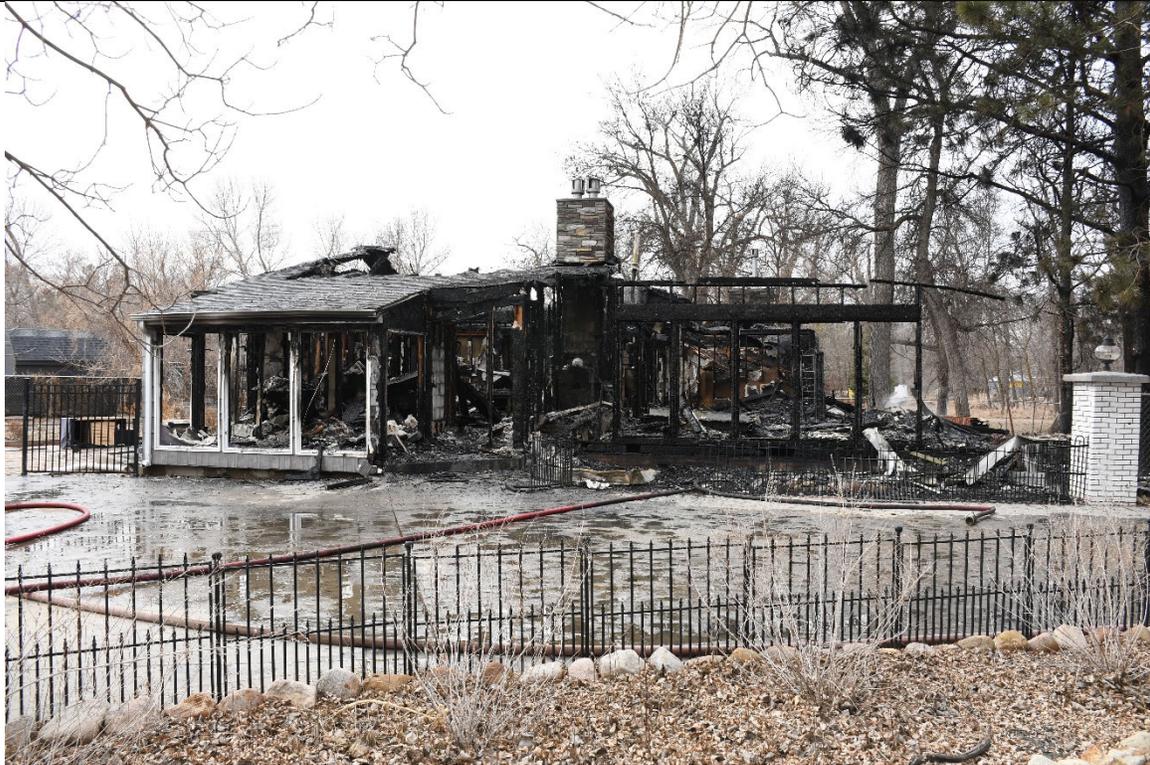
Moving clockwise, the west side of the house still had part of its wall standing. A portion of the south end of that wall was burned, charred, and had fallen outward, while the north end was still upright. Some siding and pieces of the window frame could still be seen. (See Figure 3).

Figure 3. The progression from the south side of the home to the north can be observed.

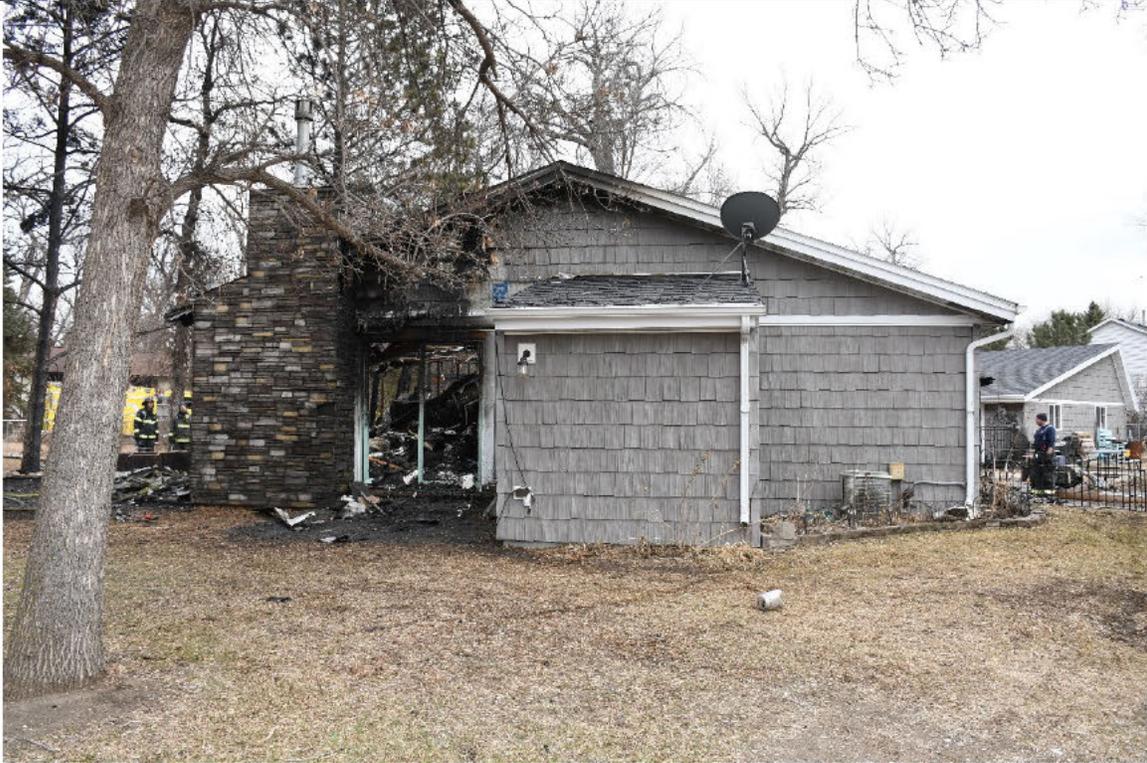
The northwest side of the home was the least affected by the fire, with the siding, eaves, and gutters still intact, with visible fire damage at the sliding glass door, the only opening on this side of the house. (See Figure 4.)

Figure 4. The northwest side of the home showing the amount of fire damage on this side of the house.

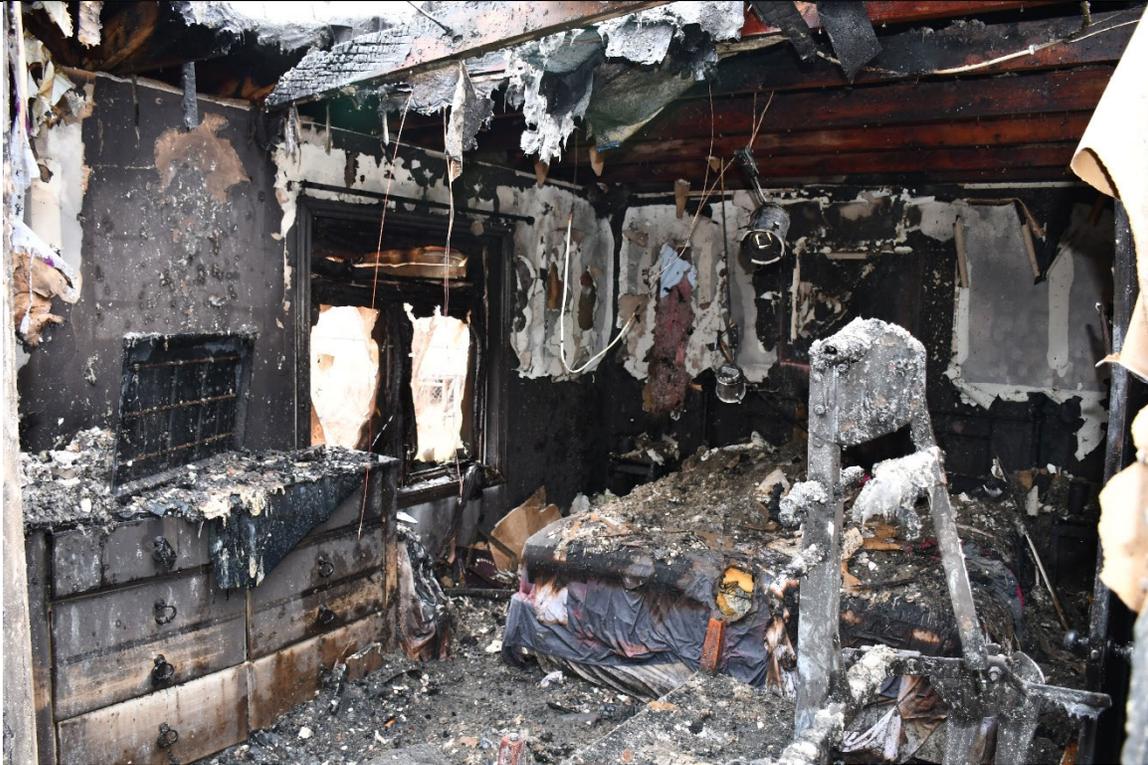
Most of the ceiling had been completely burned away and/or removed during overhaul, leaving charred joists. Several of the joists sustained charring that was greater on the north side of the joists than on the south side, with burn patterns from the top down. Electrical wiring and recessed light fixtures are hanging down with the insulation burned off the wiring. Some of the gypsum board on the walls had been removed by either the fire or during the firefighting process. Smoke and soot cover the walls from the floor to the ceiling. The dresser appeared to still have color on the bottom drawers, indicating that the fire came from the top down. (See figure 5).

Figure 5. Showing the charring and full room involvement in the master bedroom.

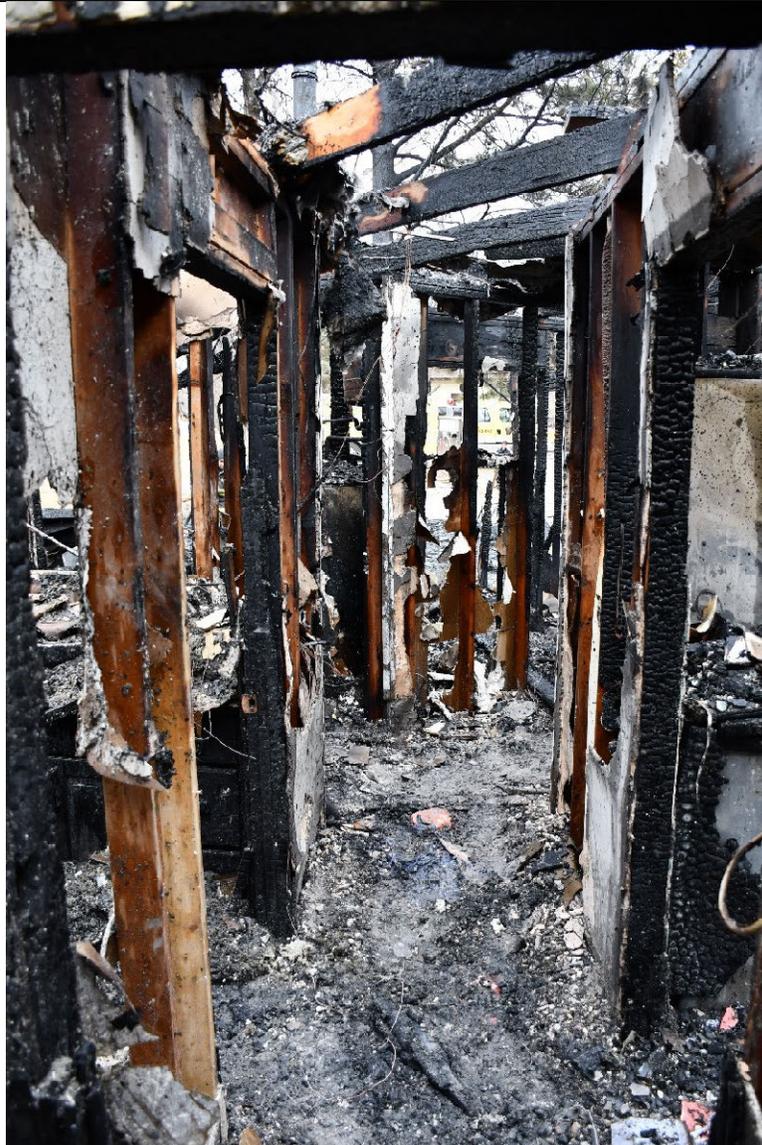
Outside the master bedroom, the gypsum board on the walls was gone, and the studs had burn patterns coming from the top down. There was more damage to the roof/ceiling of the hallway than to the floor. (See figure 6).

Figure 5. observe the charring to the studs and mass loss to the drywall.

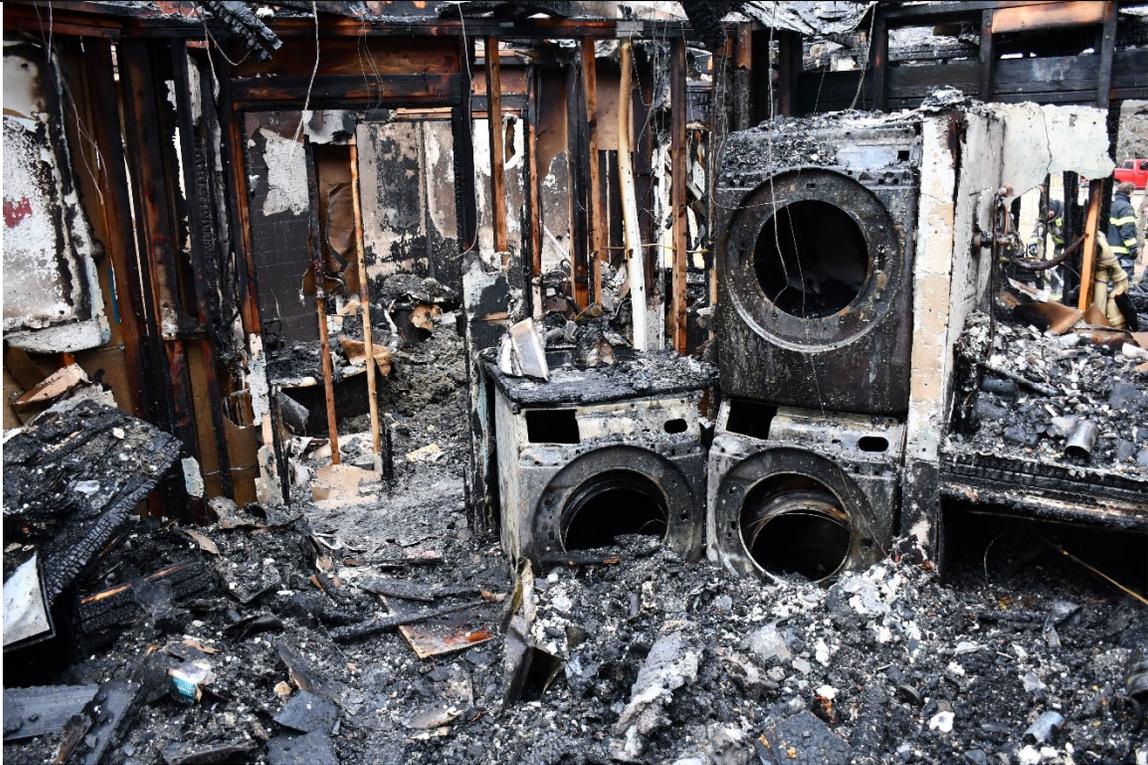
Continuing down the hallway, the laundry room had two washers and one dryer that had a heat-induced color change, and the Gypsum board from the ceiling and walls had been removed and collapsed onto the floor. The exposed wood wall studs and ceiling joists had charring. (See Figure 7.)

Figure 6. The homes laundry room located on the southwest portion of the home.

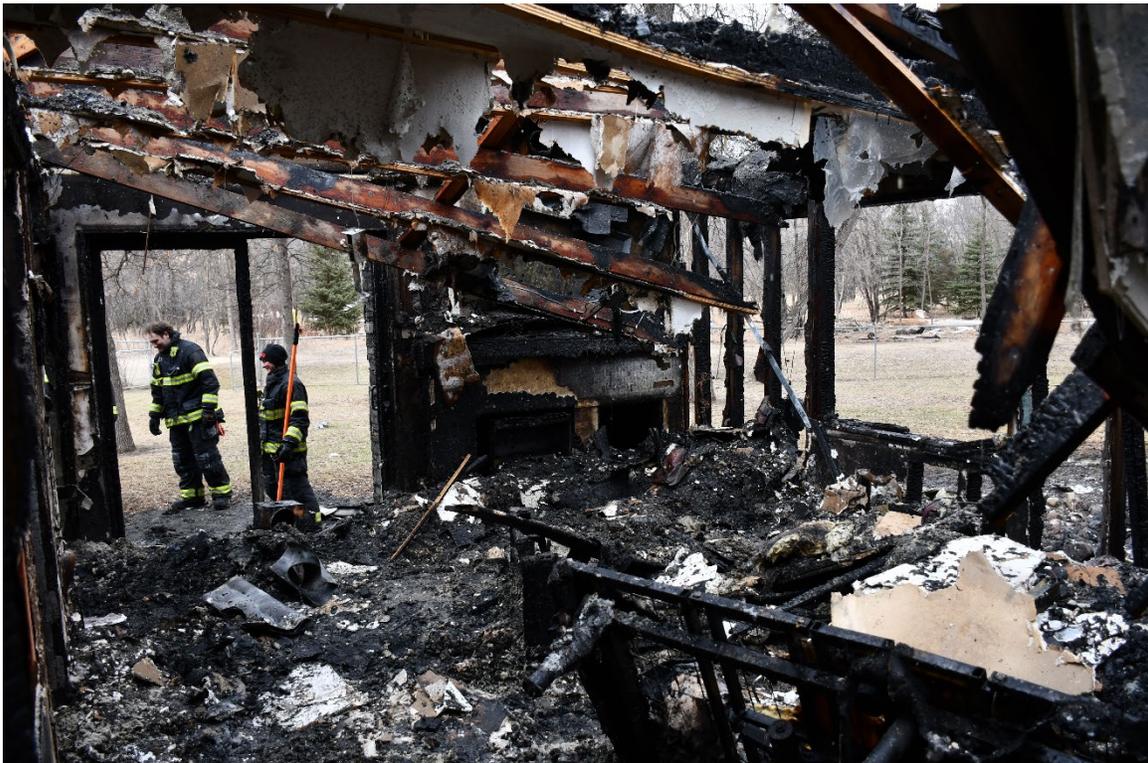
The master bedroom at the end of the hallway sustained mass loss to the room's contents, and numerous ceiling joists exhibited more loss on the north portion of the room than the south side, with the north side ceiling joists collapsing into the room. The room's windows and sliding glass door were no longer intact, and the exterior wall studs sustained full-thickness charring. (See figure 8).

Figure 7. The master bedroom showed the ceiling joists that had been burned from the top down and had collapsed into the room.

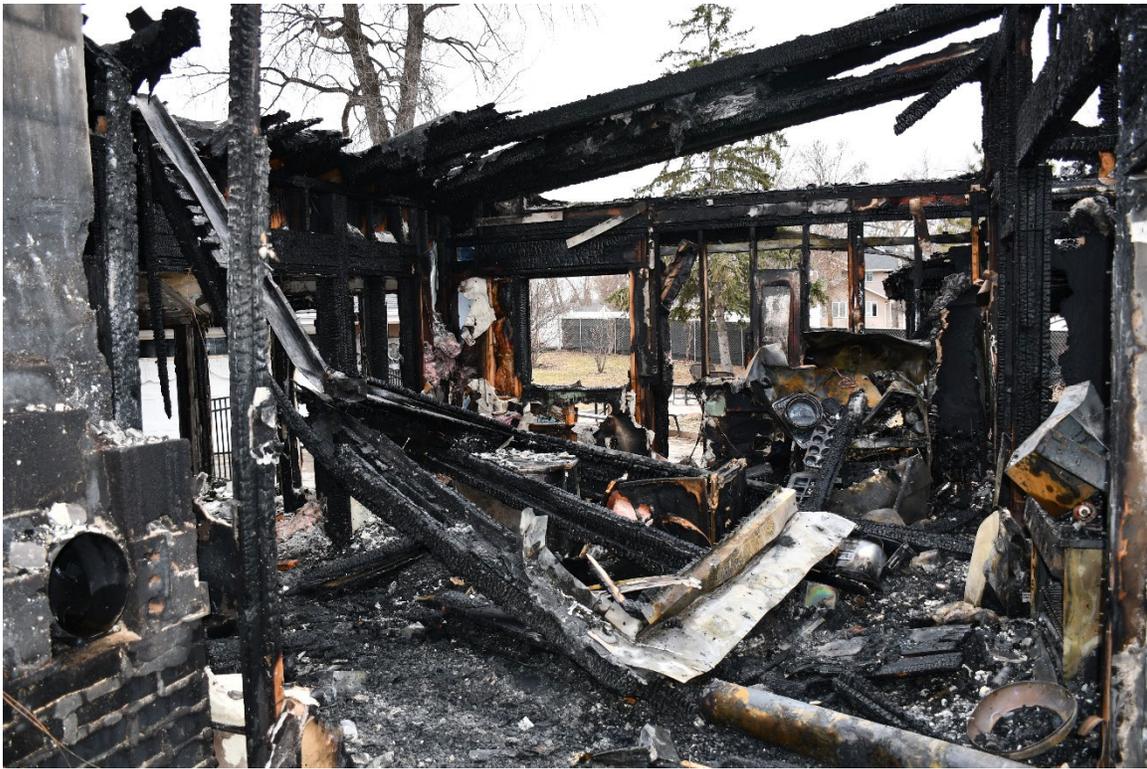
The kitchen area had significant material consumption. Only two roof trusses remained structurally intact. All wall studs and exposed wood members displayed full-thickness charring. All the gypsum board from the room's ceiling and walls was gone. The side of the stove and the metal flashing from the room's skylight exhibited heat-induced color change and surface oxidation. (See figure 9).

Figure 8. Showing the kitchen and the mass loss sustained to the roof joists and wall studs.

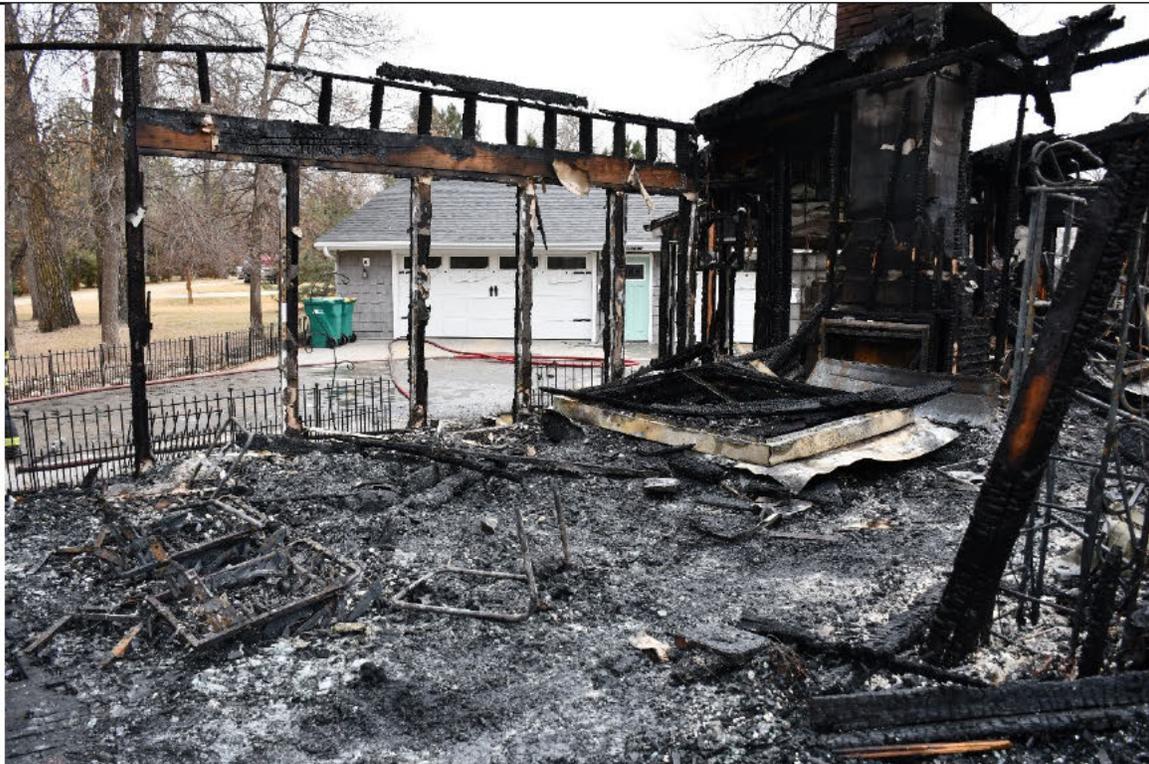
The front living room, located on the southeast part of the structure, sustained mass loss to the items inside the structure, with the southwest exterior wall still having some support studs standing, but all windows were no longer present. The beam on the southwest exterior wall had a saddle burn, indicating burning from the top down during the fire. (See figure 10).

Figure 9. The home's main living room located at southeast portion of the home.
