INCIDENT REPORT

Agency Incident ID: NDSFM25-031

Investigation Title: CARRINGTON MARLOW FIRE

North Dakota State Fire Marshals Office (ND)
INCIDENT ORIGIN & CAUSE NARRATIVE
Official Law Enforcement Report – Unauthorized Dissemination is Prohibited

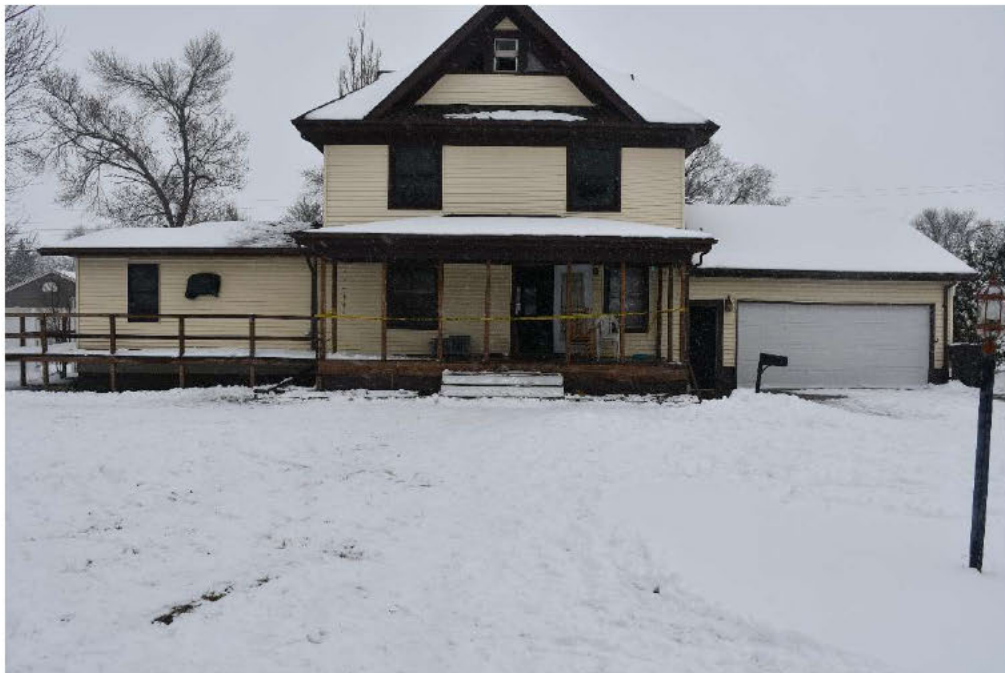
Figure 1 Photograph DSC_0001.JPG North Exterior Wall Of Structure Facing South

A fire occurred in a three-story single-family residence with a basement at 552 2nd Street S, Carrington, North Dakota. The Carrington Fire Department responded to extinguish the fire. The fire was contained to the kitchen area near the southeast corner. There were no injuries or fatalities reported to the North Dakota State Fire Marshal Office. (See Figure 1)

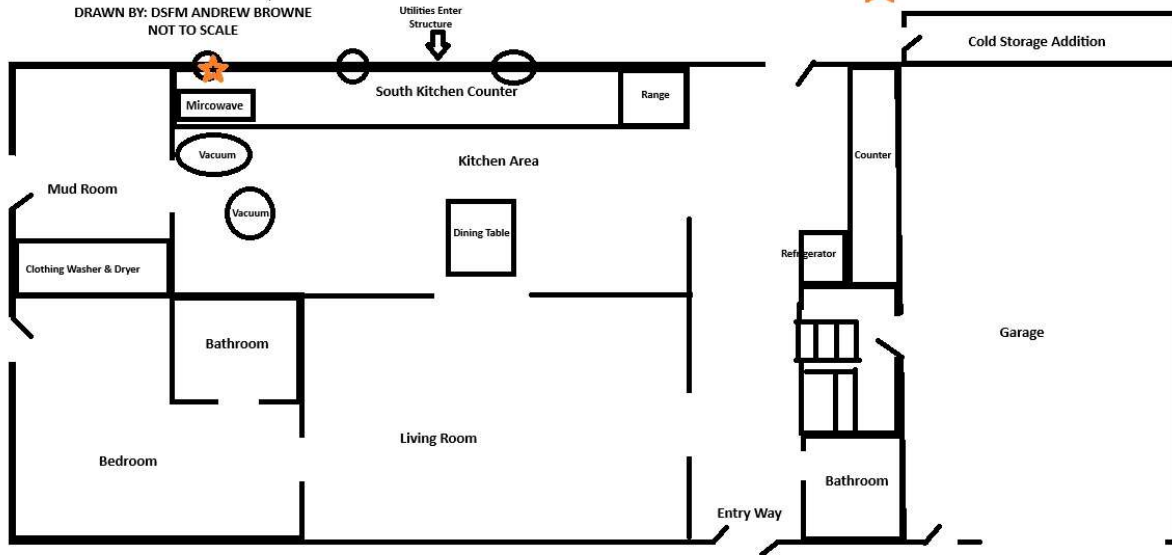
NDSFM25-031
CARRINGTON MARLOW FIRE
DATE OF FIRE: APRIL 2, 2025
552 2ND ST. S. CARRINGTON, ND
DRAWN BY: DSFM ANDREW BROWNE
NOT TO SCALE

The sketch of the main level was drawn by Deputy State Fire Marshal Andrew Browne. The sketch was not drawn to scale. The sketch will remain with the file.

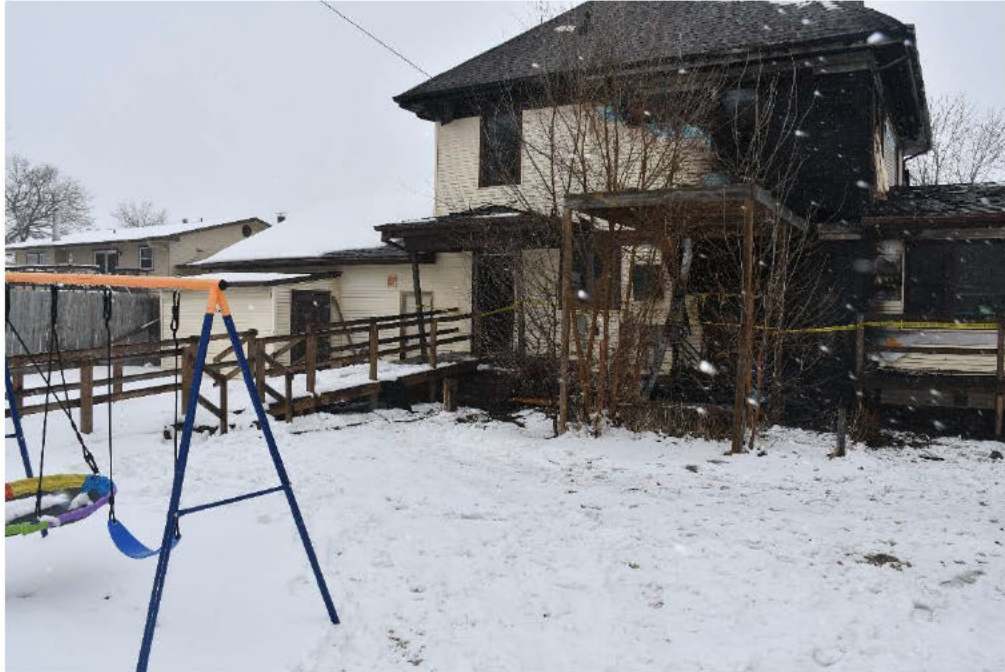
Figure 2 Photograph DSC_0007.JPG South Exterior Wall Of Structure Facing North

The exterior south wall had a south entry/exit door, garage service entry/exit door, three main level windows, and two second story windows. All the windows and glass along the south exterior wall were broken consistent with firefighting operations. Approximately along the easternmost half of the south wall was a wooden deck that extended from the structure with a wooden ramp that extended near the entry/exit door. The wood deck and ramp had no damage noted. Extending approximately in the middle of the south wall of the structure was a wooden trellis that extended from the structure. The wood trellis had no damage noted. Extending in the westernmost portion of the structure was a cold storage addition. The cold storage addition door was closed and no visible damage noted. The electrical services and natural gas entered the structure on the south wall to the east of the ramp. The siding to the east of the electrical services and natural gas meter was melted and the wood was charred. The fire damage started near the foundation and extended upward to the second story of the structure. As you went away from this area, the siding remained intact. The soffit and fascia of the roof directly above was charred. (See Figure 2)

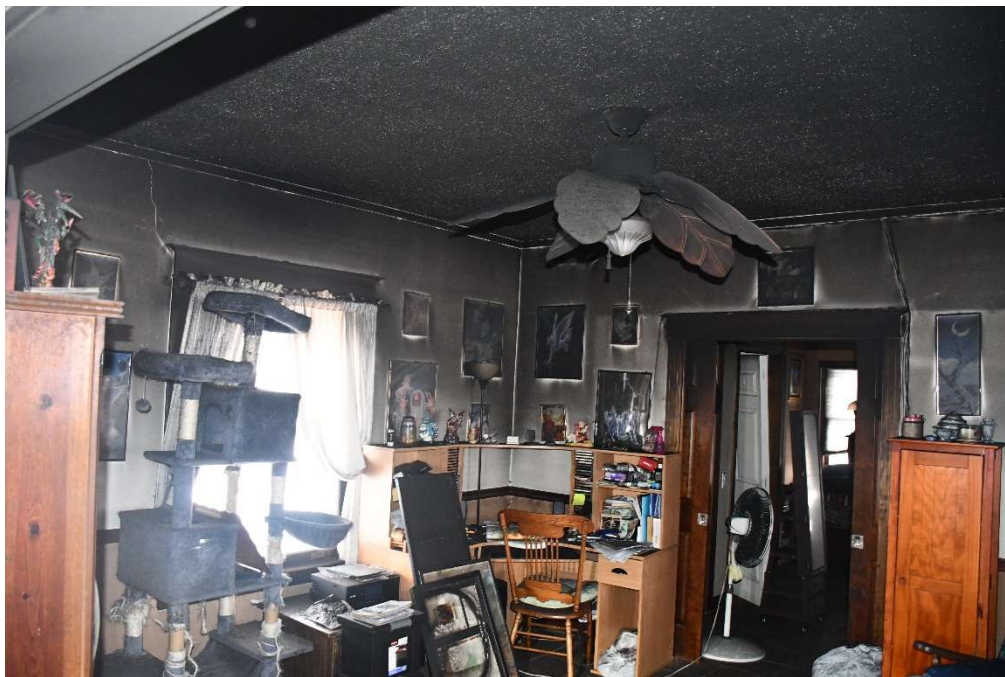
Figure 4 Photograph DSC_0098.JPG Northeast Corner And North Hall Of Main Level Living Room

Continuing to the east through the north/south hallway was a living room. The west wall had an opening that led to the north/south hallway along the southernmost portion of the wall and a gun cabinet along the northernmost portion of the wall. Along the north wall was a cat tower, and intact window, and an office desk in the northeast corner. Along the east wall was a door that entered the master bedroom/bathroom, a wood storage stand, and a metal stand. Along the south wall in the easternmost portion was an opening that led to the dining room. In front of the opening was a couch, rocking chair, and coffee table. In the southwest corner was a wood stand. There were soot deposits along the ceiling that extending down the walls towards the floor. The soot deposits decreased from top/down. In approximately middle of the living room was a ceiling fan. The fan blades were covered in soot and annealed downward. In the southeast corner of the living room was a smoke detector. The smoke detector had acoustic soot agglomeration on the horn speaker. In the living room there was barbeque style lighter observed on the top of the westernmost wood stand. All the contents within the living had soot deposits throughout. (See Figure 4)

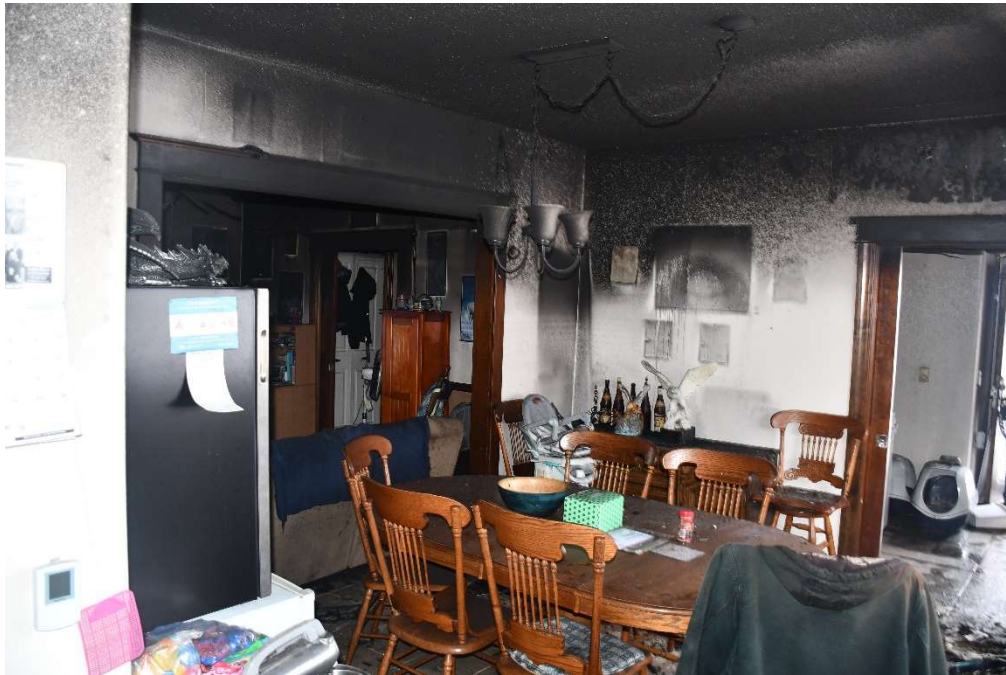
Figure 5 Photograph DSC_0139.JPG Kitchen Dining Room Facing Northeast

In the northernmost portion of the kitchen was a dining room. The living room had a dining room table and chairs, an open space along the northern wall that led into the living room, a refrigerator along the west wall, and a wood table along the east wall. There were soot deposits on the ceiling that extended down the walls that decreased towards the floor. The items within this area remained intact with soot deposits throughout. The dining room had a security camera located on the northernmost wall. (See Figure 5)

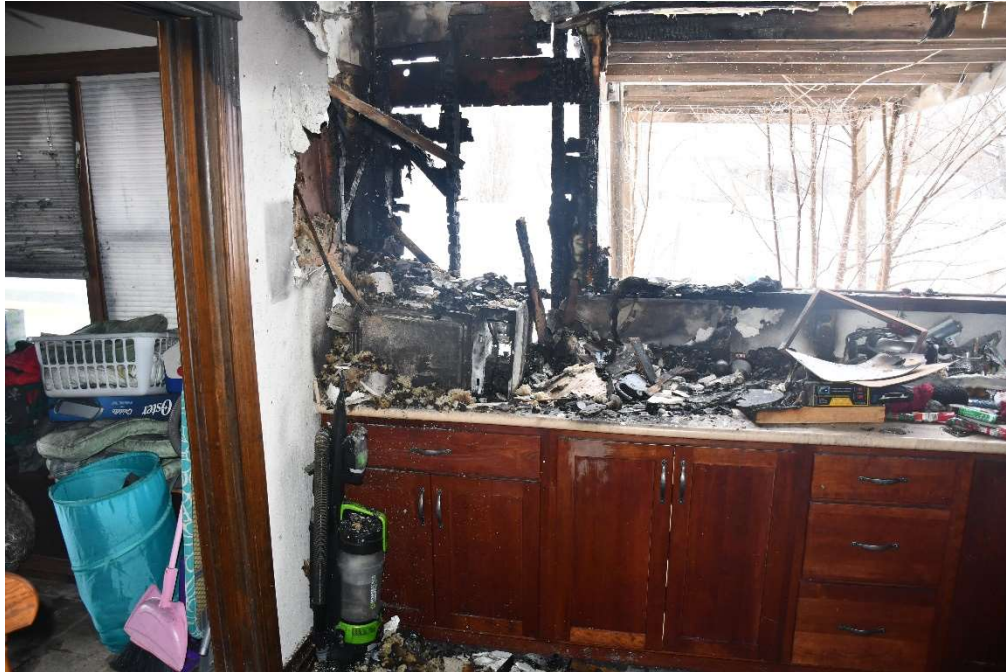
Figure 6 Photograph DSC_0150.JPG Southeast Corner Of Kitchen Easternmost Portion Of The South Counterspace

Along the southern wall of the kitchen there was an oven in the westernmost portion of the wall. To the east of the oven was a built-in range in the counterspace. The counterspace extended from the oven to the east along the whole south wall of the kitchen. Along the counterspace there were items being stored throughout such as cooking utensils, cooking spices, paper towels, Google Home, pots, medications, cardboard boxes, Christmas decorations, batteries and a microwave. The items on the easternmost portion of the counter were charred and decreased towards the west, with most of the items along the western portion of the counter remaining intact. Along the south wall was an air conditioning unit. The air conditioning unit had soot deposits and was not plugged in. To the east of the air conditioning unit was a window. The window and window frame were removed and laid on the ground directly below the opening. The glass was broken. The wood window trim had charring throughout with more damage along the east portion compared to the west portion. The microwave was on the easternmost portion of the counter. The microwave had melted and was oxidized and warped. The cabinets on the lower portion of the south counter had soot deposits but remained intact. (See Figure 6)

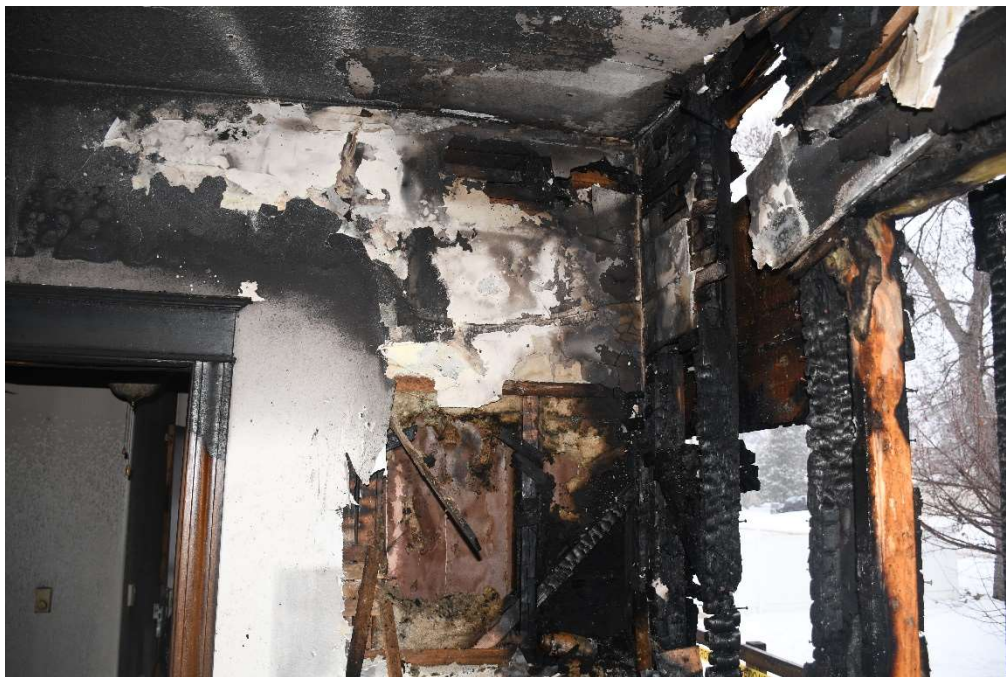
Figure 7 Photograph DSC_0153.JPG Southernmost Portion Of East Wall In Kitchen

In the southeast corner of the kitchen directly above the area where the microwave was there was charring and mass loss to the wall that extended upward and out towards the ceiling, making a v-pattern. Along the upper portion of the wall and ceiling in the southeast corner the lath and plaster were peeled and cracked that extended outward and decreased the further away from the southeast corner. (See Figure 7)

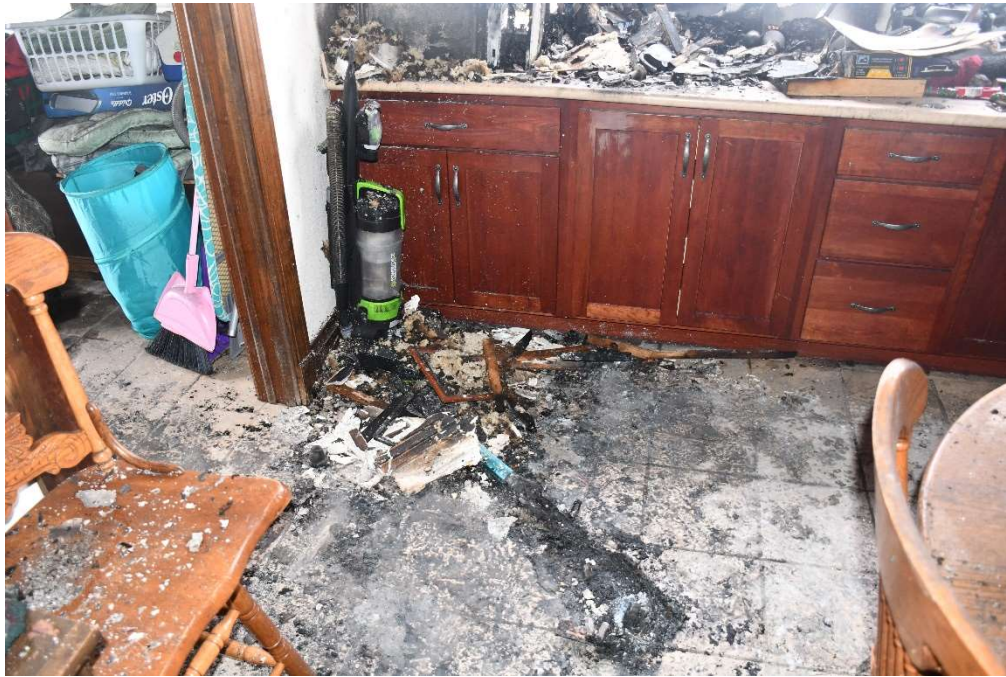
Figure 8 Photograph DSC_0149.JPG Southeast Corner Of Kitchen Floor Facing South

Layering started just to the west of the microwave along the easternmost portion of the south counter and floor directly below the counterspace and continued towards the east. Along the floor was the remains of a battery vacuum. The vacuum was not

plugged in and no visible line cords extending from the vacuum. There was mass loss to the uppermost portion of the vacuum and the batteries were oxidized. Along the east portion of the wall was a vacuum. The vacuum sustained melting to the upper portion. The vacuum was not plugged in, and the line cord was intact and wrapped up in the rear support brackets. (See Figure 8)

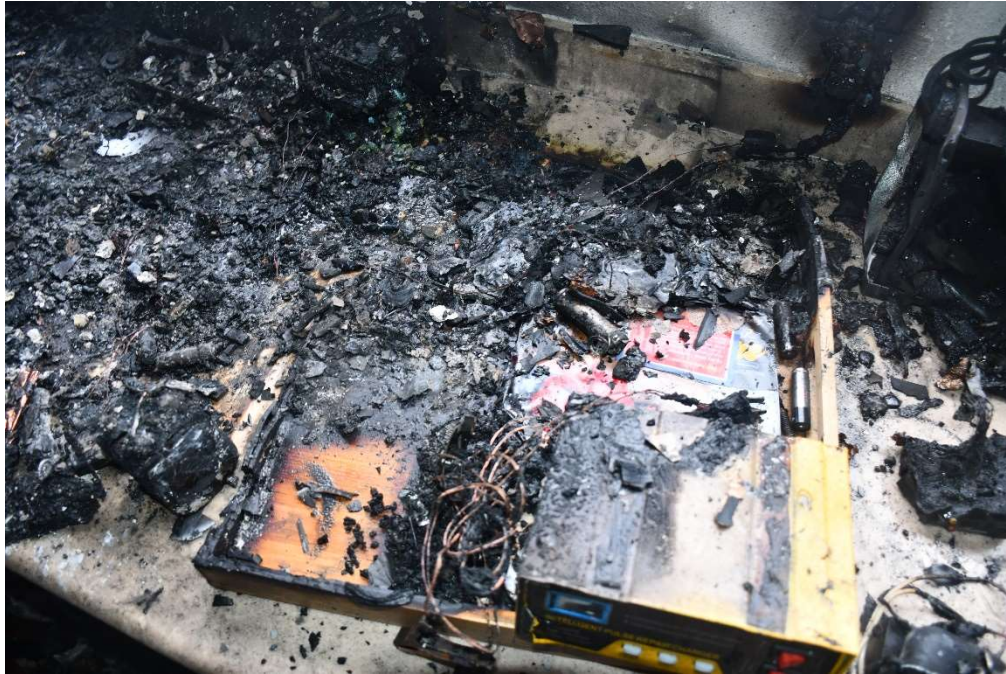
Figure 9 Photograph DSC_0173.JPG South Kitchen Counter Start Of Layering Easternmost Portion Of Counterspace

Along the westernmost portion of the counter layer discovered a receptible with a Google Home plugged into the socket. The line cord sustained melting of the exterior plastic jacketing, and the wires were oxidized and broken off approximately midway. The receptible sustained melting to the exterior faceplate but the interior of the receptible remained intact. Along the counter was a battery charger. The battery charger line cord exterior plastic jacketing was melted and was not plugged in. Along the line cord of the battery charger the metal wiring remained intact. (See Figure 9)

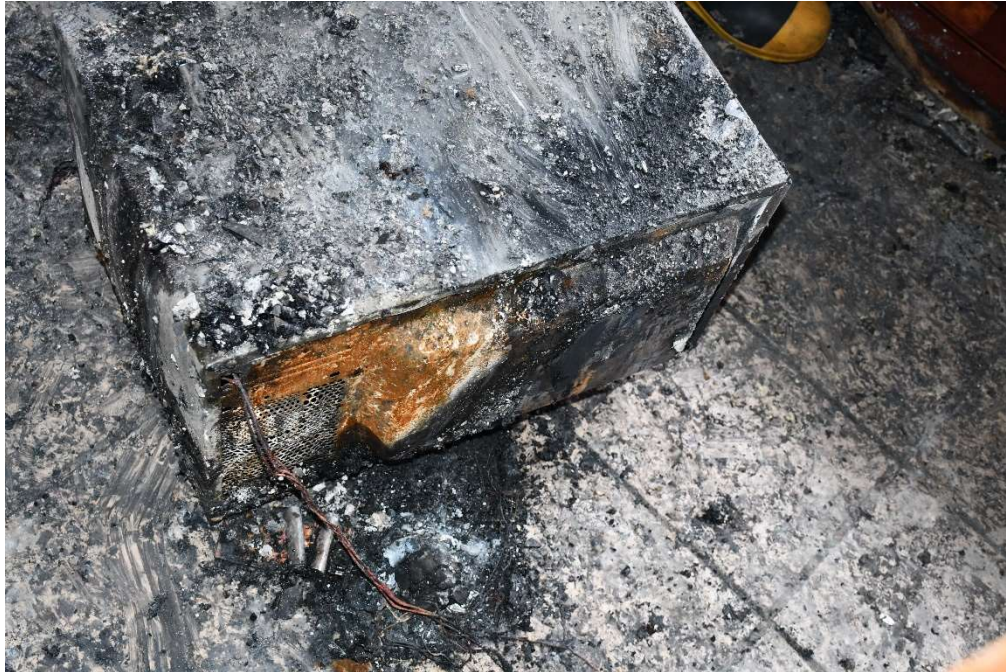
Figure 10 Photograph DSC_0179.JPG Back Side Of Microwave Facing Along South Wall In Kitchen

Layering continued to the microwave. On the top of the microwave was several batteries that were oxidized. The microwave exterior plastic was melted. The microwave was oxidized. Along the back portion of the microwave that was facing south there was a v-pattern that extended along the westernmost portion with a rust discoloration. The discoloration was found only in this area on the microwave compared to the other areas on the microwave. The interior line cord inside the microwave was charred and remained intact exiting the microwave. As the line cord continued away from the microwave the line cord had sustained oxidation compared to the remaining portions. The line cord was frayed at the end of the line cord. I was unable to find the plug-in components on the line cord within the area or plugged inside the socket of the receptacle. (See Figure 10)

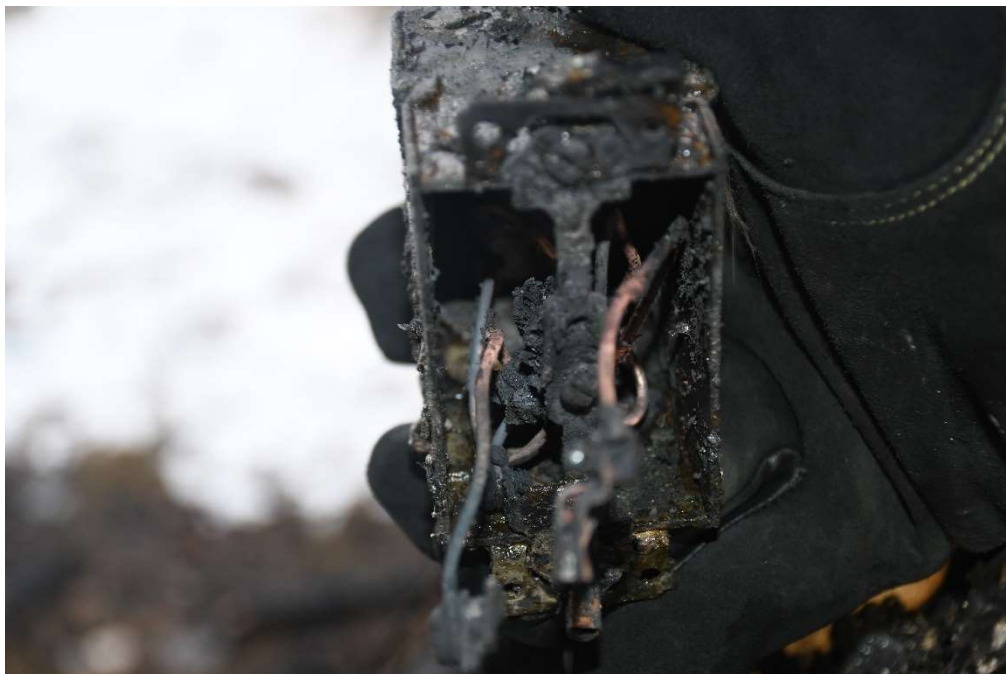
Figure 11 Photograph DSC_0194.JPG Closeup Of Receptacle Behind Microwave

Continuing layering, the receptacle that the microwave was plugged into was laying outside on the ground with the line cord oxidized and intact. The receptacle was consumed and oxidized. Inside the receptacle there was arc splatter visible. Inside the receptacle there was electrical resistive heating along the conductors. (See Figure 11)

- The easternmost receptacle behind the microwave on the south wall has sustained resistive heating.
 - The fire damage was the greatest in this area compared to the other areas of the structure.

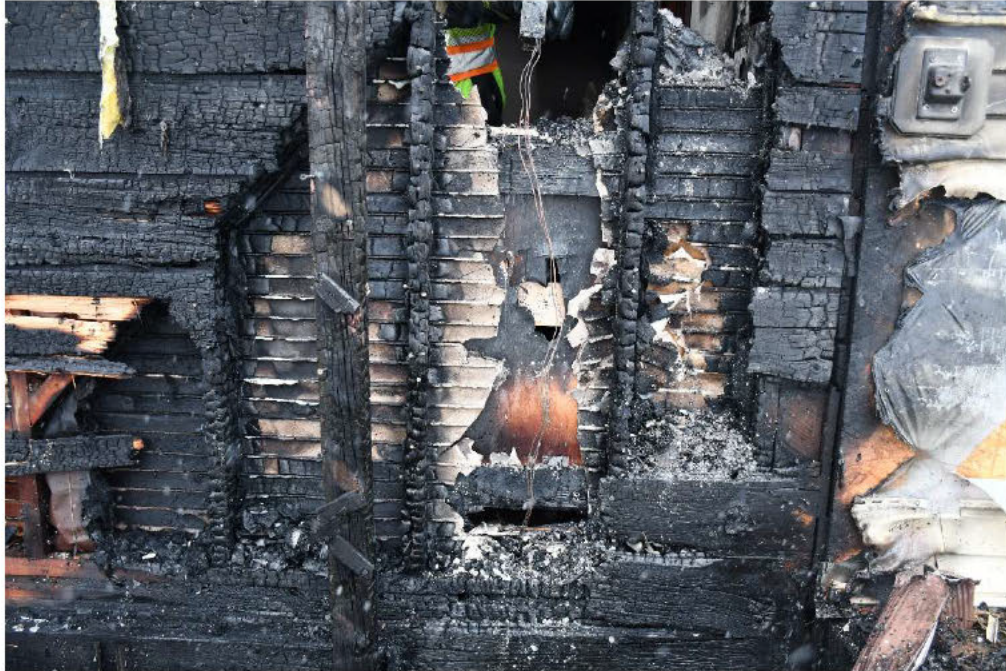
Figure 12 Photograph DSC_0182.JPG South Kitchen Wall Space In The Easternmost Portion Of The Wall From Exterior Facing North

Reconstruction of the receptacle and line cord were put back in its approximate location prior to fire. The receptacle and the discolored v-pattern at the rear (southern) portion of the microwave were parallel with one another. From the line cord

extending towards the ground, there was more mass loss between the two wood studs compared to the other wood studs' interstitial space. Where the receptacle was inside the structure in the easternmost portion above the counter there was more mass loss to the wall compared the remaining wall spaces in the kitchen. Inside the interior/exterior wall space there was mass loss to the wood wall studs and decrease the farther away from where the line cord ran through the wall space. (See Figure 12)
