INCIDENT REPORT

Incident Type: Fire / Undetermined

Agency Incident ID: NDSFM25-071

Investigation Title: PINGREE SIEBERT FIRE

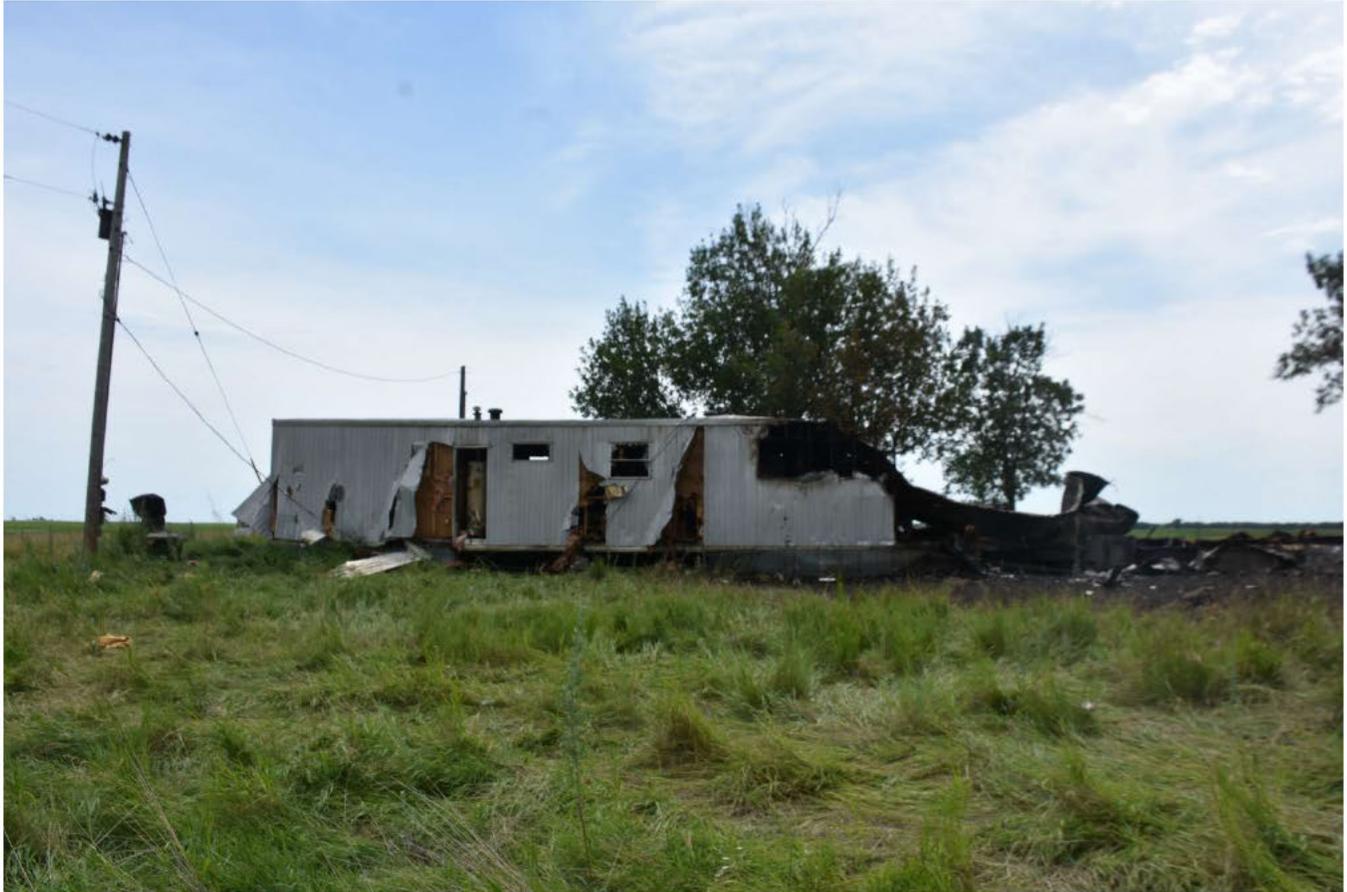
Figure 1: The fire occurred at 7374 12th St. SE, Pingree, ND. The view is from the north side of the building looking south.

The fire was called into 9-1-1 at approximately 10:00 AM by a neighbor after locating smoke and then flames on the southwest corner of the building. The Pingree Rural Fire Protection District responded and extinguished the fire.

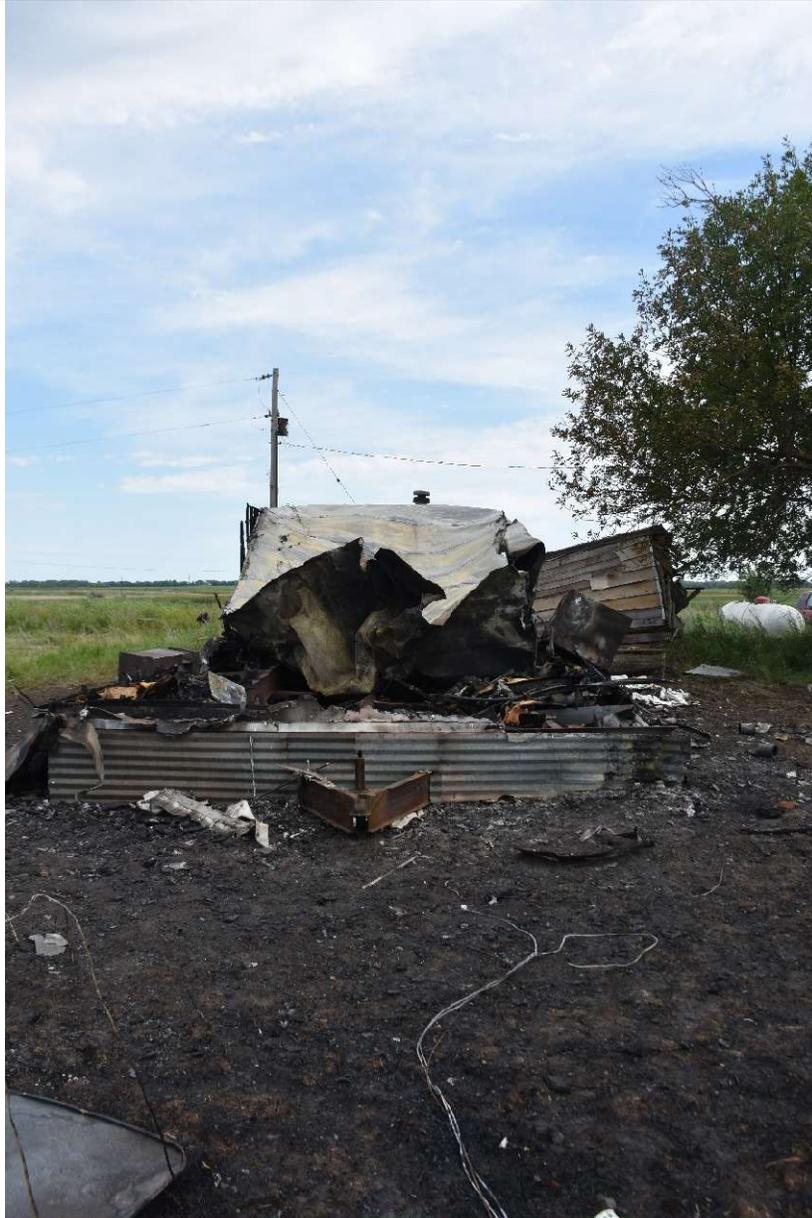
The west side of the residence had sustained mass loss. The west wall had significant mass loss, the only remaining portion of the west wall was the corrugated steel paneling that was located below the level of the trailer home's floor. The corrugated steel panels were charred on the south side along with heat induced color change. (See figure 2.) The grass and vegetation along the west, northwest, and southwest side of the structure sustained charring and mass loss. The amount of charred vegetation and how far the charring extended from the residence varies.

Figure 2: West side of the trailer home. Wall that sustained mass loss and corrugated paneling below the floor line. The charring on the ground was burned vegetation. The burned vegetation expanded out from the trailer home on the west side of the structure.

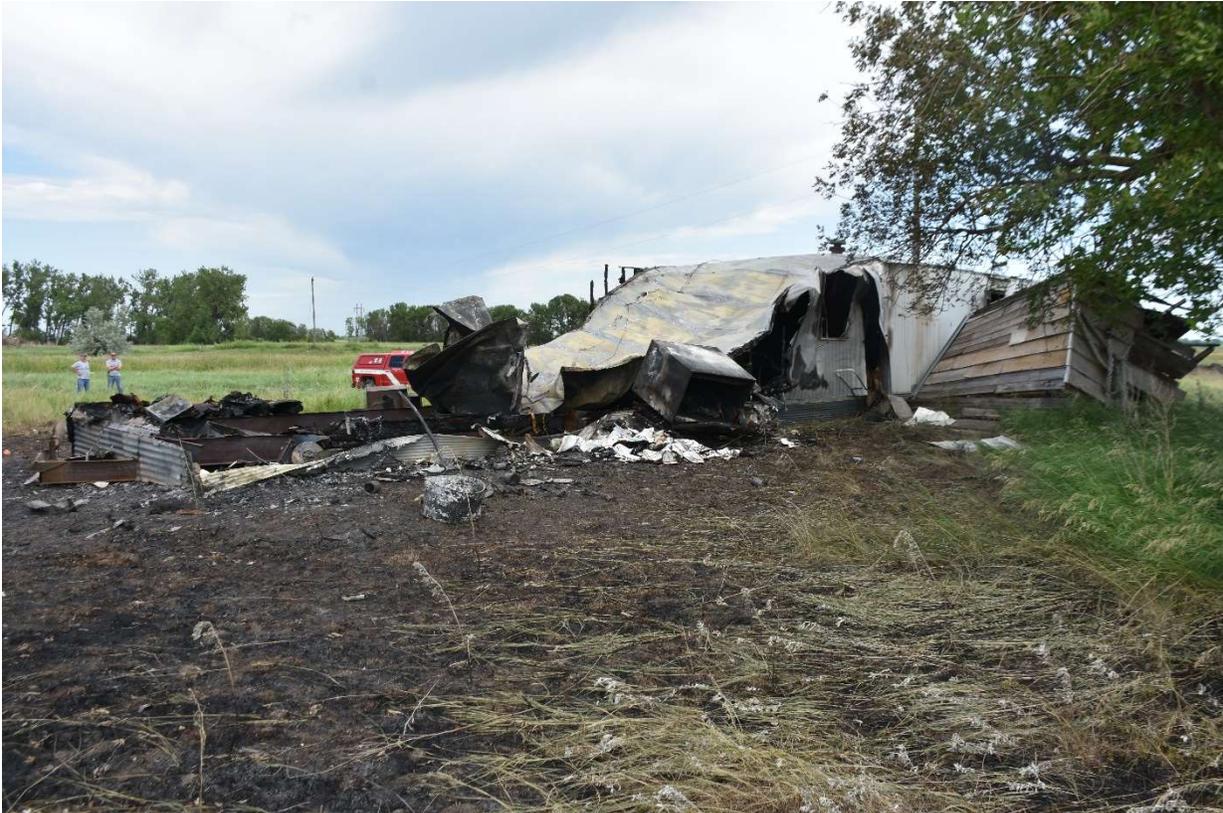
The south side of the trailer home had mass loss to the wall on the west side. The mass loss extended east approximately half the length of the trailer home. The wood studs for the south wall sustained mass loss from west to east. The wall studs on the south side of the trailer home had mass consumption that went further east than the north side of the trailer home. The western most south side window had no glass remaining and the steel siding southwest of the window had heat induced color change. The east side of the south wall had siding removed that was consistent with fire department operations exposing wall studs. The exposed wall studs had areas of charring, with greater charring on the northeast side of the exposed south wall. The easternmost window on the south wall had no glass in it, there was indication the window was covered with plywood. The plywood was mostly removed, which was consistent with fire department operations. The door into the trailer home was observed in an open position. The window on the door was broken out; the remaining window was smoke stained. The inside of the door was charred and smoke stained. The corrugated steel at the base of the

trailer home was folded down at the southwest corner. The corrugated steel had heat induced color change also in the southwest corner. Four fuel cans were located on the south side of the trailer house. A metal fuel can was located at the base of the wall west of the chest freezer. The metal fuel can sustained heat induced color change and oxidation. The fuel can was empty and still had the twist cover on the drain spout. There were also three fuel cans located in the debris of the wood building; two gas cans and one diesel can. The one gas can that was not trapped by the debris of the wood structure was checked and determined to have been empty. There was a wood framed structure that had collapsed to the southeast. The structure appeared to have been at one time attached to the trailer home even though it no longer was. The wood structure had no signs of fire damage. (See figure 3.)

Figure 3: South side of the trailer home looking from the southwest to the northeast. The west side of the trailer home had mass consumption to the west side of the south wall. A wood structure on the south side of the trailer home had been attached to the residence at one time before collapsing. The wood structure did not sustain any visible fire damage.

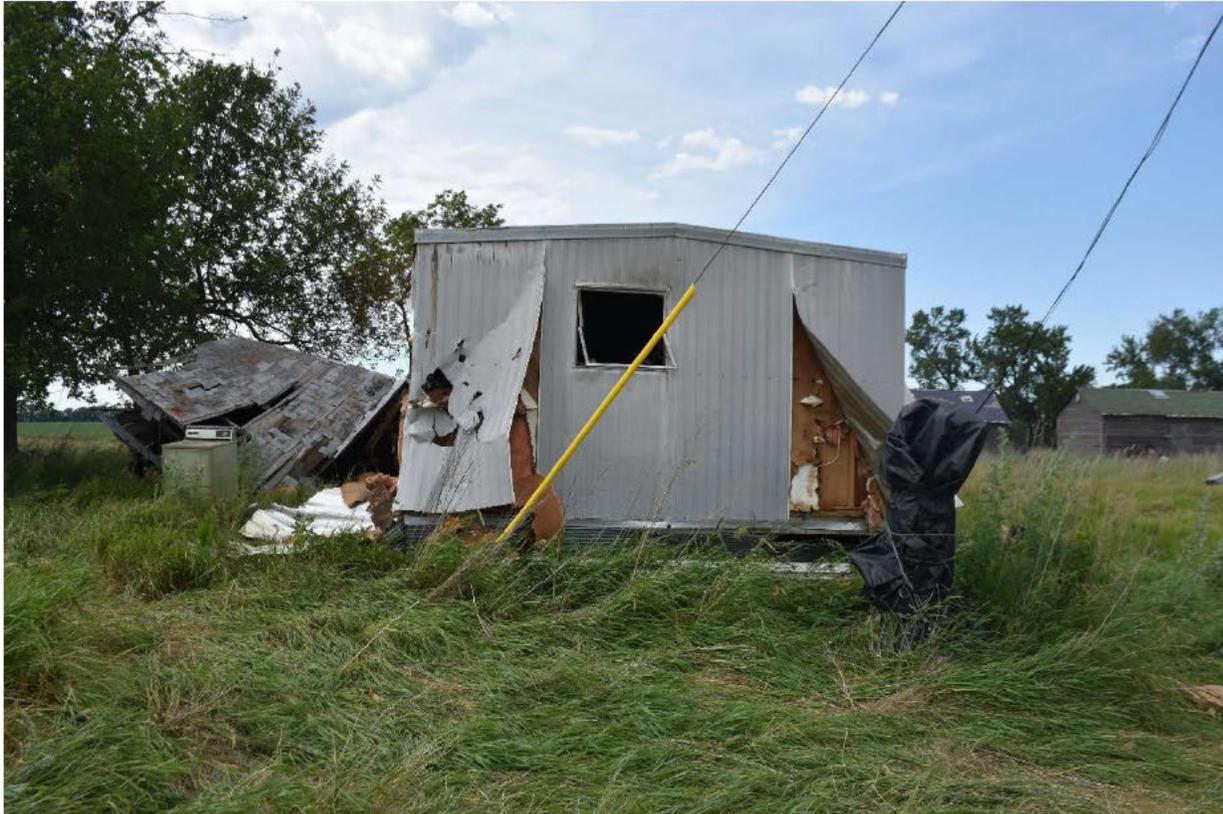
The east side of the trailer home had some smoke staining to the metal siding above the window. The smoke staining was greater on the top north side of the window. The window was broken out, the damage to the bottom of the window frame was consistent with fire department operations. There were areas of the metal siding that had been removed exposing the walls studs. The removed siding was consistent with fire department operations. No charring was observed to the exposed wall studs on the east wall. (See figure 4.)

Figure 4: View of the fire damage to the east side of the trailer home. View looking from east to west.

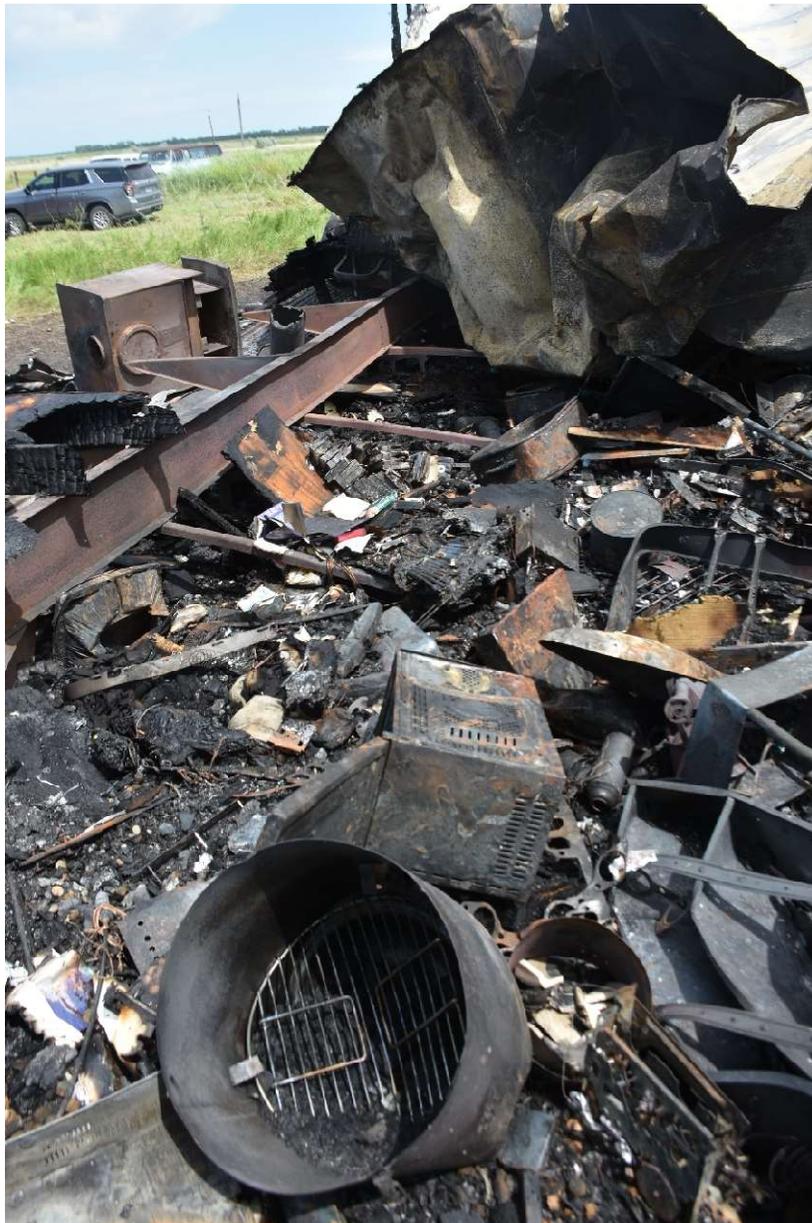
home. The items located in the debris on the west side of the trailer home included, a metal cylindrical container with a metal cooking grate at the bottom, the charcoal located under the cooking grate would indicate the cylindrical container was either a grill or a smoker. The grill had sustained some areas of oxidation and there were still some solid pieces of charcoal in the bottom. Also located in the debris was a collapsed metal shelf, motor vehicle parts, a microwave, and some aerosol cans. The metal objects located in the debris had heat-induced color change and oxidation. (See figure 5.)

Figure 5: A charcoal grill/smoker found within the fire debris on the west side of the trailer home. The view is from the west side of the trailer home looking east.

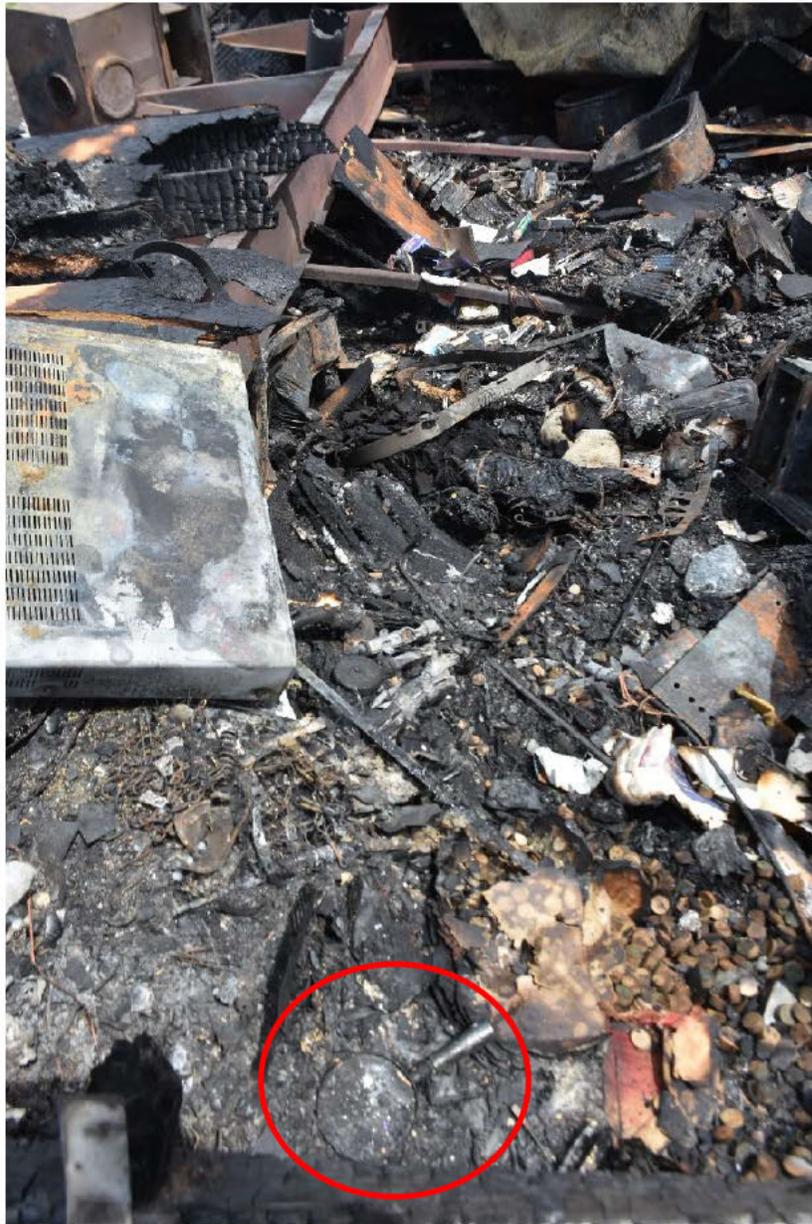
In the debris along the west wall, north of the charcoal grill, a magnifying glass was located on the top of the debris, next to a charred cardboard box containing charred and smoke stained cork tops. The glass in the magnifying glass was still intact and was not cracked or broken. The handle of the magnifying glass had sustained heat induced color change. (See figure 6.) The bottom sill on the southwest corner of the trailer home had sustained mass loss. The greatest mass loss to the bottom sill was between the first and second

Figure 6: Magnifying glass found in the fire debris along the west side of the trailer home. Looking from west to east. The magnifying glass is emphasized by a red circle around it.

The weather conditions could have had an indirect cause of the fire; the open roof of the trailer from a previous storm allowed sunlight to enter the trailer from the top; direct sunlight exposure onto a magnifying glass could have refracted the sunlight to ignite nearby combustible materials. The wind direction and wind speed did not contribute to the spread of the initial fire reported at approximately 10:00 AM on July 9, 2025. The wind speed and direction could have contributed to the reignition of the fire and contributed to the spread of the second fire that was reported at approximately 9:30 PM on July 9, 2025.

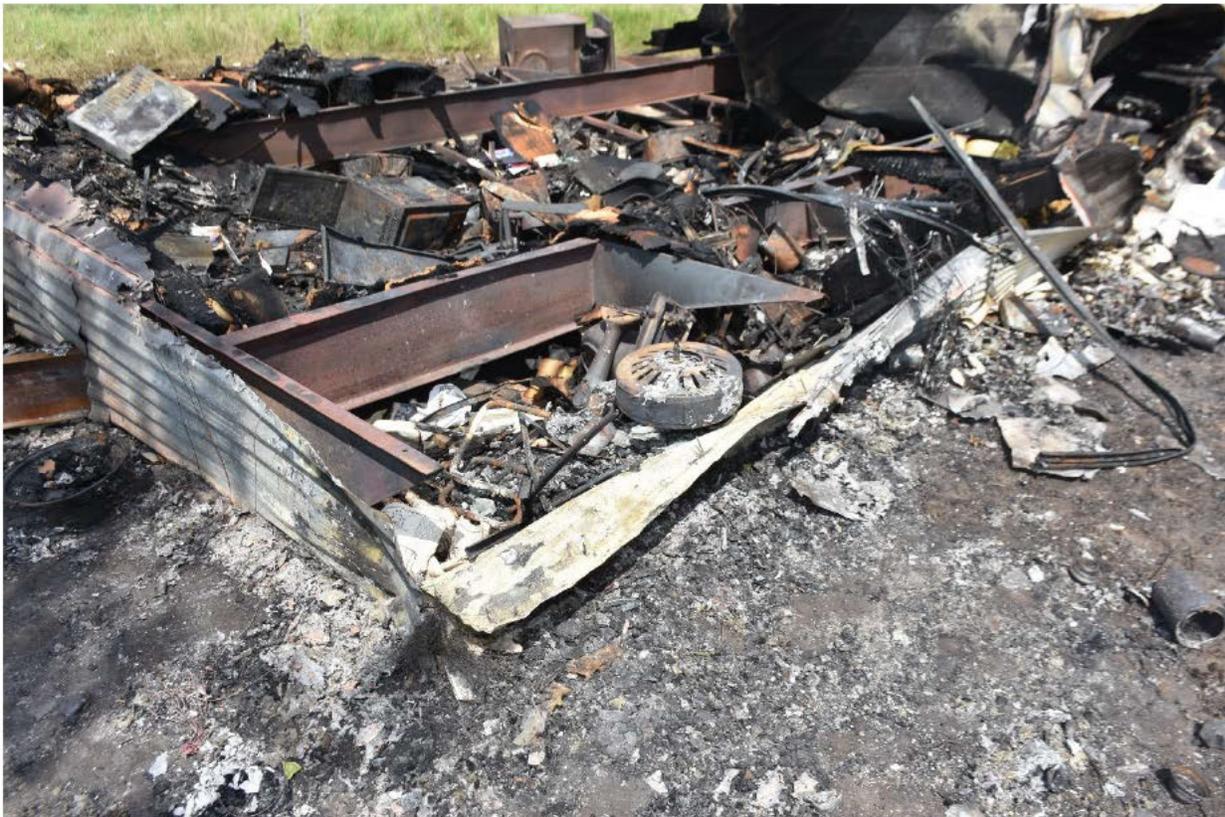
Based upon the systematic examination of the fire scene, witness statements, and other data collected, the area of origin was determined to be at, on, or near the interior of the structure on the southwest side. (See figure 7.)

Figure 7: The area of origin, the southwest side of the trailer home. View is from the exterior looking from southwest to northeast.

Due to the significant mass loss of the area origin and inability to identify the start of the ignition sequence, multiple credible competing hypothesis for the cause of the fire remained. Due to there being multiple remaining hypothesis, the fire cause will be undetermined to be in accordance with NFPA 921.
