## INCIDENT REPORT

Agency Incident ID: NDSFM25-075

Investigation Title: RYDER JOHANSEN FIRE

**North Dakota State Fire Marshals Office (ND)**  
**INCIDENT ORIGIN & CAUSE NARRATIVE**  
**Official Law Enforcement Report – Unauthorized Dissemination is Prohibited**

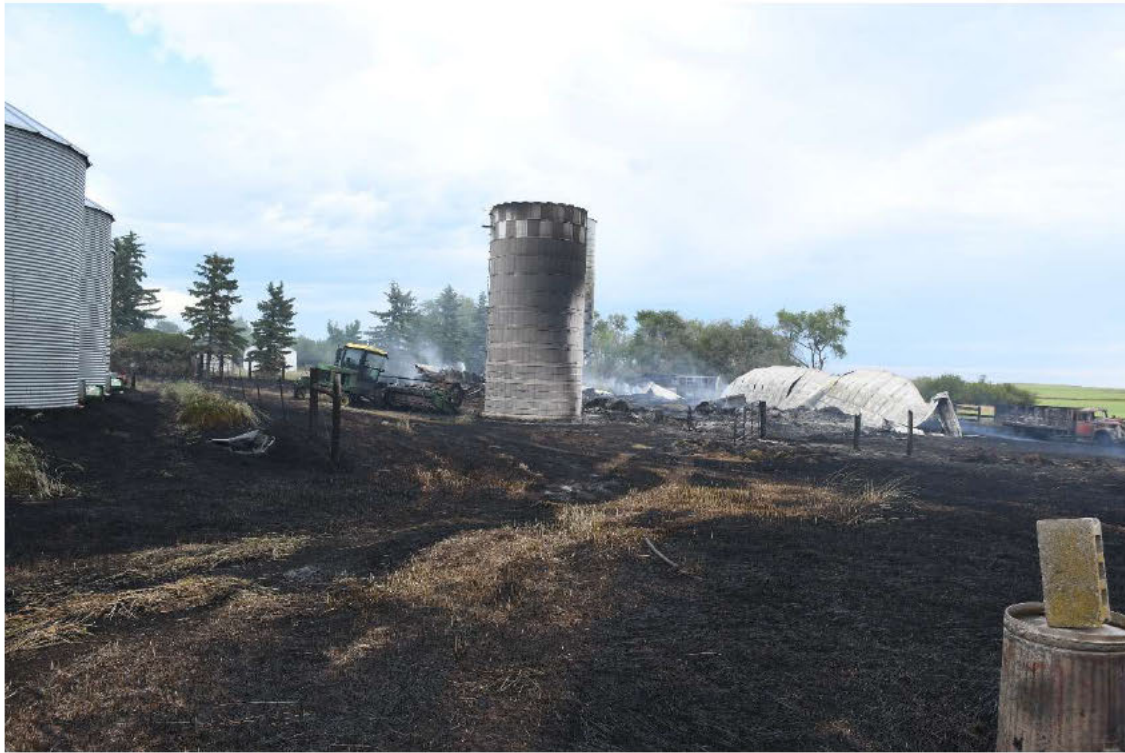
On Sunday July 13, 2025, at approximately 3 PM the Ryder-Makoti Rural Fire Protection District was dispatched to a grass fire that was close to a barn. The fire was reported to be at 29001 240<sup>th</sup> St. NW, Ryder, ND 58779. Upon the fire department's arrival, the fire began to impact two agricultural barns. During extinguishment efforts, the fire department was informed of an adult male that was unaccounted for. During search efforts, a deceased victim was recovered in the debris of a collapsed barn. (See Figure 1)

Figure 1 DSC\_0011.JPG Swather, Silo, Dairy Barn

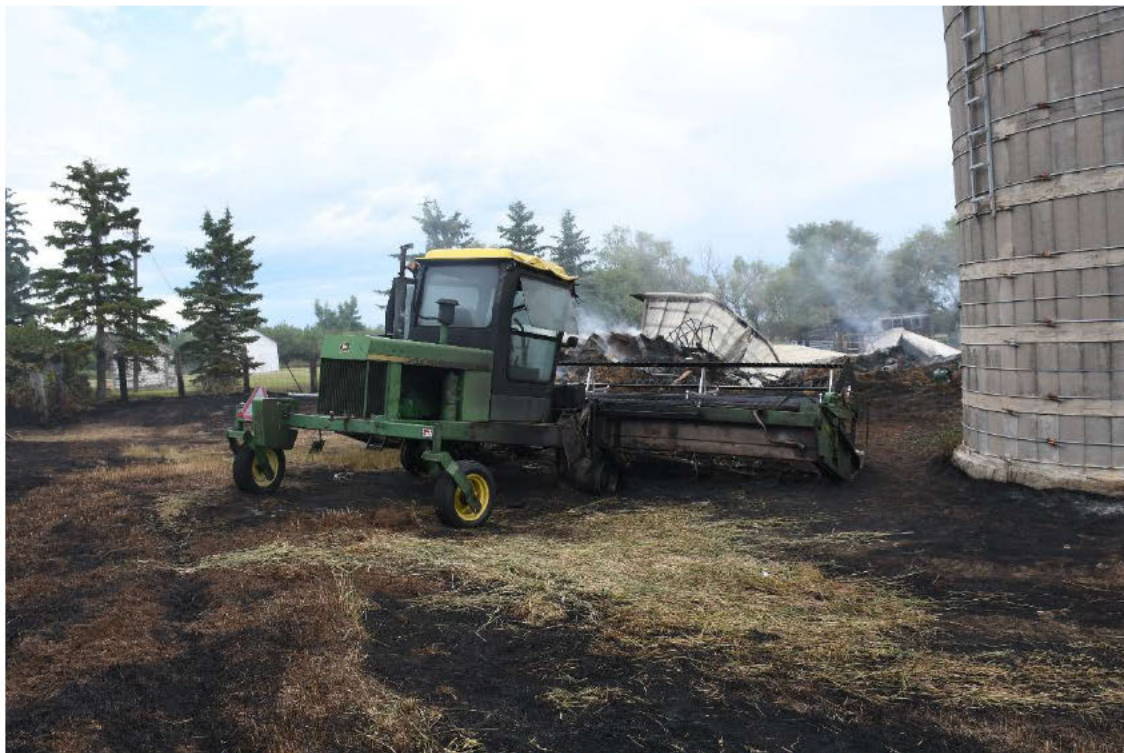
The John Deer 2420 Swather was orientated east/west with the swather attachment facing the collapsed dairy barn. South of the John Deer 2420 Swather was a concrete silo. Vegetation surrounding the John Deer 2420 Swather was charred. (See Figure 3)

*Figure 3 Photograph DSC\_0013.JPG John Deer 2420 Swather, Silo, Dairy Barn*

The south side of the tractor had oxidation at the swather attachment connection. As extension went to the rear oxidation and soot deposits decreased. The front tire was nearly consumed with little reaming. The cab windows remained intact. The back side of the swather header was oxidized. The oxidation was greatest to the area closest to the ground and decreased as extension went up the header.

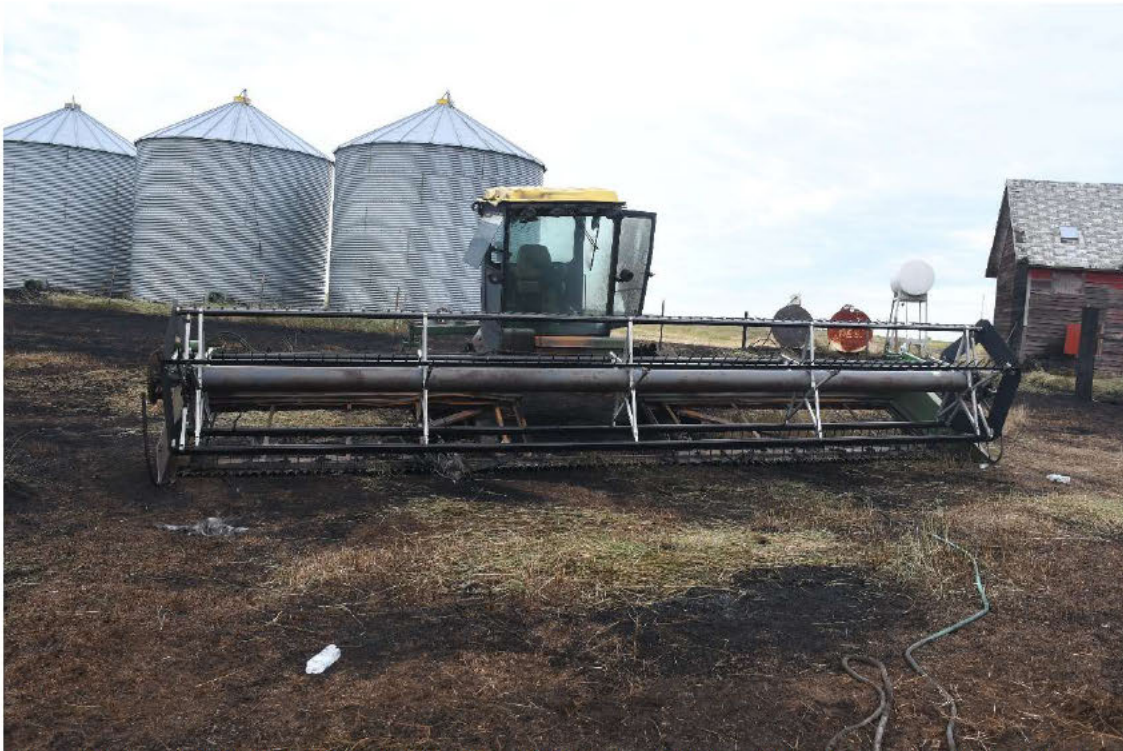
The front of the John Deere 2420 Swather had the swather attachment. The south half of the swather attachment had greater oxidation, melting, and consumption compared to the north half. The rake teeth along the southernmost half had melting and mass loss. As the extension went north the melting and mass loss to the rake teeth decreased. The remains of the conveyor

belt were visible extending north/south. The conveyer belt frame had more warping on the southernmost half compared to the northernmost half. Oxidation extending up and to the north was visible below the windshield. The windshield remained intact. The flood lights attached to the roof area had melting but remained attached.

A line of demarcation of unburned and charred vegetation was noticed in front of the swather attachment consistent of where the swather came to a stop. Drag marks were noticed in the soil in front of the swather attachment. The marks were consistent with dragging the John Deere 2420 to the west. Approximately the center of the swather rocks were noticed. A pile of charred vegetation was noticed in proximity to the rocks. (See Figure 4)

Figure 4 Photograph DSC\_0015.JPG Front of John Deere 2420 Swather, Oxidation, Melting, Consumption, Charred Vegetation
