INCIDENT REPORT

Investigation Title: ANAMOOSE RUDNICK FIRE

North Dakota State Fire Marshals Office (ND)
 INCIDENT ORIGIN & CAUSE NARRATIVE
 Official Law Enforcement Report – Unauthorized Dissemination is Prohibited

On Monday, July 28, 2025, at approximately 12:52 PM a fire occurred in a commercial structure identified as the Anamoose Café. The Anamoose Café was located at 705 Main Street, Anamoose, ND. (See Figure 1)

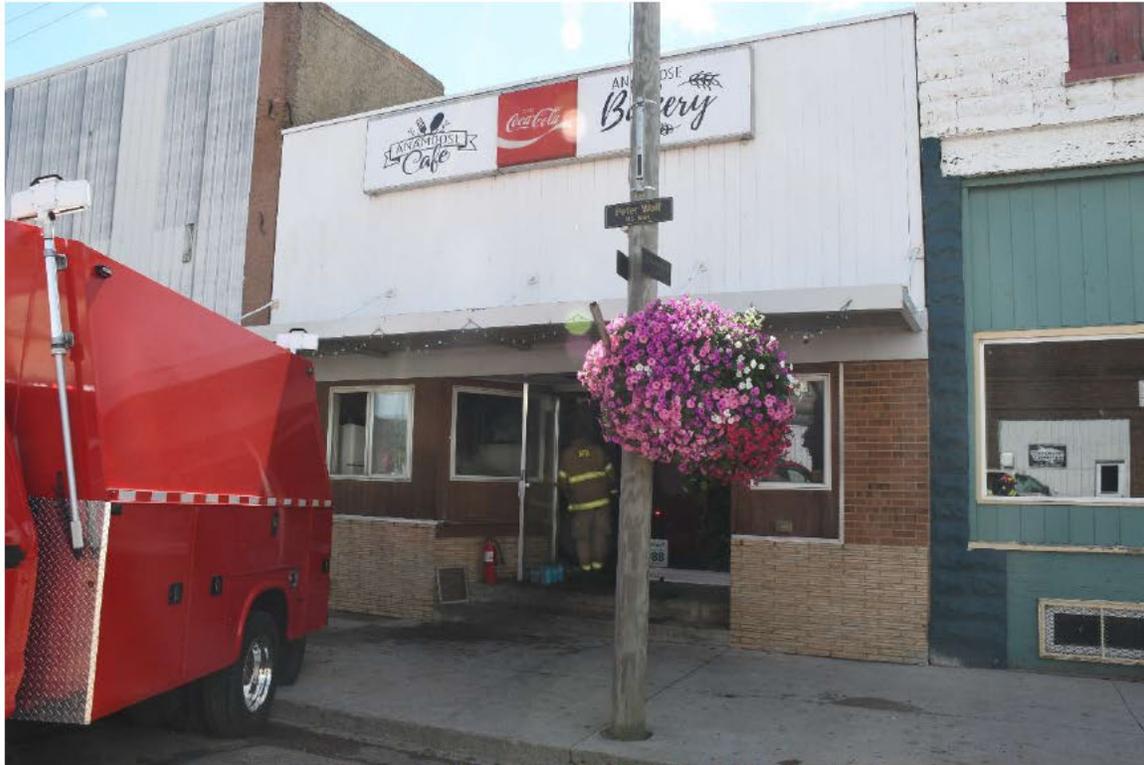
Figure 1 Photograph DSC_0002.JPG Exterior East Side - Store Front

The exterior east side of the structure faced Main Street and had a metal sided parapet. Approximately center of the wall was a recessed entryway with two concrete steps leading to the main entry/exit door. The entry/exit door was propped open and was comprised of glass panels. Windows were on each side of the recessed entryway. The window at the southernmost end was open. A window screen and two portable fire extinguishers were on the ground along the southernmost end. No fire or heat damage was noticed on the exterior east side. (Refer back to Figure 1)

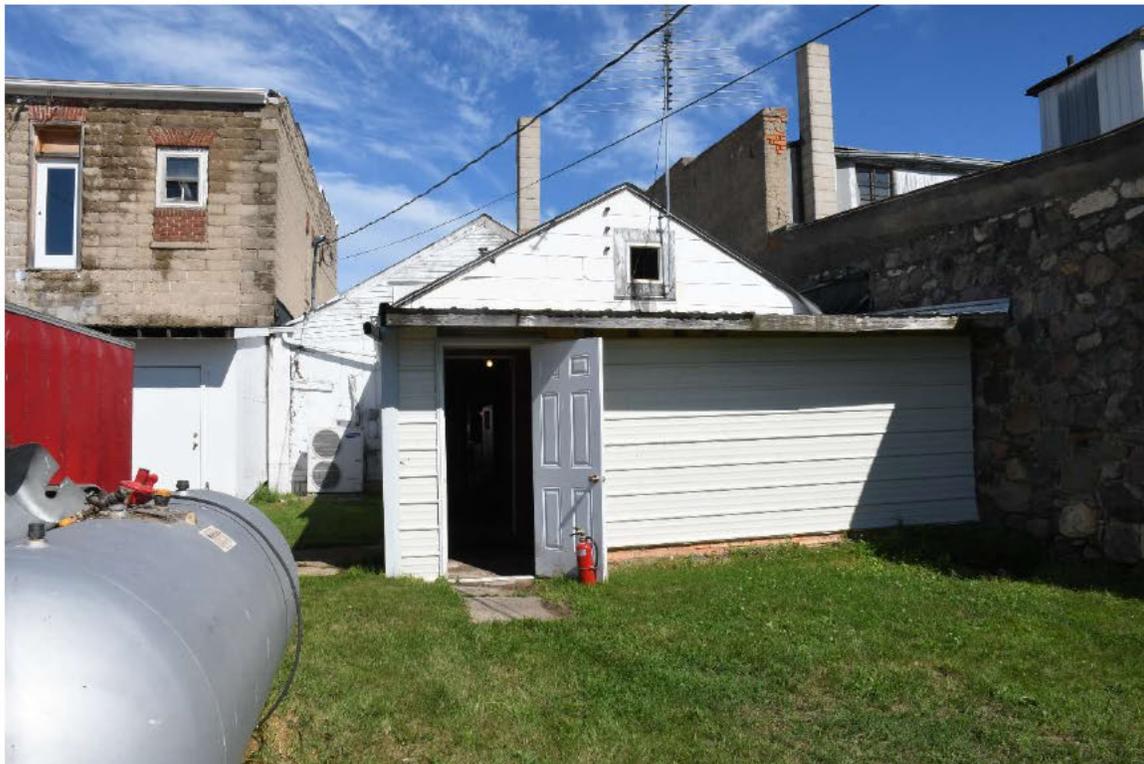
The west side of the building had an addition and faced an alleyway. The backside of the building had wood siding and one entry/exit door. The door was propped open with a portable fire extinguisher. Above the door was a small opening that provided attic access. No fire or heat damage was noticed on the exterior west side. (See Figure 2)

Figure 2 Photograph DSC_0020.JPG Exterior West Side - Backside of Building

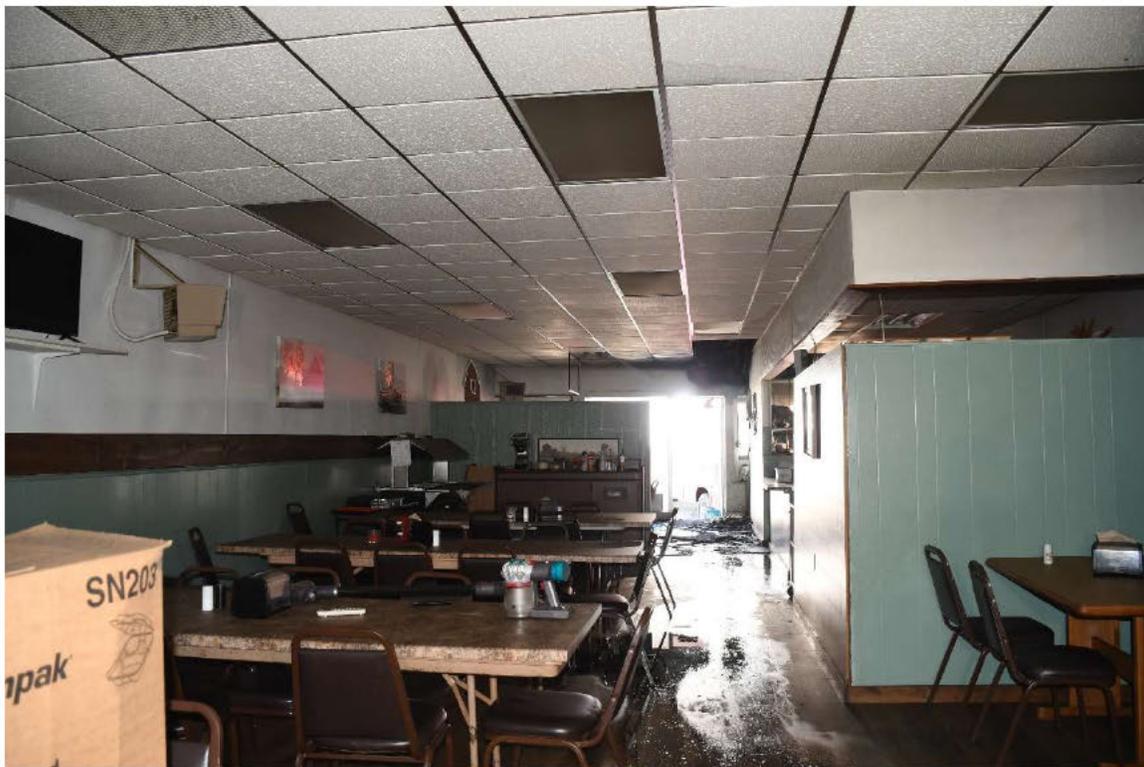
The northern half of the restaurant area was used as seating. Tables and chairs extended along the north wall. A partition wall extended east/west and enclosed the kitchen area from the seating area. (See Figure 3)

Figure 3 Photograph DSC_0060.JPG Main Restaurant Area - Seating/Kitchen

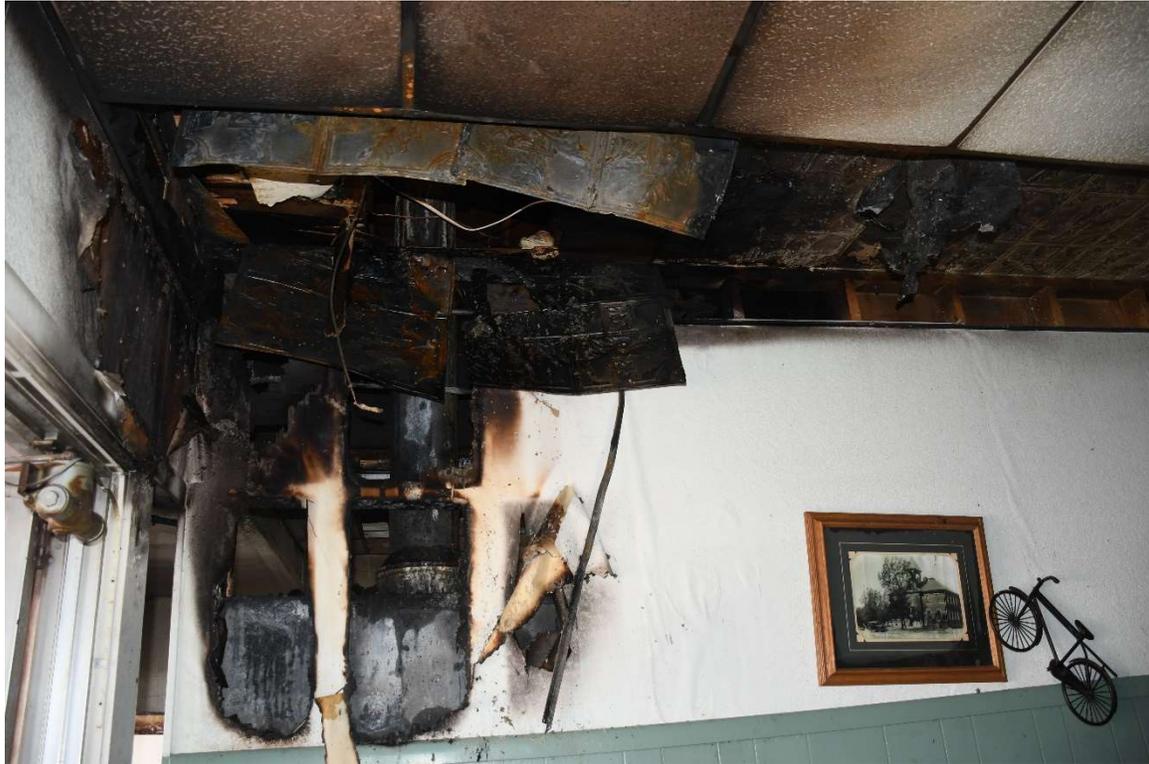
The east wall of the seating area was the glass entry/exit door and a large picture window north of the door. The door was open, but all the glass remained intact. The area of greatest damage that occurred to the seating area was at the partition wall and ceiling in proximity to the entry/exit door. The ceiling tiles along the partition wall were of metal material. The metal ceiling tiles closest to the door sustained the greatest damage compared to the rest of the ceiling tiles. The ceiling tiles were hanging by the railing, were warped and oxidized. Insulation and charred fire debris collapsed to the floor from the damaged ceiling area. A v-pattern extended up and out from the partition wall. On the south side of the damaged portion wall was the commercial cooking hood. (See Figure 4)

Figure 4 Photograph DSC_0088.JPG Burn Pattern on Partition Wall, Ceiling Tile Damage

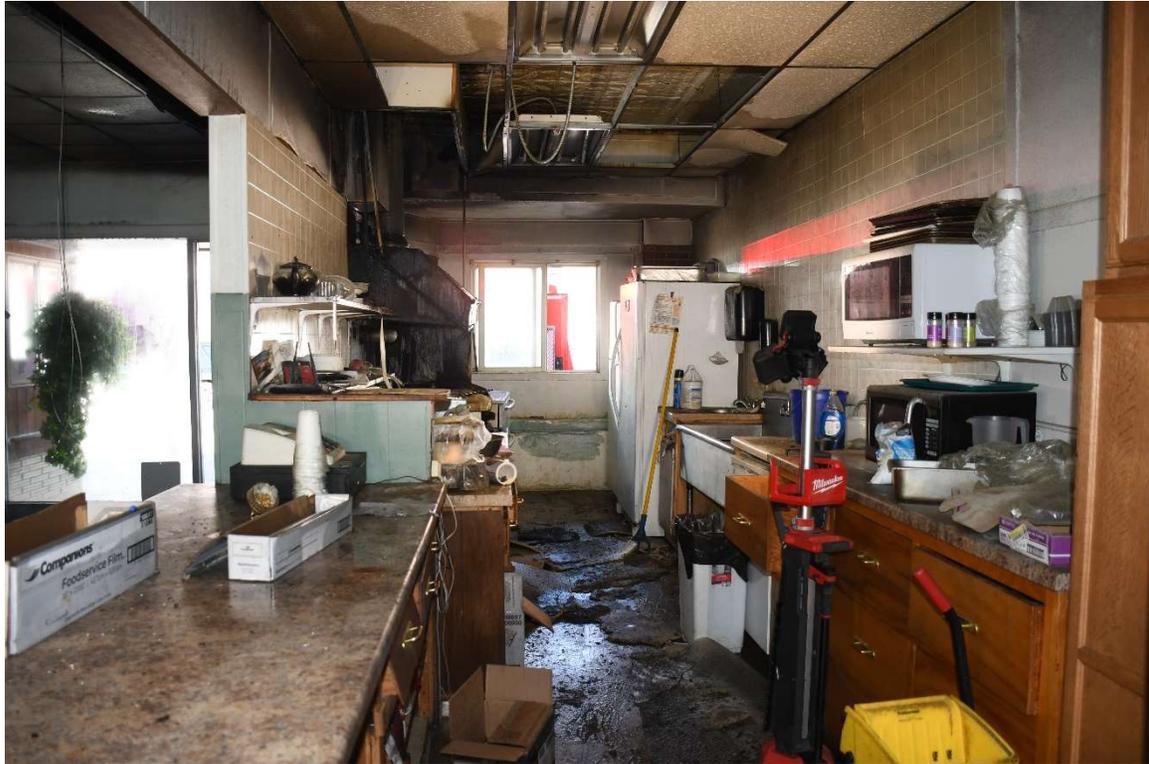
The kitchen area was along the southern half of the restaurant. The kitchen area was designed as a galley kitchen with cooking appliances and counter tops along the north wall and south wall. The area of greatest damage to the kitchen area occurred in the area the commercial cooking hood. (See Figure 5)

Figure 5 Photograph DSC_0098.JPG Kitchen Area

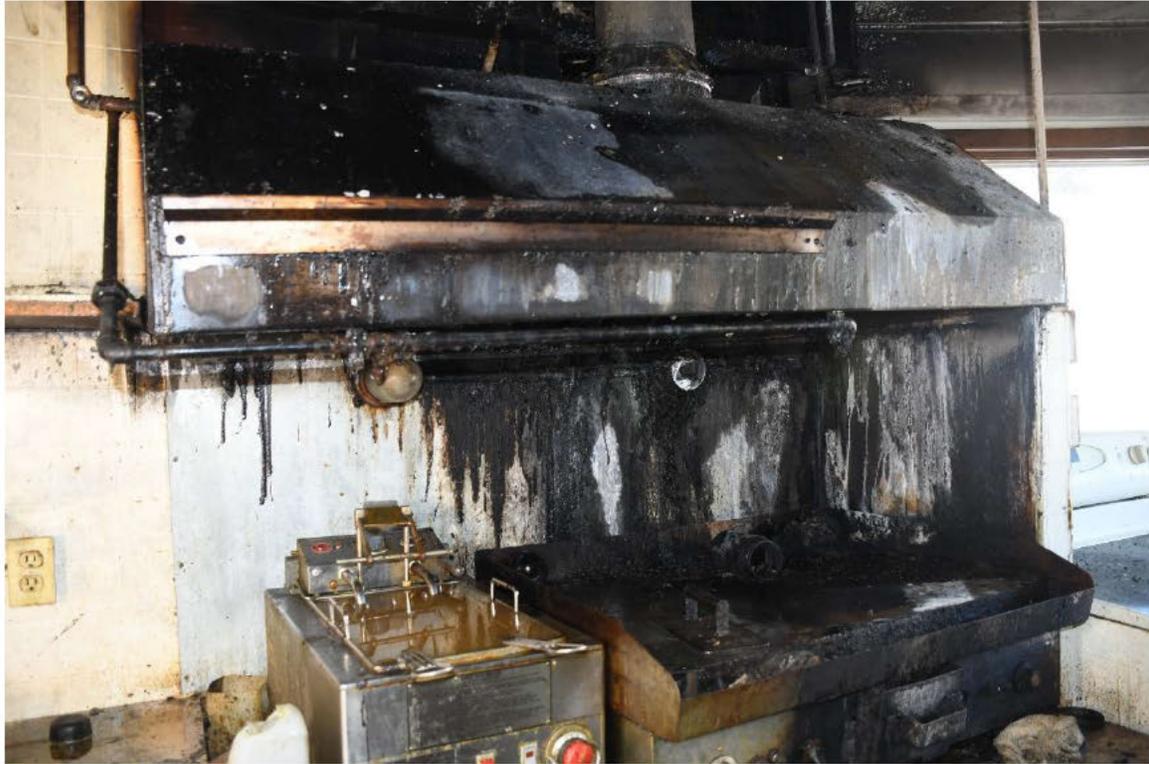
No fire or heat damage occurred to the east wall or south wall. The area of greatest damage occurred in the area of commercial kitchen hood. The grease fryer was along the westernmost end of the hood with the flat-top grill along the easternmost end of the hood. The grease fryer remained intact with a brown liquid filling the grease vat. Along the north wall under the hood were two light fixtures. The light fixture above the grease fryer was cracked but remained mounted to the wall. The light fixture above the flat-top grill was damaged and no longer in place. The glass from the light fixture remains were on the surface of the flat-top grill. Miscellaneous cooking utensils were on the flat-top grill surface. Charring and an oily residue were throughout the flat-top grill and walls extending up from the flat-top grill. The hood had discoloration and an oily residue throughout. The hood vents had the greatest discoloration and warping in the area of the flat-top grill. As extension went to the west over the grease fryer the discoloration and warping of the hood decreased. A v-pattern extending up and out from the flat-top grill was visible. (See Figure 6)

Figure 6 Photograph DSC_0101.JPG Flat-top grill Surface, Cooking Utensils, Hood Damage, V-pattern

The front of the flat-top grill had a grease trap extending the length of the flat-top grill. Miscellaneous cloth and plastic remnants were within the grease trap. The grill control panel was below the grease trap. Not all the flat-top grill dials appear to be in the “OFF” position. Approximately center of the control panel was a grease trap the extended the width of the flat-top grill. The grease trap was in place and closed. The easternmost end of the flat-top grill and walls sustained the greatest charring, discoloration, soot deposition and dial damage.

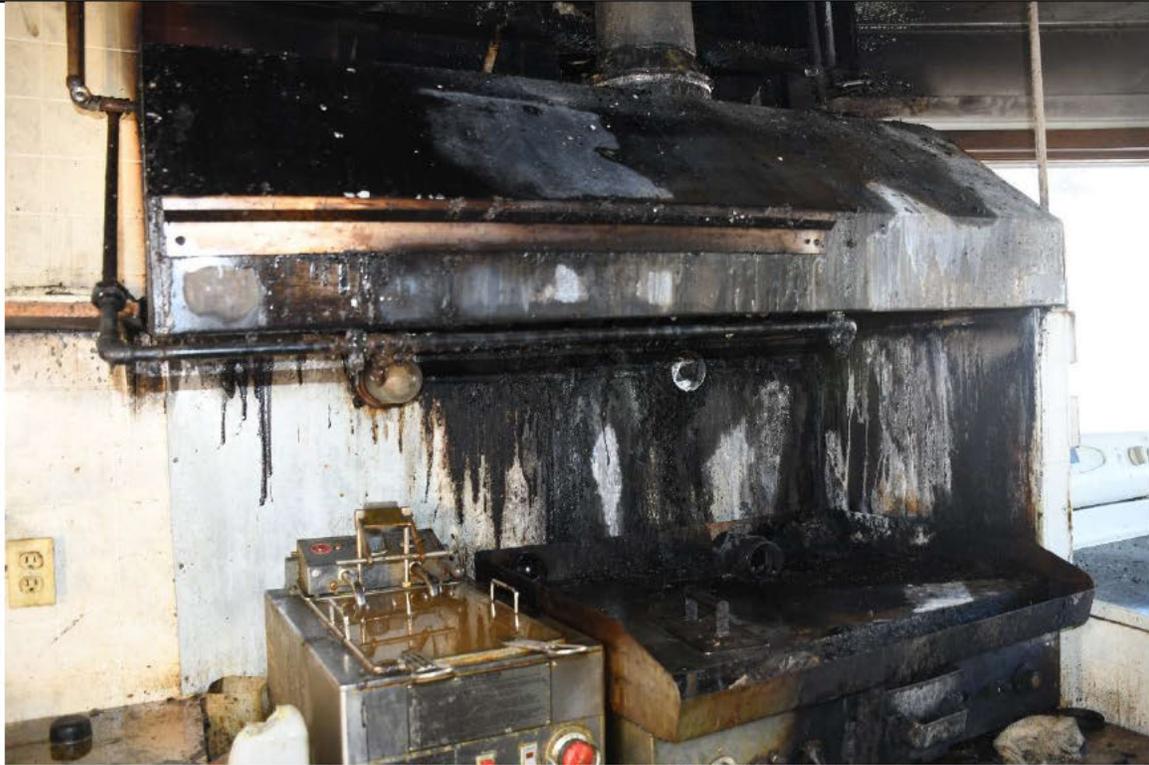
Area of Origin:
 Based on the examination of the fire scene, witness statements, and other data reviewed, the area of origin was determined to be at or near the flat-top grill.

Figure 7 Photograph DSC_0101.JPG Flat-Top Grill, Hood

- This area sustained the greatest damage compared to the rest of the appliances and structure.
- The flat-top grill sustained the greatest amount of damage compared to the rest of the appliances.
 - As extension went away from the flat-top grill less charring and discoloration occurred.
- The hood directly above the flat-top grill sustained the greatest amount of discoloration and soot deposition compared to the area above the grease fryer.

- The surfaces in proximity to the flat-top grill sustained the greatest charring, discoloration and soot deposition.
- A v-pattern was visible extending up and out from the flat-top grill.
- As extension went up, the exhaust and ceiling were impacted above the hood.
- As extension went away from the flat-top grill charring, discoloration and soot deposit decreased.

The cause of the fire was determined to be the ignition of combustible materials located in close proximity to the flat-top grill, or the ignition of overheated grease deposits that had accumulated on or near the grill.
