# North Dakota State Fire Marshals Office (ND)

## INCIDENT ORIGIN & CAUSE NARRATIVE

**Investigation Title: Bismarck knopp Fire**

On January 26<sup>th</sup>, 2025, at approximately 10:00 pm, Daryl Knopp called to report a structure fire in a two-story single-family home at 126 Watercress Ave, Bismarck, ND 58503. No injuries or fatalities were reported. (See Figure 1.)

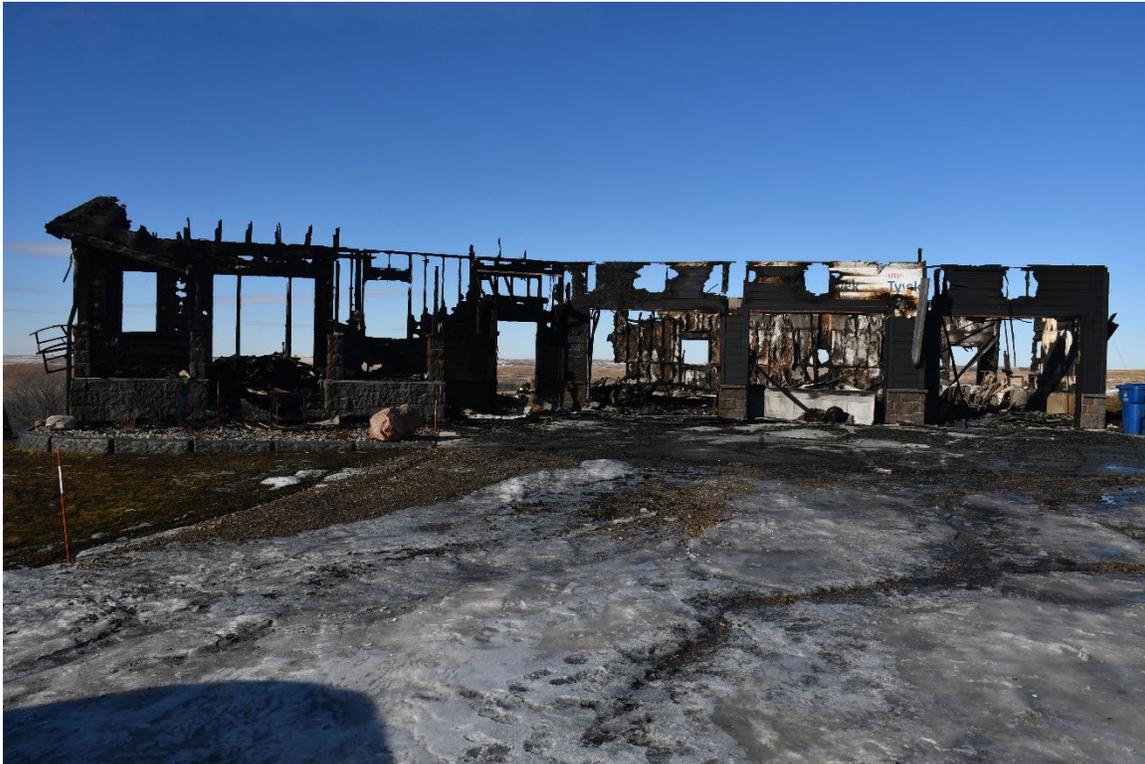
*Figure 2. South side of the home.*

The south side of the home, which faced the street, sustained mass loss to the windows, doors, and garage doors. The exterior walls had charring, with the southeast side of the home sustaining greater damage to the exterior walls than the southwest (See Figure 2).

The north side of the home sustained mass loss. The burn pattern shows the home had burned from the east to the west, with the northeast exterior wall sustaining mass loss and the garage's exterior wall intact, but the roof, windows, and door were consumed. The garage's exterior wall had deformed siding, with multiple holes that had burned through the wall. (See Figure 2.)

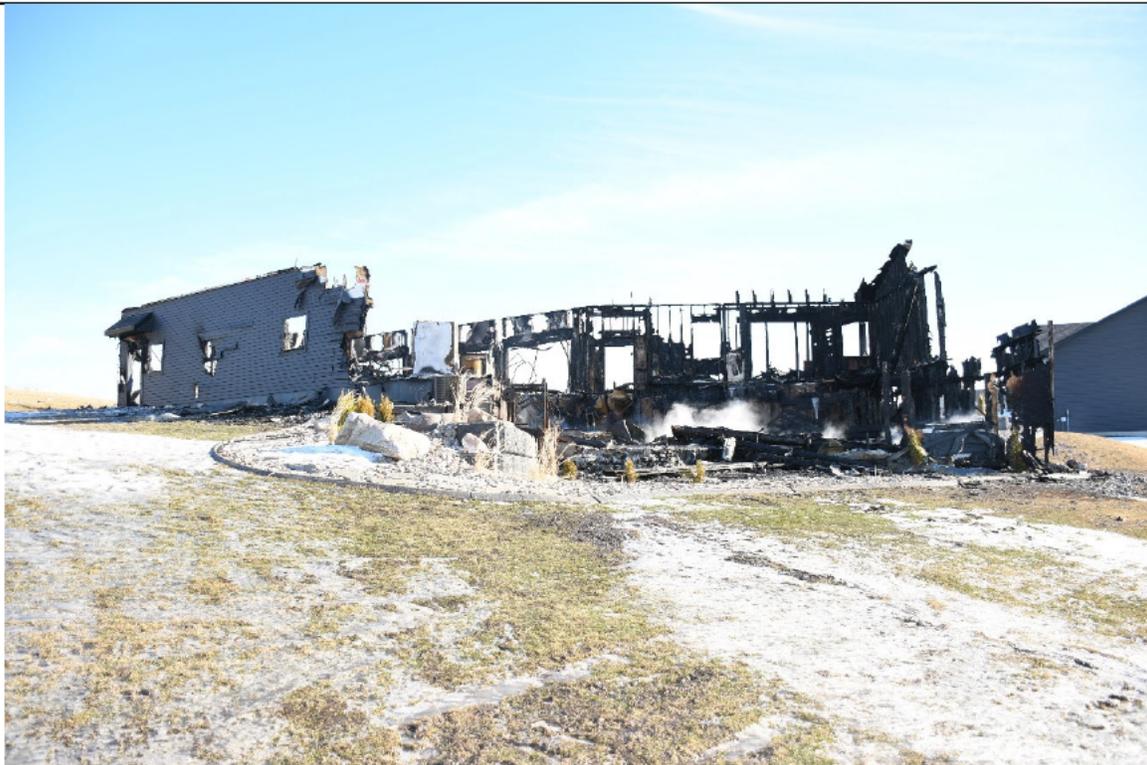
Figure 3. The north side of the home shows the damage compared to the northeast and northwest of the home.

The home's garage was located on the east side of the house. The northeast side of the wall was burned completely through, with the fire patterns showing a burn pattern on the north wall left on the south exterior wall, sustaining mass loss that progressed from the north to the south of the home. The plywood walls under the vinyl siding show charring and smoke damage, with the vinyl siding being melted and distorted.

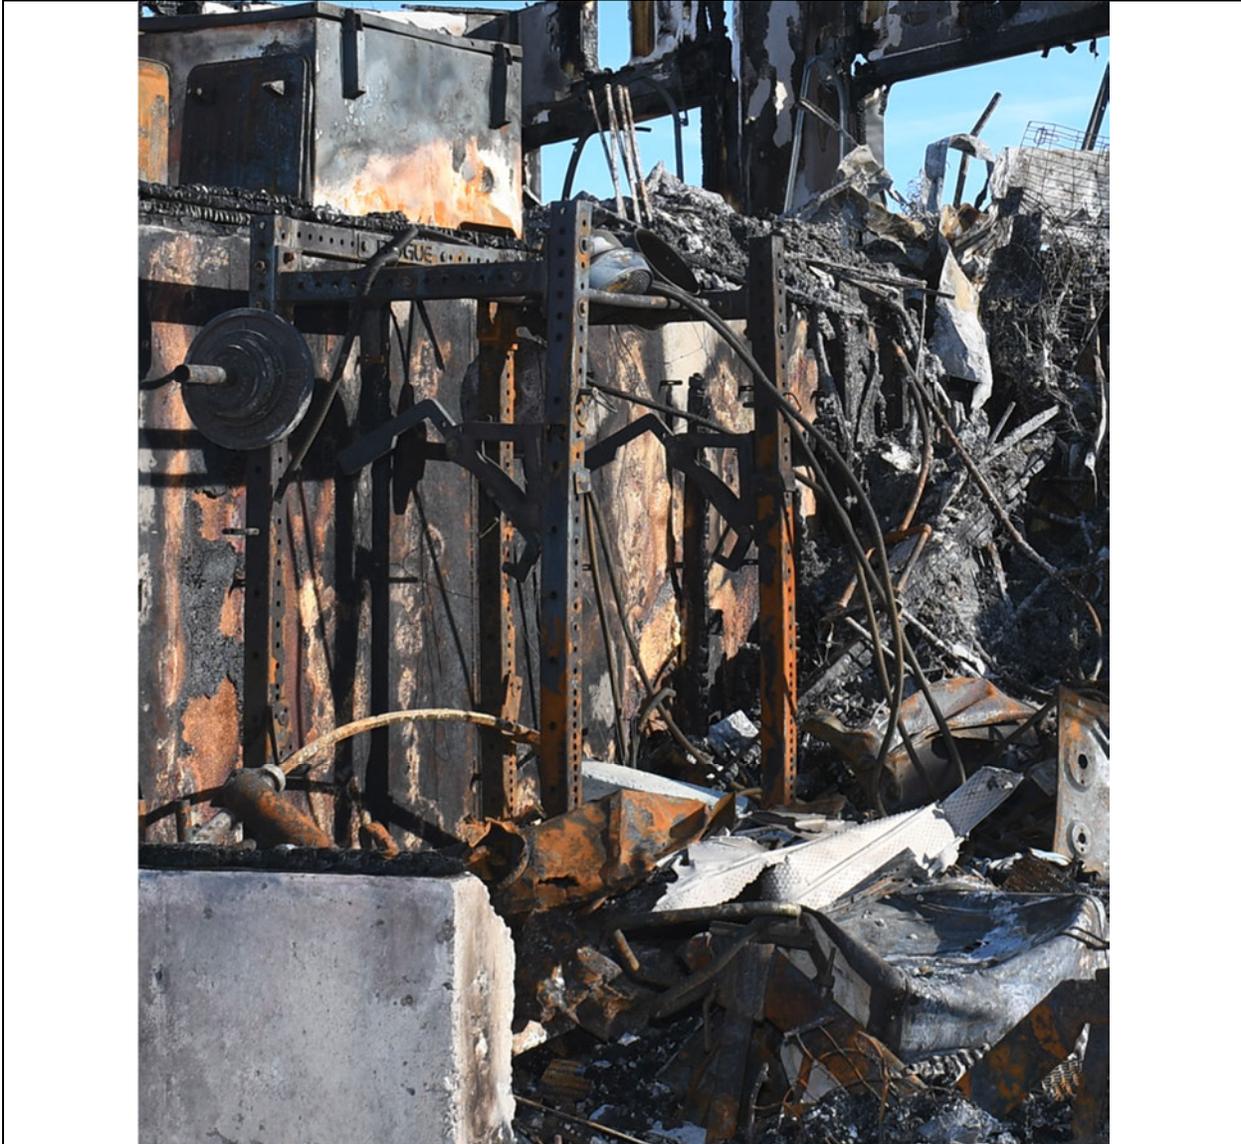
*Figure 4. The weight rack located in the basement had a heat-induced color change.*

My interior examination was limited to taking pictures from the outside into the interior area of the home due to the exterior walls still standing in the home being unstable and swaying in the wind. The house's interior had been consumed by fire, with portions of exterior walls on the east, south, and west still standing. The burn patterns on the east exterior wall extended from the north to the south and from the bottom to the top. The southern exterior wall had the most standing, with the burn patterns coming from the top down, with more of the wall still standing towards the bottom than the top. The west exterior wall had a portion of the exterior basement and upper floor wall standing, with the burn pattern showing a burn from the north to the south. I observed a heat-induced color change in the weight-lifting rack in the basement of the home (See Figure 4).

- Fire Effects
  - The west side of the home sustained more damage than the east side of the home.
  - A heat-induced color change was observed on the weight-lifting rack that was in the basement.

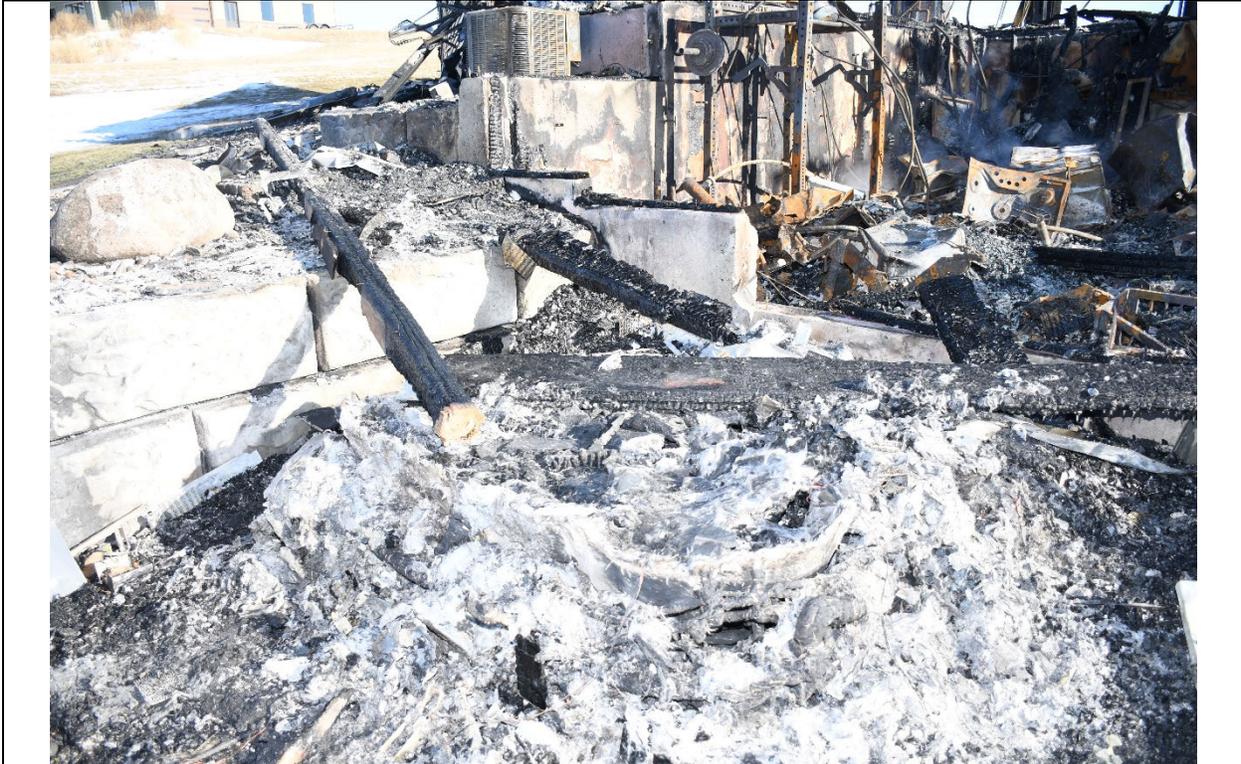
*Figure 5. Showing the mass loss sustained to the hot tub on the northwest side of the home.*

Below is a picture of where the homeowner's hot tub was located. On the evening of the fire, Daryl Knopp sat in that hot tub and had two beers and two or three cigarettes. The hot tub and the deck above it sustained mass loss (see Figure 5).

The area of origin was on the northwest side of the home on the home's patio.

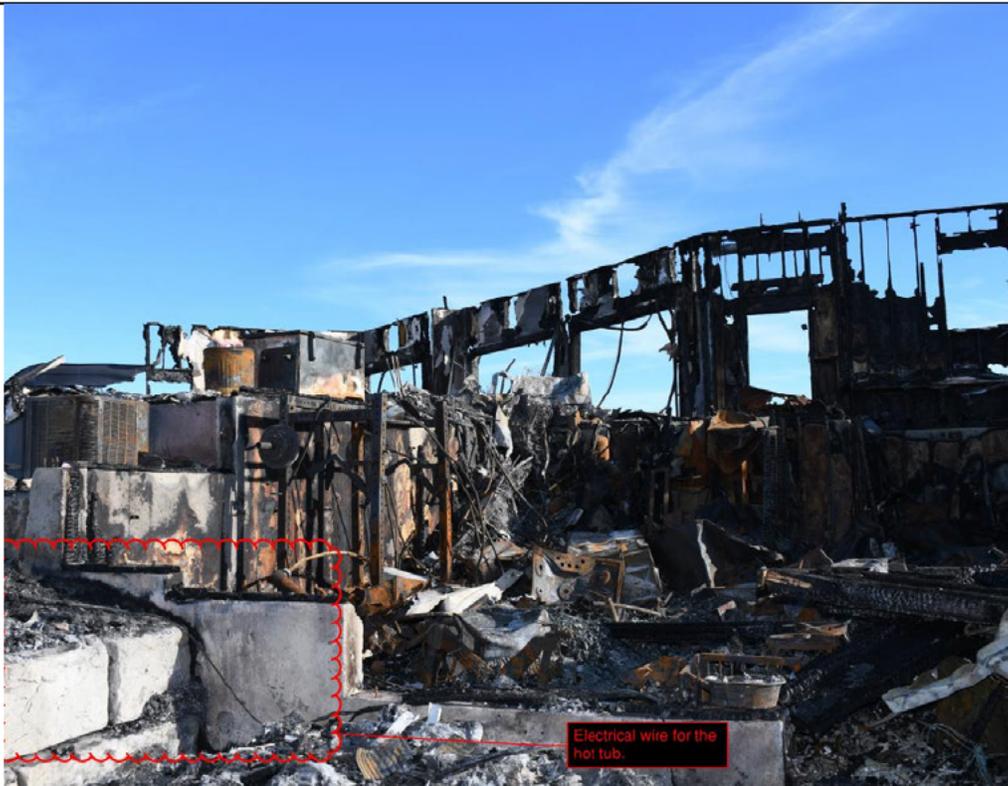
Figure 6. A wire was observed on the north side of the home with a burn pattern on the home's foundation.

During the investigation, I observed the wiring for the hot tub. The wiring had sustained mass loss and also had a burn pattern that progressed from the east to the west down the foundation of the home. (See Figure 6.)

3. An overheating of the hot tub's electrical wiring created sufficient heat for a duration long enough to ignite ordinary combustible materials such as paper, plastic, wood, and dried leaves.
  - The area of origin had electrical wiring running through the area.
  - The electrical wiring in the area of origin had mass consumption of electrical insulation.
  - The owner of the home installed the electricity for the hot tub.
  - This hypothesis could not be eliminated as the potential cause of the fire.
