# North Dakota Office of the State Fire Marshal (ND)

## INCIDENT REPORT

Investigation Title: BURLINGTON NELSON FIRE

## INCIDENT ORIGIN & CAUSE NARRATIVE

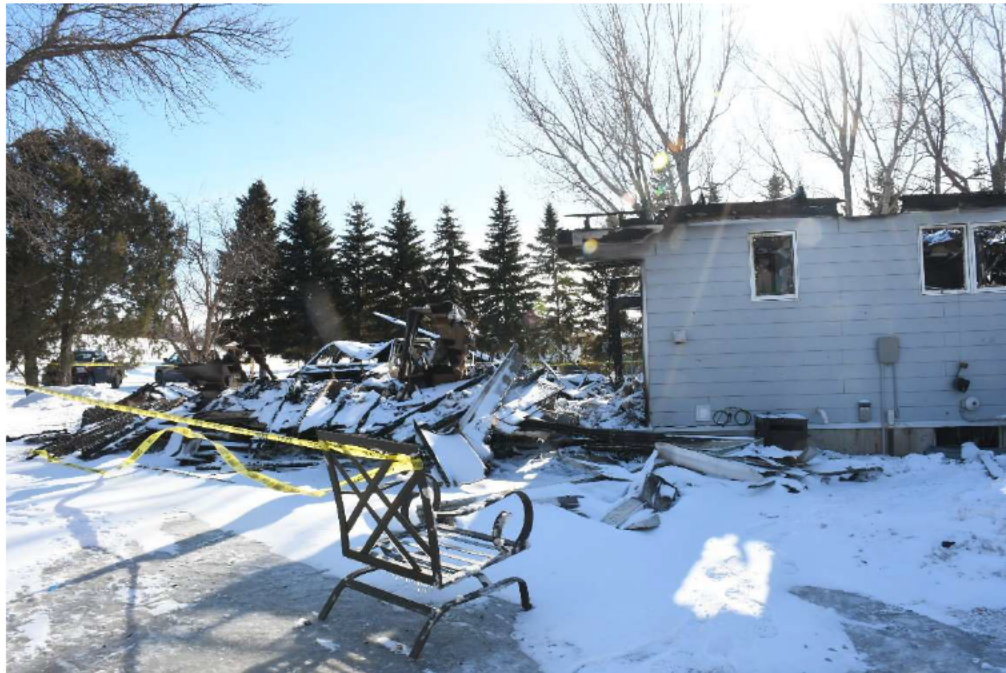
On Saturday, February 1, 2025, at 4:26 AM a fire was reported at 8001 County Road 15 W, Minot, ND 58703. The fire was reported by a neighbor. The fire was reported to be in a residential structure with an attached garage. The Burlington Rural Fire Protection District responded and extinguished the fire. No injuries or fatalities were reported to the State Fire Marshal's Office. (See Figure 1)

*Figure 1 Photograph DSC\_0001.JPG Exterior North Side, Garage Consumption/Collapse*

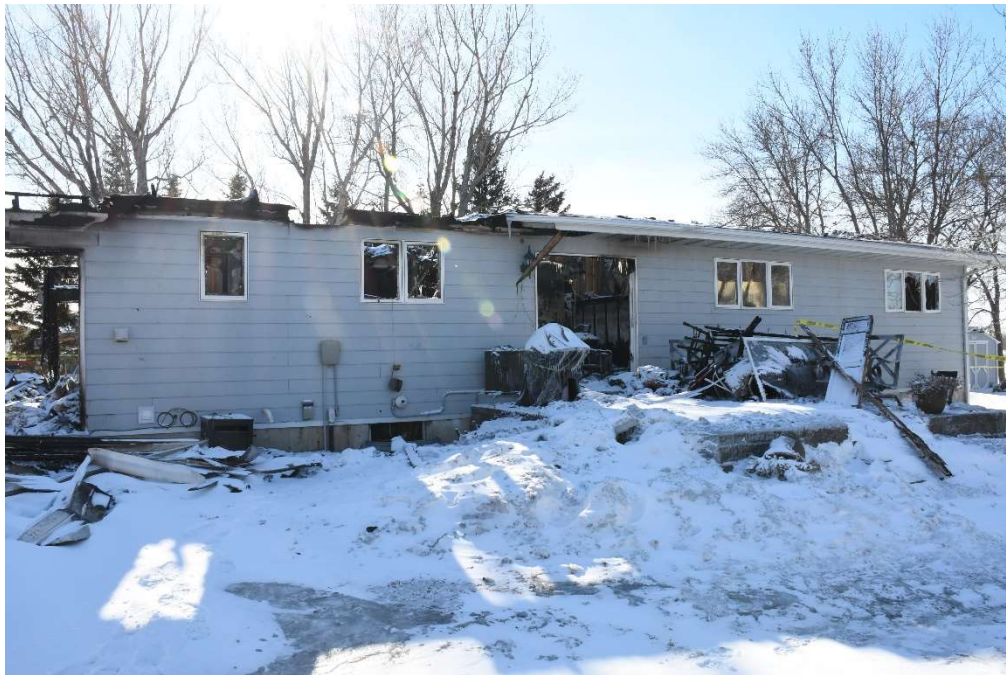
had collapsed or was consumed as extension went from the garage to the west. The soffit, eave, and fascia had collapsed or was consumed in the area closest to the garage. As extension continued west, less collapse and consumption occurred to the roof assembly. Approximately the center of the remaining wall was an opening where the patio doors were. Snow and ice covered wood deck extended north from the opening. Fire debris was along the west end of the deck. (See Figure 2)

Figure 2 Photograph DSC\_0003.JPG Exterior North Side, Residential Portion, Deck, Roof Remains

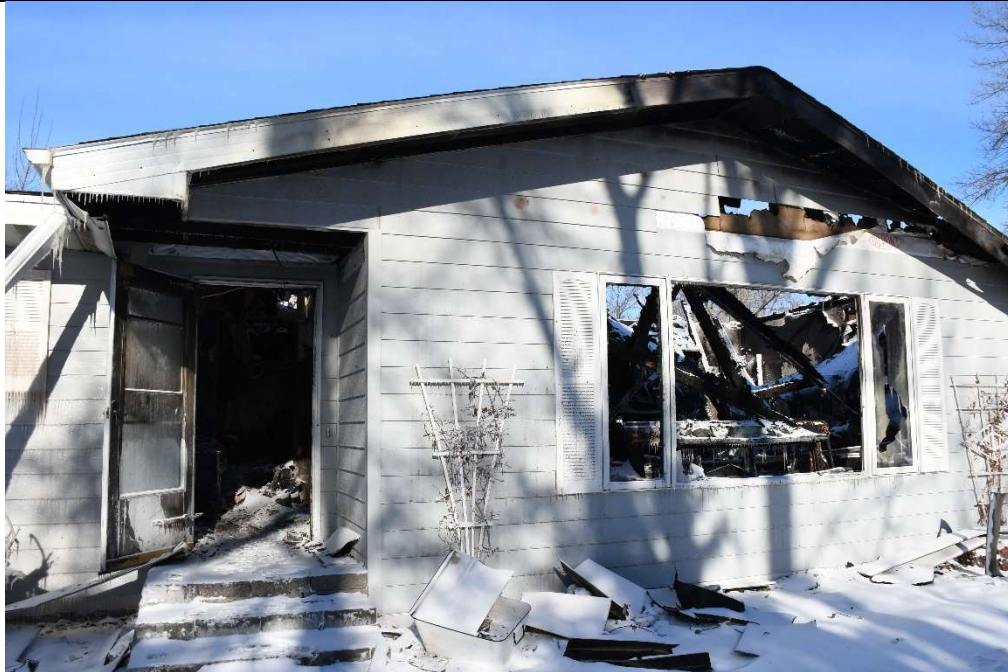
The south side of the structure faced the driveway and had the main entrance. The screen door was open. The main door was removed and placed along the west side of the structure. The siding on the main residence remained intact with a small portion collapsed or removed above a window east of the main entrance. The soffit along the east portion of the main residence had collapsed. Soot deposits and discoloration were along the facial extending east to the garage. (See Figure 3)

*Figure 3 Photograph DSC\_0015.JPG Exterior South Side, Main Entrance, Soffit/Facia Damage*

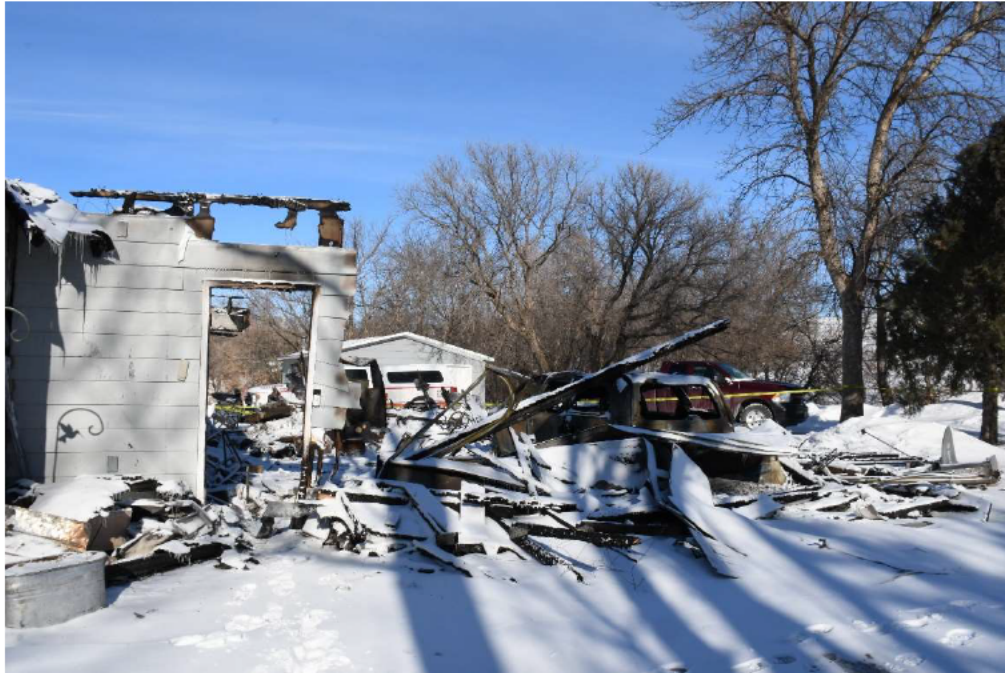
The south wall of the garage was consumed or had collapsed. The remains of an entry door frame remained along the shared wall of the garage and main residence. The door was no longer in place. The remains of an overhead door had collapsed along the south wall. The collapsed structural members were snow covered. (See Figure 4)

*Figure 4 Photograph DSC\_0018.JPG Exterior South Side of Garage, Consumption/Collapse*

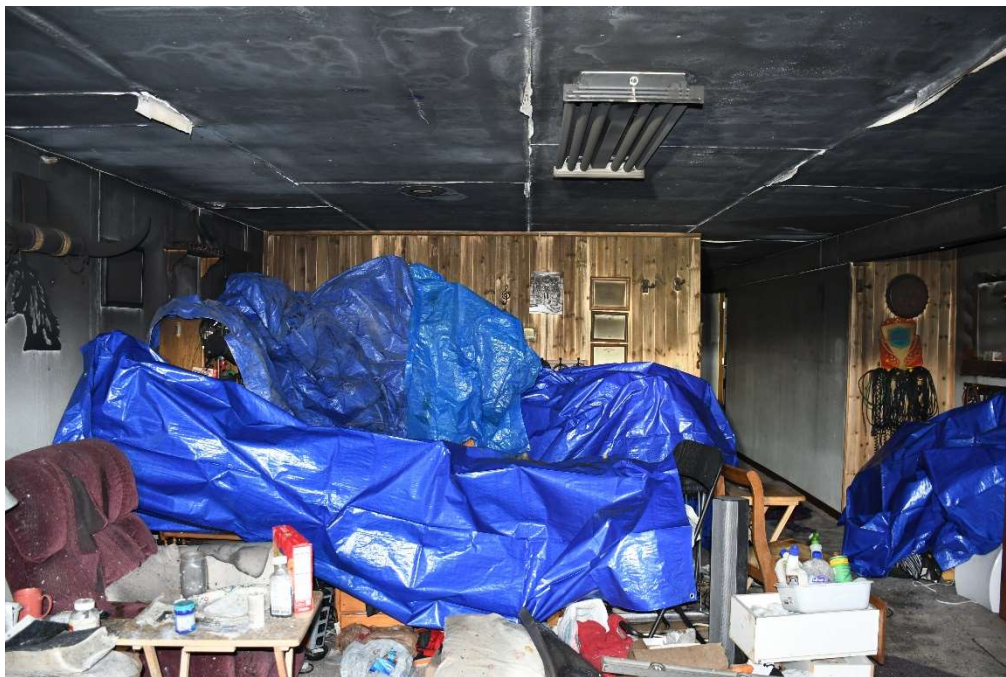
At the bottom of the stairs was a living room. Along the south wall was a sofa, recliner, coffee table, lamp and other miscellaneous furniture. A blue tarp covered the furniture along the west wall. Soot deposits were throughout the ceiling and extended approximately three feet down the south wall and west wall. Soot deposits and fire debris were noticed throughout the furniture.

Figure 5 Photograph DSC\_0037.JPG Basement Living Room, Furniture, Covered Furniture, Hallway

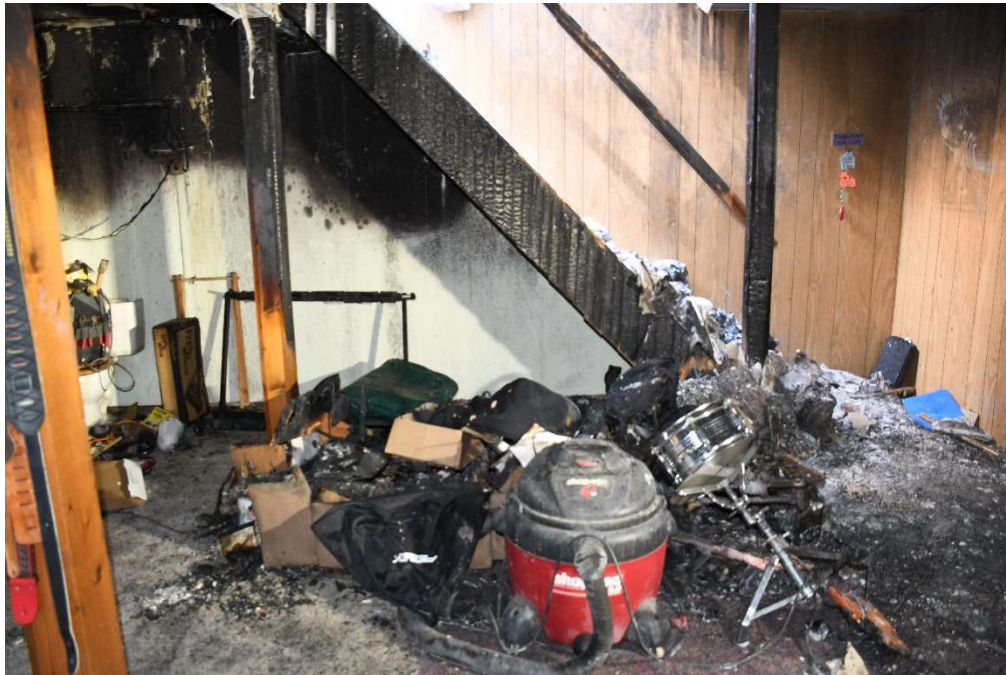
Along the east wall was the staircase. This area sustained the greatest amount of damage compared to the rest of the basement. The remains of a sofa and miscellaneous storage were along the staircase. The back rest and upper portion of the sofa were consumed. The noncombustible remains of the sofa seat were visible. The remains of musical instruments were on the sofa and in front of the sofa. The cloth materials along the bottom front portion of the sofa remained. The staircase behind the sofa had wood paneling on the living room facing side. The paneling was charred throughout. The handrail facing the living room was charred extending to the top of the stairs. The structural support beam closest to the sofa had charring approximately two feet from the floor extending up to the ceiling. The area facing the sofa had the greatest amount of

charring compared to the rest of the beam. Miscellaneous tools and an orange extension cord within proximity to the sofa. (See Figure 6)

*Figure 6 Photograph DSC\_0044.JPG Staircase, Sofa Remains, Wood Paneling Char, Charring on Handrail*

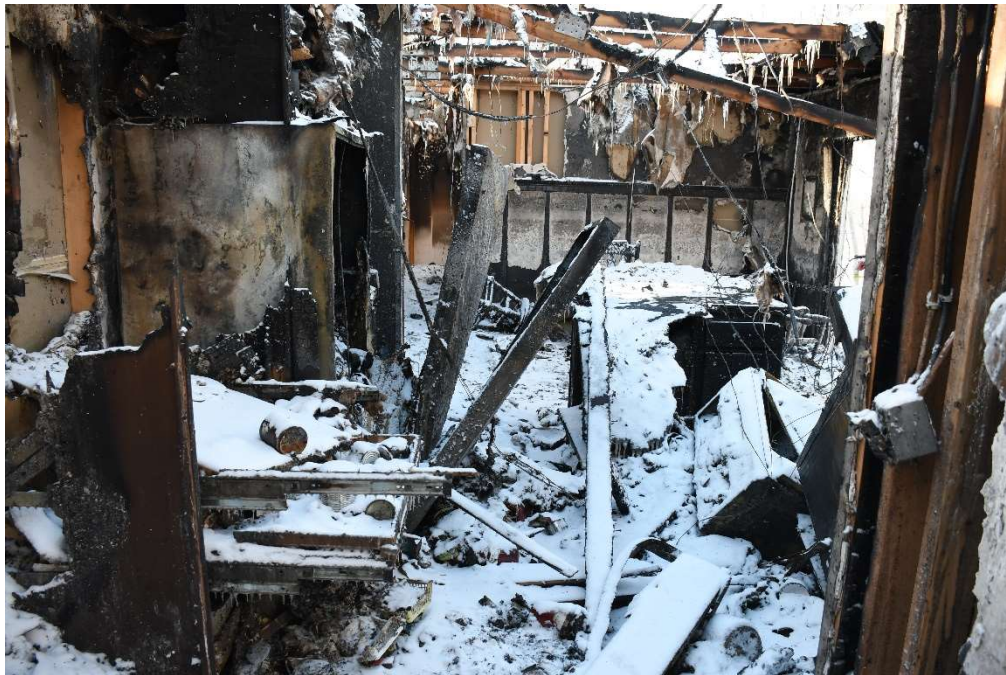
At the top of the stairs, on the north wall was the laundry room. To the west was the kitchen area. Most of the ceiling and roof assembly had collapsed or was consumed. The contents were covered in fire debris and snow. The remains of the refrigerator were noticed along the south wall of the kitchen area. (See Figure 7)

Figure 7 Photograph DSC\_0106.JPG Top of Stairs, Kitchen Area

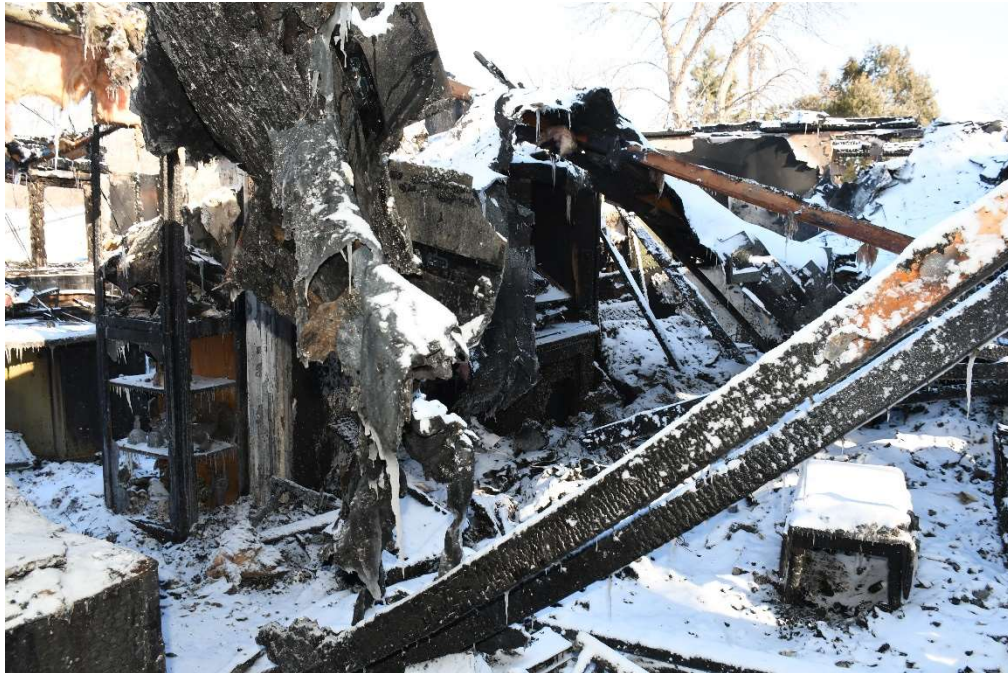
Through the entry door was a foyer with a closet on the north wall. Some of the drywall on the walls had collapsed. The remaining drywall was calcinated throughout. The ceiling had collapse. The bottom chord to the roof trusses were visible. The upper portions of the trusses were consumed or had collapsed. East of the foyer was the living room. The ceiling and roof assembly in the living room had collapsed to the interior. Most of the combustible materials within the living room were consumed. Fire debris and remains of the roof assembly covered the foyer and living room contents.

*Figure 8 Photograph DSC\_0120.JPG Living Room Area*

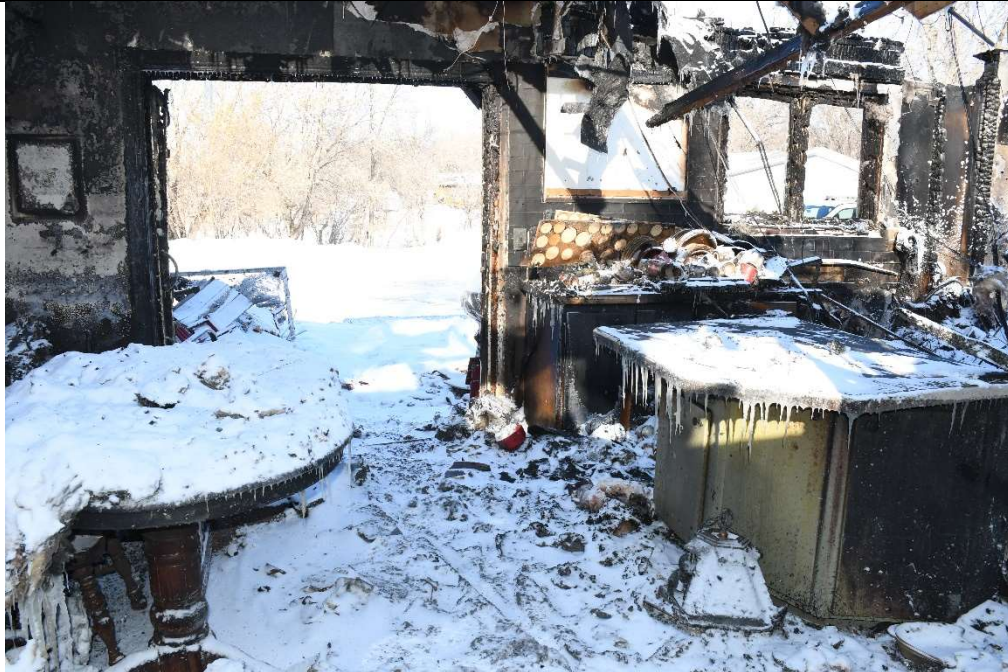
North of the living room was the kitchen and dining area. The kitchen area and dining area sustained comparable damage to the living room. Most of the roof assembly had collapsed or was consumed. The patio doors were no longer in place. The dining table and chairs were charred. (See Figure 9)

*Figure 9 Photograph DSC\_0126.JPG Dining Area, Kitchen*

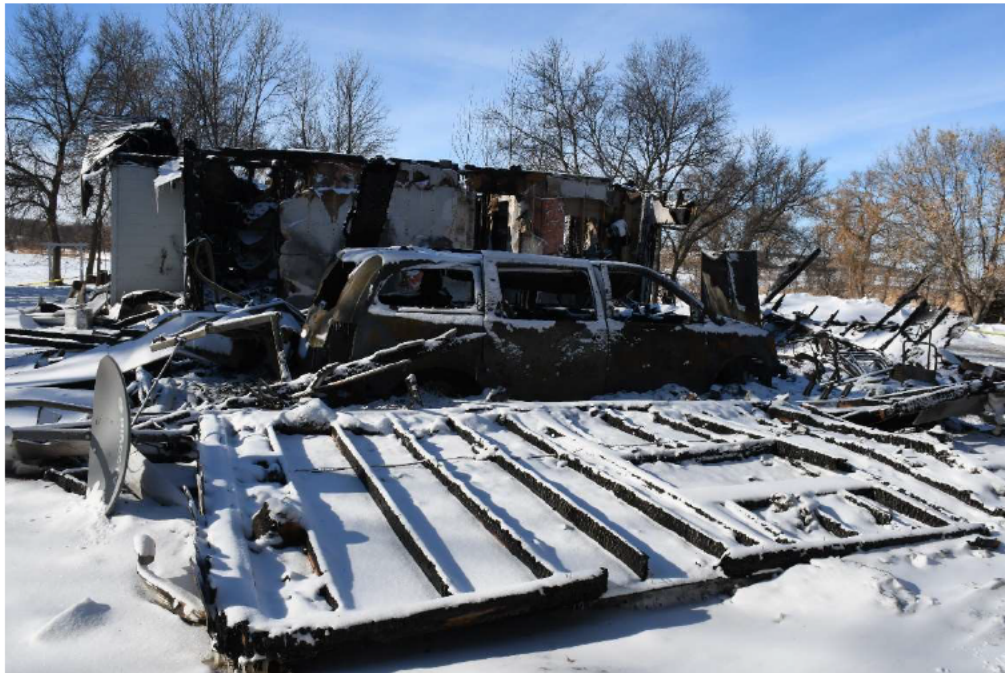
The attached garage sustained the greatest amount of damage compared to the rest of the structure. Most of the garage roof had collapsed or was consumed. Most of the combustible materials within the garage were consumed. Due to structural collapse and extent of damage throughout the structure, not all electrical circuits could be fully evaluated. Noncombustible remains of various items were throughout the garage. Fire debris and snow covered the area. The north, south, and east walls were consumed or had collapsed. The east wall was shared with the main residence. Most of the drywall was calcinated with areas of collapse. The shared door between the garage and main residence was no longer in place. The noncombustible remains of a vehicle were along the east wall. The noncombustible remains of a refrigerator were along the north wall. (See Figure 10)

Figure 10 Photograph DSC\_0021.JPG Garage, Roof Consumption/Collapse, Wall Consumption/Collapse, Noncombustible remains of Vehicle
