INCIDENT REPORT

Investigation Title: LANGDON BAKER RENTALS LLC FIRE

A fire occurred in a multi-family dwelling with one injury reported.

INCIDENT ORIGIN & CAUSE NARRATIVE

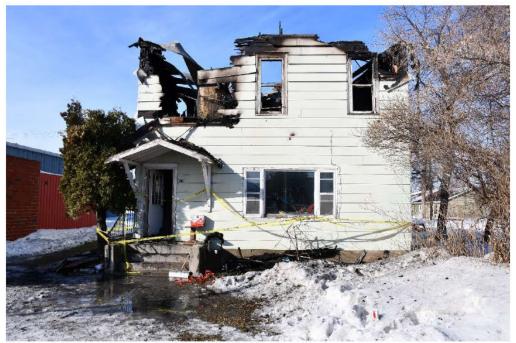
Figure 1 Photograph DSC 0013.JPG East Exterior Wall Facing West

On February 23, 2025, at 4:29 pm the Langdon Fire Department was dispatched to a two-story multi-family dwelling with a basement at 912 3rd St, Langdon, ND. The fire occurred in an occupied second story unit of the structure and spread to an adjacent second story unit of the structure. There was one injury reported. The patient was transported to Regions Hospital Burn Center in St. Paul, MN. (See Figure 1)

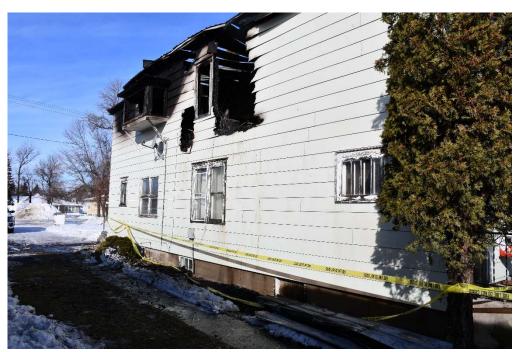
Figure 2 Photograph DSC_0001.JPG South Exterior Wall Facing Northwest

My examination of the fire scene began on the exterior south side and continued in a clockwise direction. During my initial walkthrough a Scene Safety Assessment Form was completed and will remain with the file.

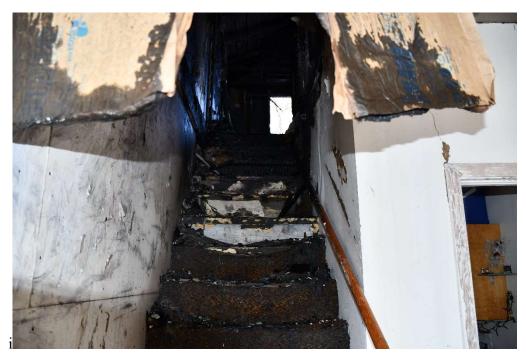
Figure 5 Photograph DSC_0079.JPG West Stairwell to West Second Story Unit

Continuing I entered the westernmost second story unit through the west entry/exit door that lead to a stairwell that went upstairs. This unit was known as unit #4. The stairwell treads had remains of charred ceiling materials towards the top treads and decreased towards the bottom treads. The stairwell walls had soot deposits throughout and increased towards the top. The top portion of the stairwell walls had charring on both sides. The ceiling of the stairwell was charred towards the top and decreased as you went towards the bottom. (See Figure 5)

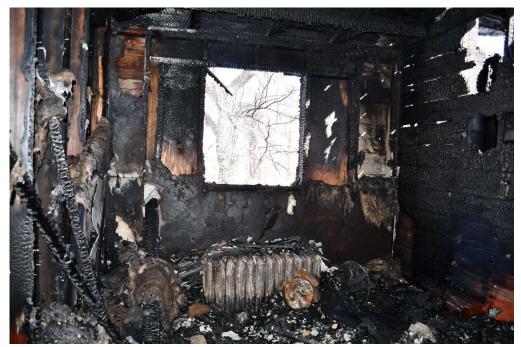
Figure 6 Photograph DSC 0082.JPG West Second Story Unit Entryway Room

At the top of the stairwell was an entry room. The entry room had a window along the north wall. The window was damaged, and no glass remained. The wood window frame had charring along all four sides. Most of the ceiling's insulation and plaster had fallen. The ceiling truss members were charred throughout. The entry room walls were charred throughout with the greatest damage along the east wall compared to the other walls within the entry room. Most of the personal contents within the entry room were consumed. The north wall around the window had more damage compared to the rest of the entry room. (See Figure 6)

- This was consistent with ventilation patterns observed within the entry room of unit #4. The door was reported to have been left open and the north window failed early described by witnesses. This allowed fresh air to enter the structure and exit the structure, contributing to the growth and spread of the fire. The damage within the entry room was consistent with ventilation and not the area of origin.

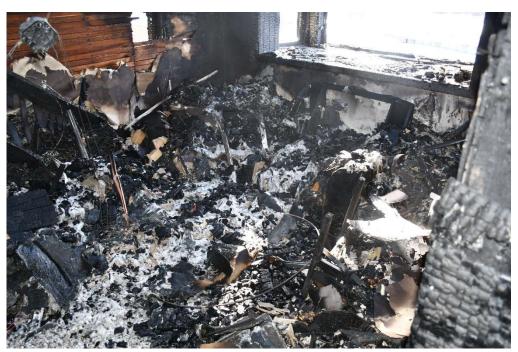
Figure 7 Photograph DSC_0096.JPG West Second Story Unit Living Room Facing South

damage was consistent with east second story unit's damage along the southwest corner of the east second story unit. (See Figure 7)

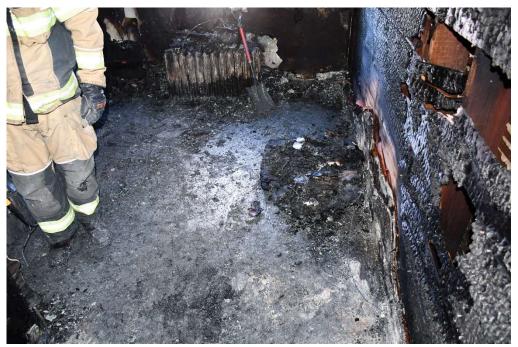
Figure 9 Photograph DCS_0143.JPG After Layering Of West Most Second Story Unit Entry Room

Still in the entry room, layering along the west wall revealed the remains of a laptop computer and charging cable. The west wall did not any electrical receptacles nearby. Near the laptop were six batteries that were intact. Continuing layering to the east wall there was the remains of two tables along the east wall. The northernmost table was consumed. The southernmost tabletop portion was intact with mass loss along the southern portion of the tabletop. Along the east wall was an electrical receptable above the southernmost table. The electrical receptable had melting on the exterior faceplate and in the interior was intact. Along the east wall an empty cigarette package and a lighter that was found. (See Figure 9)

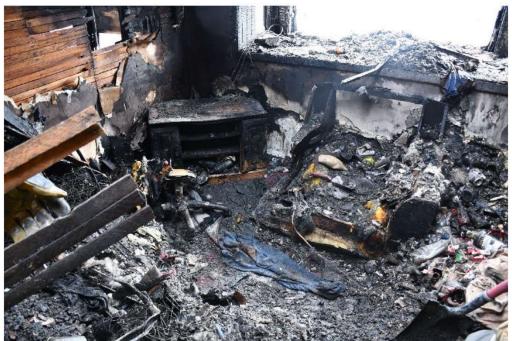
Figure 10 Photograph DSC_0181.JPG Southeast Corner of Living Room In Westernmost Second Story Unit After Layering

The chair arm rest along the west side was intact and the east arm rest was consumed and melted. The chair backrest was charred. The chair cushion was charred. There was more damage on the east side of the chair

compared to the west side of the chair. Extending from the chair was a V-Pattern on the wall that extended upward from the chair. The ceiling truss members were consumed directly above the chair, exposing the exterior steel roofing. Directly on the floor to the north of the chair was a cellphone charger with a cellphone plugged in. The cellphone was intact and turned over to BCI Special Agent Craig Zachmeier. The cellphone charger was plugged into an extension cord. The extension cord had charring on the exterior plastic jacket consistent with fire impingement. On the cellphone charger cable there was an arc splatter approximately in the middle of the cable. (See Figure 10)

The southeast corner of the living room had more damage compared the rest of the unit.

- Consistent with fire spread.
 - From the southeast corner of the living room in unit #4 which sustained more damage among the truss members, the damage decreased further away. This would be consistent with the spread and growth of the fire to adjacent areas of the structure.

Improperly handled or discarded cigarette which fell between the arm rest and cushion of the chair which ignited cloth materials that sustained enough heating to ignite a fire.

- Kirk's states that cloth has an ignition temperature of a range of approximately 410 to 750 degrees Fahrenheit.
 - The arm rest on the east side of the chair sustained melting and charring. This damage was more compared to the west side of the chair.
