Investigation Title: OAKES PAHL FIRE

## INCIDENT ORIGIN & CAUSE NARRATIVE

A fire occurred in a residential mobile trailer home at 9805 103<sup>rd</sup> Ave SE in Oakes, ND. The fire was reported on March 11, 2025, at approximately 8:09 PM. The Oakes Fire Department responded and extinguished the fire. The property owner was in the shop at the time of the fire and had family members call 911. No injuries or fatalities were reported. (See Figure 1)

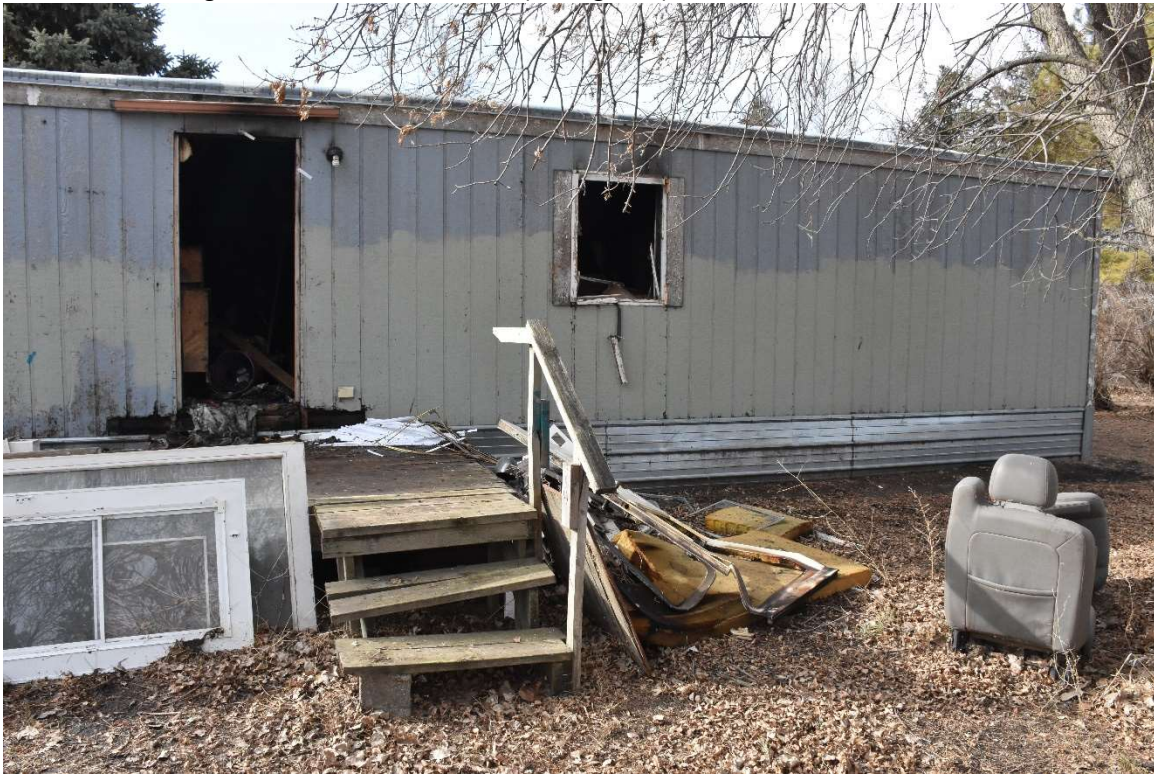
*Figure 2 Photograph NJF\_0005, North side of structure with door removed*

The north side of the structure had received smoke staining to the top portions of the windows with all window glass broken into the structure. The exterior door on the deck was removed prior to arrival on scene and was found on the west side of the deck. The door received mass loss to the top portion of the door and the center glass broke. No damage was observed on the roof. (See Figure 2)

| <b>Photo #:</b> | <b>Direction:</b> | <b>Description:</b> |
|---|---|---|
| 0005 | S | North side of structure, windows broken, smoke staining on top portion of the windows. Walk in door removed. |

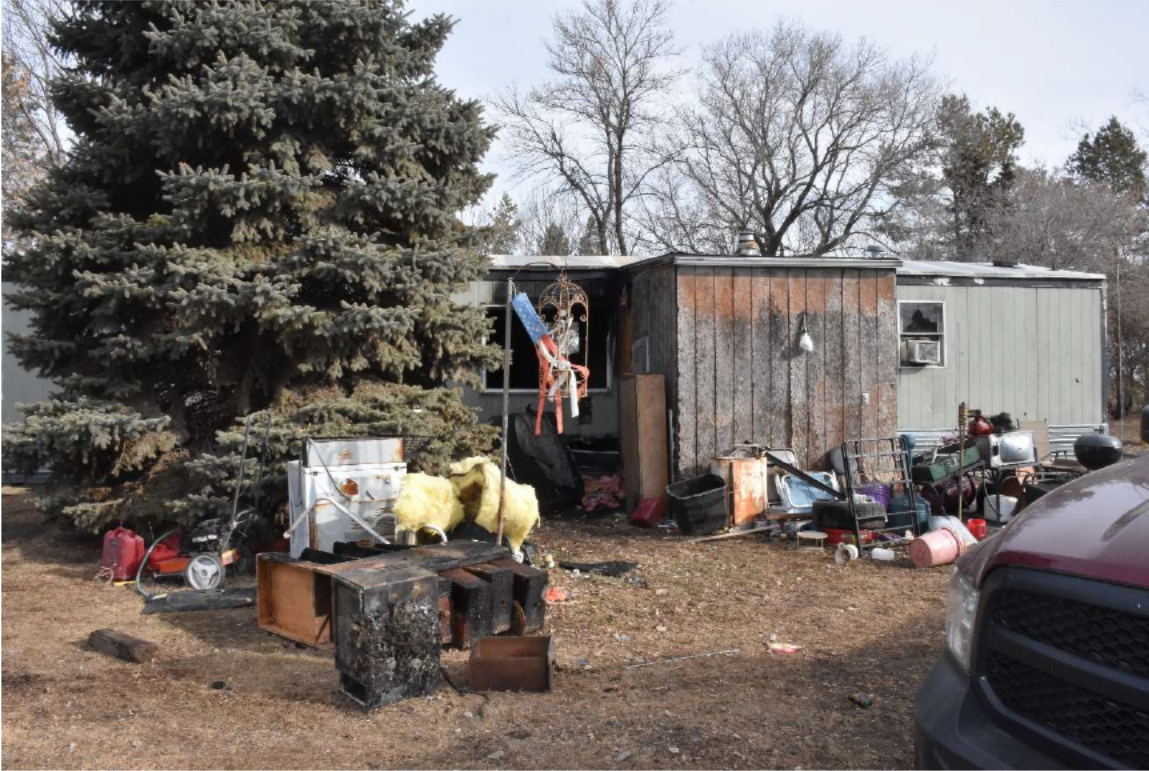
*Figure 3 Photograph NJF\_0011 South side of the structure*

The south side of the structure had all windows broken with smoke staining on the upper portion of the window framing continued up the wall. The mud room addition received smoke staining to the upper portion of the doorway that continued to the siding. The door had glass broken out of the door.

The ground next to the structure was observed with multiple plastic fuel containers and fire debris removed from the structure. This portion of the structure also had appliances, plastic buckets, tires, wooden furniture

and chairs. (See figure 3)

| <b>Photo #:</b> | <b>Direction:</b> | <b>Description:</b> |
|---|---|---|
| 0011 | N | South side of structure, windows broken with smoke staining on the upper portions of window and siding. Debris in yard charred wooden furniture, with many gas cans in yard. |

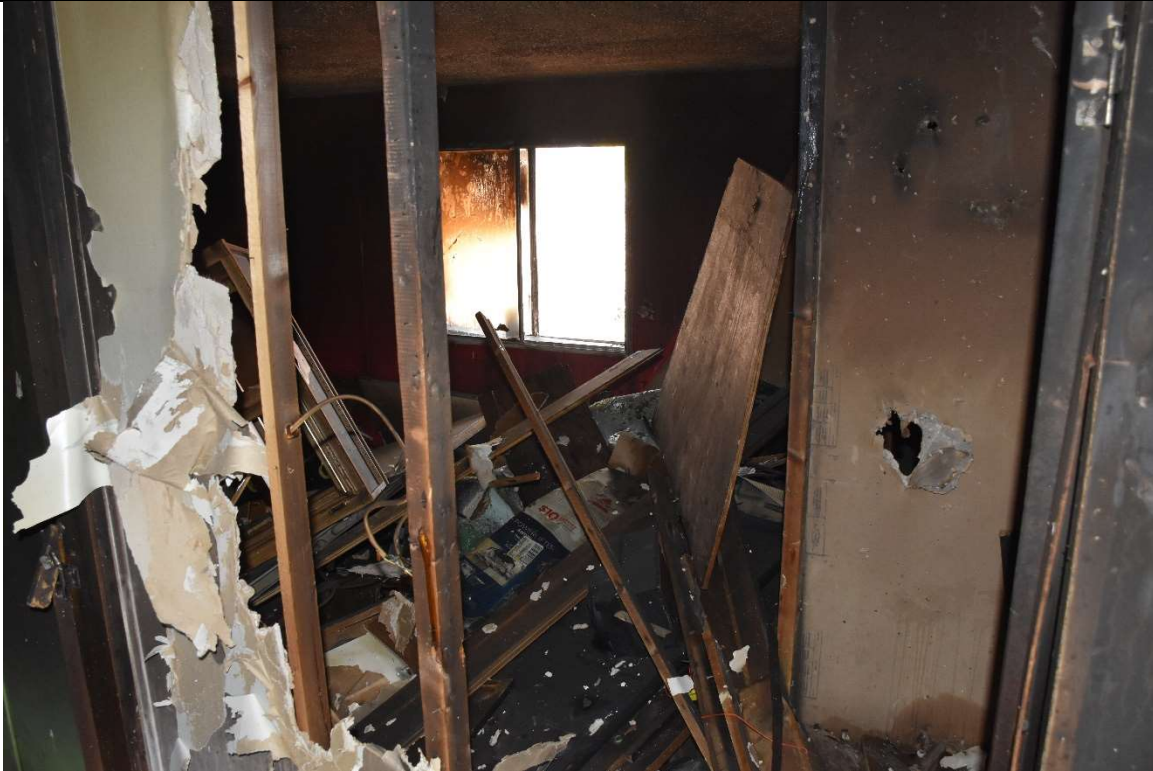
*Figure 4 Photograph NJF\_0020, West bedroom with storage*

Entry was made into the structure at the doorway on the deck of the north side of the structure. The bedroom furthest west received smoke staining to the upper half portion of the walls and ceiling. The room was filled with a large portion of wood materials and furniture pieces that made the room unable to fully enter. (See Figure 4)

| 0020 | W | West bed room, broken window with smoke staining on window, walls and ceiling, wooden furniture stacked in room with large amount of wooden boards in the room. Line of demarcation around the top half of the walls. |

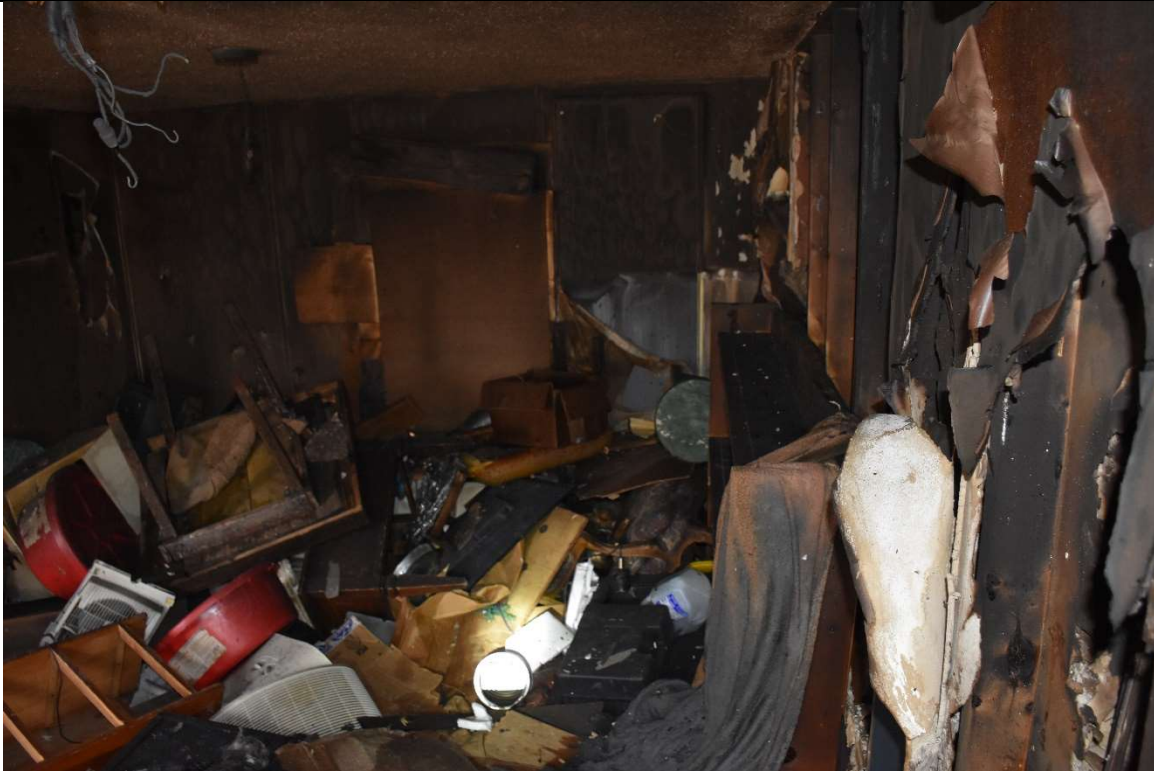
*Figure 5 Photograph NJF\_0024, Open area with smoke staining and charring to wall paper.*

The open area received smoke staining to the walls and ceiling. Wallpaper on the east wall showed charring and deformation. The light fixtures from the ceiling were missing with exposed wiring observed in place. A large amount of items were observed such as wooden furniture, plastic totes, and card board boxes. (See figure 5)

| 0024 | S | Open area, wooden furniture stacked, smoke staining to all walls and ceiling, plastic totes and cloth material, electrical wiring in ceiling with no fixtures. Charring to wall paper on walls |

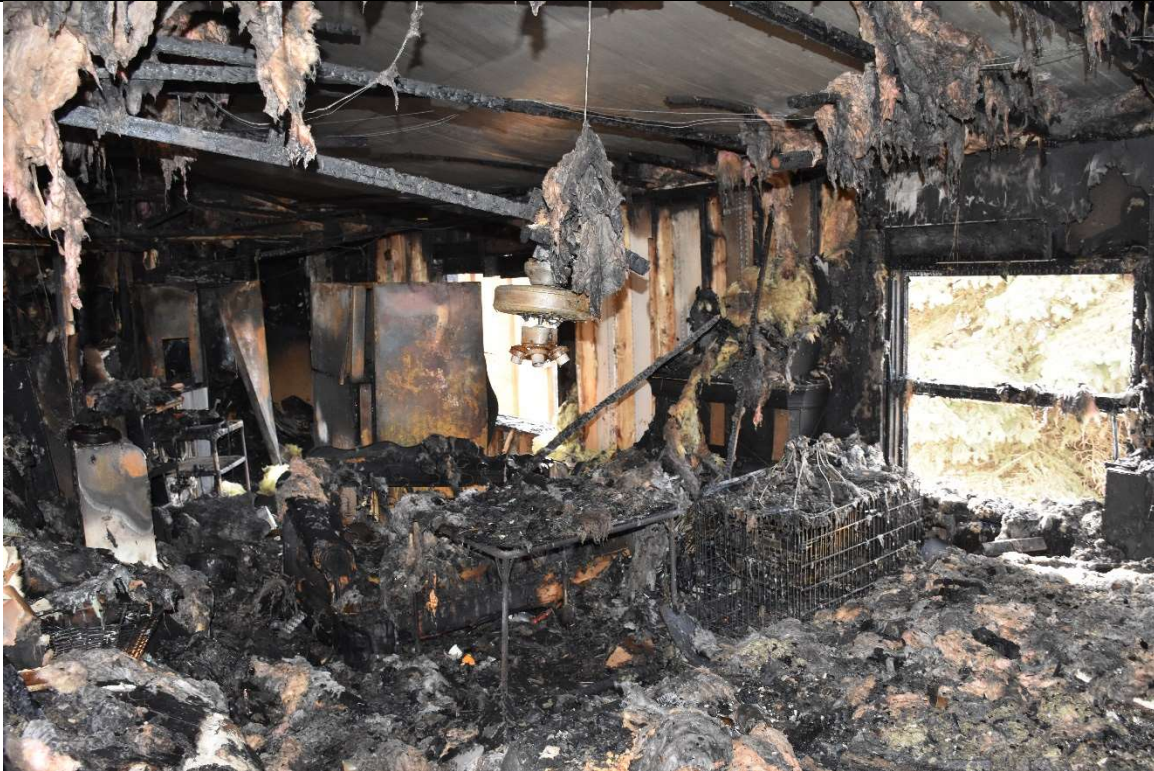
*Figure 6 Photograph NJF\_0028 Living Room, south wall.*

The living room received mass loss of insulation and gypsum board. Mass loss to roof trusses at the center point with charring from bottom up along the rest of the trusses. A ceiling fan was observed in the center of the room still connected by the wiring and mass loss of the fan blades and oxidation to the motor housing. Furniture in the living room was observed as a couch and mattress that both sustained mass loss and charring from east to west. A large amount of items were observed in the living room as of wooden furniture pieces, mattress, dog kennel, couch, paper and cloth materials, cardboard and plastic containers. (See figure 6)

| 0028 | S | Living room, mass loss to gypsum boards on ceiling and insulation. Charring to wooden rafters with sections of mass loss. Mattress with mass loss and charring. Smoke staining to all walls and ceiling, charring to wooden furniture. |

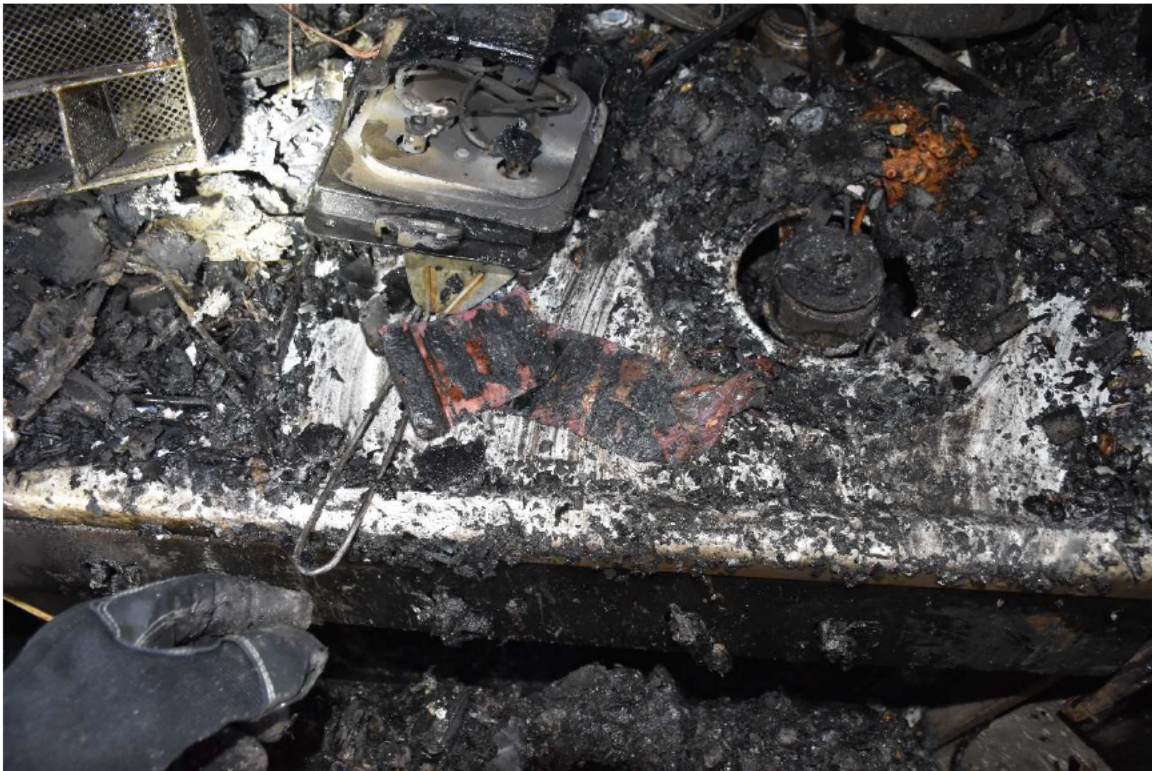
*Figure 7 Photograph NJF\_0069 Lithium-ion battery sheets discovered in kitchen*

The kitchen sustained smoke staining to the walls and ceiling. The east wall received mass loss of the gypsum boards and mass loss of three wall studs with smoke staining to the wall studs at counter top level. On the north side a line of demarcation was discovered on the lower portion of the cabinets with charring on the top portion of the cabinets. On the counter space located near the stove on the right-hand side multiple lithium-ion batteries and battery sheets were discovered with multiple cigarettes filter ends found. (See figure 7)

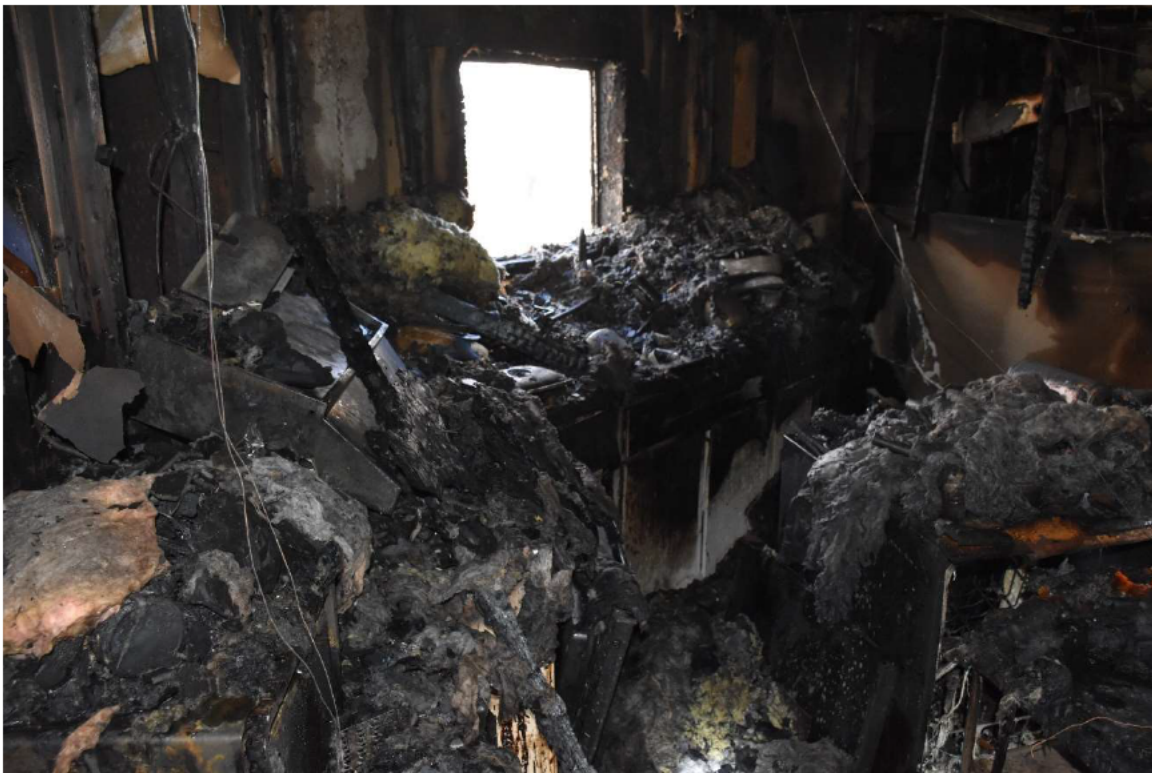
*Figure 8 Photograph NJF\_0052 Kitchen*

Based on the fire scene examination, witness statements, and other data reviewed, the area of origin was determined to be in the kitchen. (See figure 8)
