North Dakota Office of the State Fire Marshal (ND)

INCIDENT REPORT

Investigation Title: WALHALLA VERVILLE FIRE

INCIDENT ORIGIN & CAUSE NARRATIVE

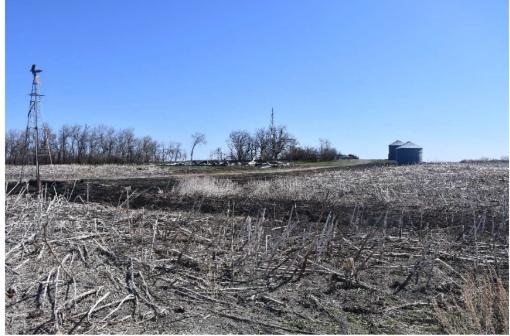
Figure 1 Photograph DSC_0003.JPG Southwest Corner Of Farmyard Facing East

On Friday, April 25, 2025, at approximately 8:30 pm, Fire Chief Mitch Lee of the Walhalla Fire Department received a telephone call regarding a grass fire in rural Northeast Cavalier County. Fire Chief Lee responded to the scene and observed a slowly moving grass fire and two impacted buildings that were already consumed and collapsed. Walhalla Fire Department was dispatched to extinguish the fire. (See Figure 1)

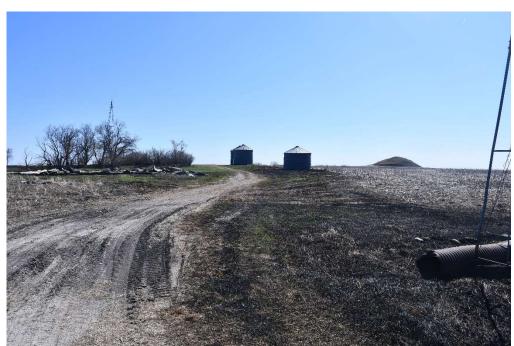
Figure 2 Photograph DSC_0007.JPG Southernmost Portion Of The Farmyard Facing Grain Bins Along The Field And Farm Yard Facing East

The southern portion of the property bordered a harvested sunflower field. Along the southernmost portion of the property were three grain bins. The grain bins were intact. The grass along the south portion of the property was charred up to the field where the field was unburned. (See Figure 2)

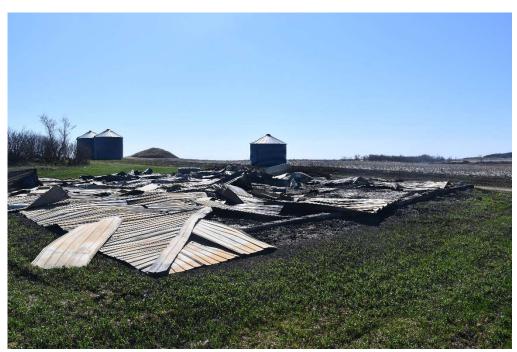
Figure 3 Photograph DSC_0015.JPG Northwest Corner Of Barn Facing Southeast

In the southwest corner of the property were the remains of a barn. The barn roof trusses were mostly consumed, and the metal roofing was oxidized and warped. All four of the walls were mostly consumed throughout. The block foundation remained intact with soot deposits throughout. There were remains of asphalt shingles throughout. The grass was charred around the whole barn. The grass lay away from the barn and the charring decreased the further you went away from the barn all four directions. There were no trees near the barn. (See Figure 3)

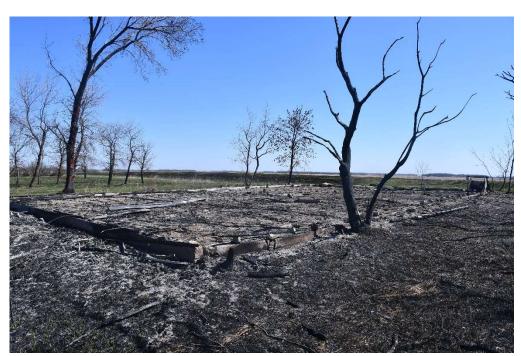
Figure 4 Photograph DSC_0031.JPG Southwest Corner Of Garage Facing Northeast

Continuing to the north was a garage, located to the northeast of the barn. The garage walls, truss members, and walls studs were consumed. There were remains of asphalt shingles throughout. The cement floor and brick footings remained intact. The trees along the exterior of the garage were charred along the side that faced the garage, where the sides not facing the garage remained unburned. (See Figure 4)

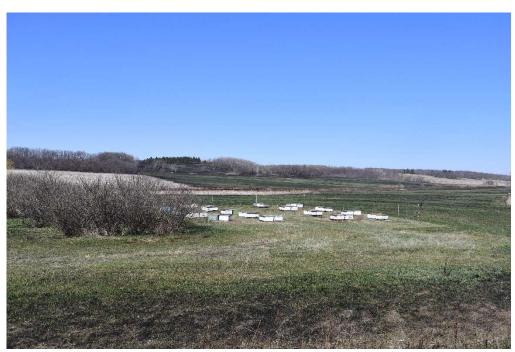
Figure 5 Photograph DSC_0057.JPG Northernmost Portion Of Farmyard Facing West By Bee Boxes

To the north of the farm site was a grass field. The grass field with trees and bushes. The trees and bushes were not damaged. To the north was a small, mowed grass patch that had bee boxes on the grass. The mowed grass was not damaged. (See Figure 5)

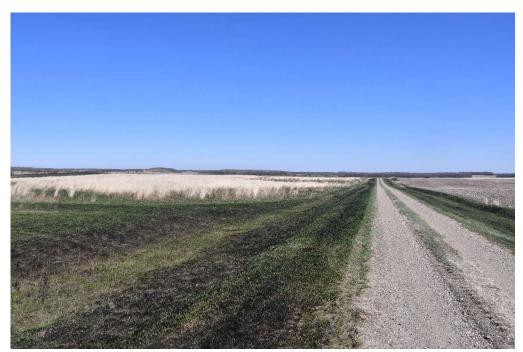
Figure 6 Photograph DSC_0063.JPG CRP Field Along West Side Of North/South Driveway Facing North

To the north of the yard was a CRP grass field. The only portion of the CRP grass that was burned was the westernmost portion of the field, close to the creek that ran northwest/southwest through the property. To the east of the CRP grass was the driveway that ran north/south. The grass on both sides of the driveway was burned approximately most of the way up the driveway, with a small portion of grass remaining intact from the roadway back to the charred grass. The grass was more burned on the south end of grass clumps compared to the north ends. The grass mostly laid facing north along the ditch of the driveway. (See Figure 6)

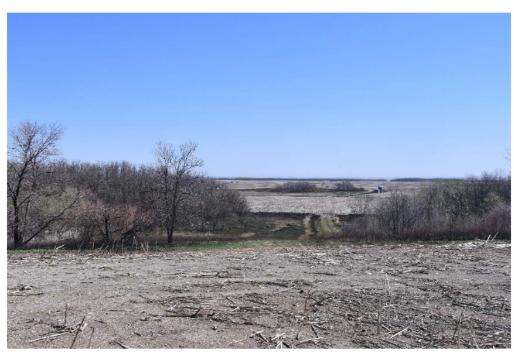
Figure 7 Photograph DSC_0096.JPG Hillside Along West Side Of The Property Facing East

To the west of the creek was a field that led to a wood line that ran north/south on the property. The wood line was on the side of a hillside slope. The grass was portion from the west extending from the northwest corner of the farmyard was burned into the trees and stopped as a crop field, directly to the west of the wood line. The grass laid mostly towards the west. (See Figure 7)

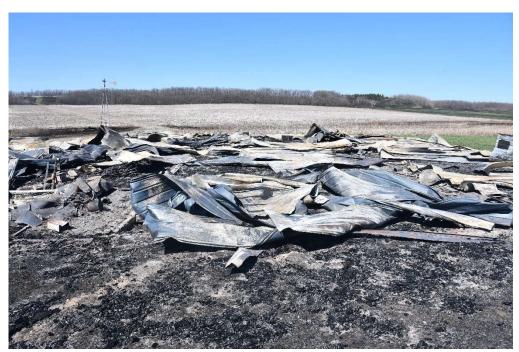
Figure 8 Photograph DSC_0021.JPG Interior Southern Half Of Barn Facing West

The southwestern most building would be best described as a barn with shiplap siding and a steel roof. The barn had a cement floor along the southernmost portion and a dirt floor along the northernmost portion. Along the south wall there were the remains of a four-wheeler and a garden tiller. Throughout the structure there were remains of charred fire debris throughout. The combustible materials inside the structure were oxidized and warped throughout. (See Figure 8)

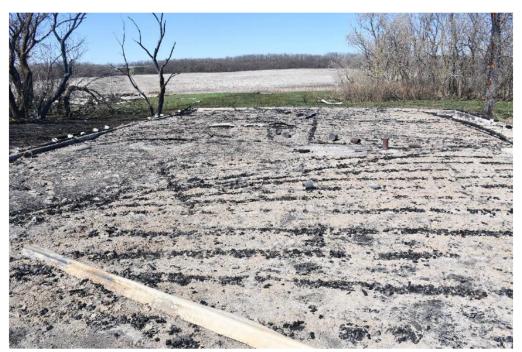
Figure 9 Photograph DSC_0042.JPG West Interior Wall Of Garage Facing West

The northeast most building would be best described as a wood garage with asphalt shingles. Inside the structure there were no remains of any items other than an oxidized unidentified object in the southeast corner. The floor had ash remains throughout. (See Figure 9)
