INCIDENT REPORT

Investigation Title: GRANVILLE JONES FIRE

## INCIDENT ORIGIN & CAUSE NARRATIVE

A fire occurred in a modular home at 201 Roosevelt Ave SW in Granville, ND. The fire was reported on May 20<sup>th</sup>, 2025, at approximately 2:20 PM. The Granville Rural Fire Protection District responded and extinguished the fire. No occupants occupied the structure at the time of the fire with a passerby who called 911. No injuries or fatalities were reported. (See Figure 1)

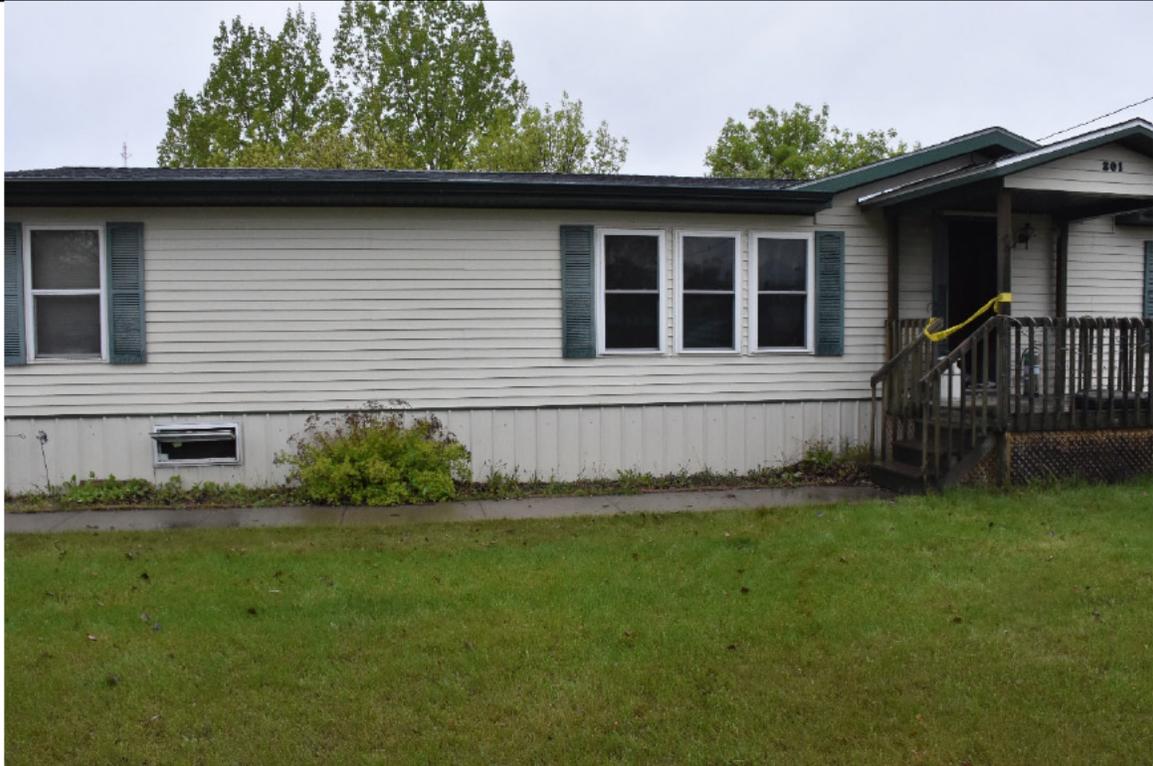
Figure 1 Photograph NJF\_0025, Direction West, modular home with crawl space no basement.

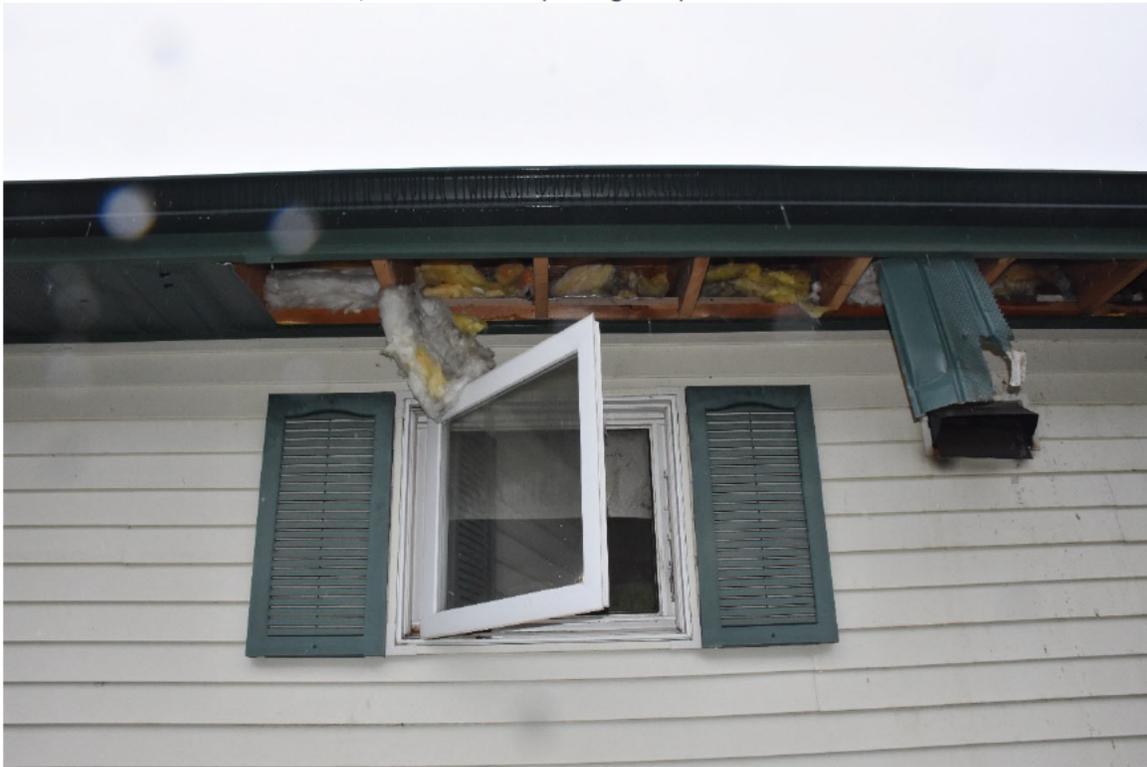
The west side of the structure had all windows intact. Near the middle of the structure on the north side of the covered porch received damage to the soffits due to fire suppression and overhaul. Smoke staining was observed around the window frame, soffit and vent. (See Figure 2)

Figure 2 Photograph NJF\_0035, west side of structure

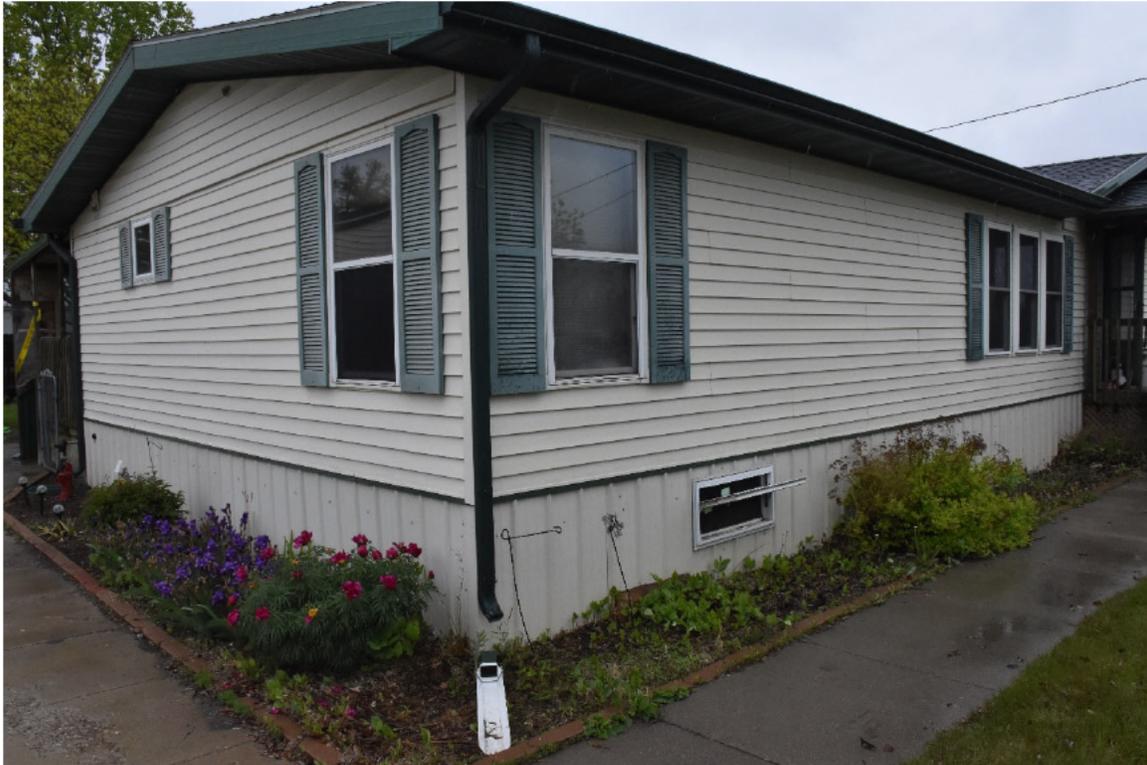
The east side of the structure had all windows intact with no signs of smoke or fire damage. (See Figure 3)

Figure 3 Photograph NJF\_0023, East corner of the structure, no fire or smoke damage

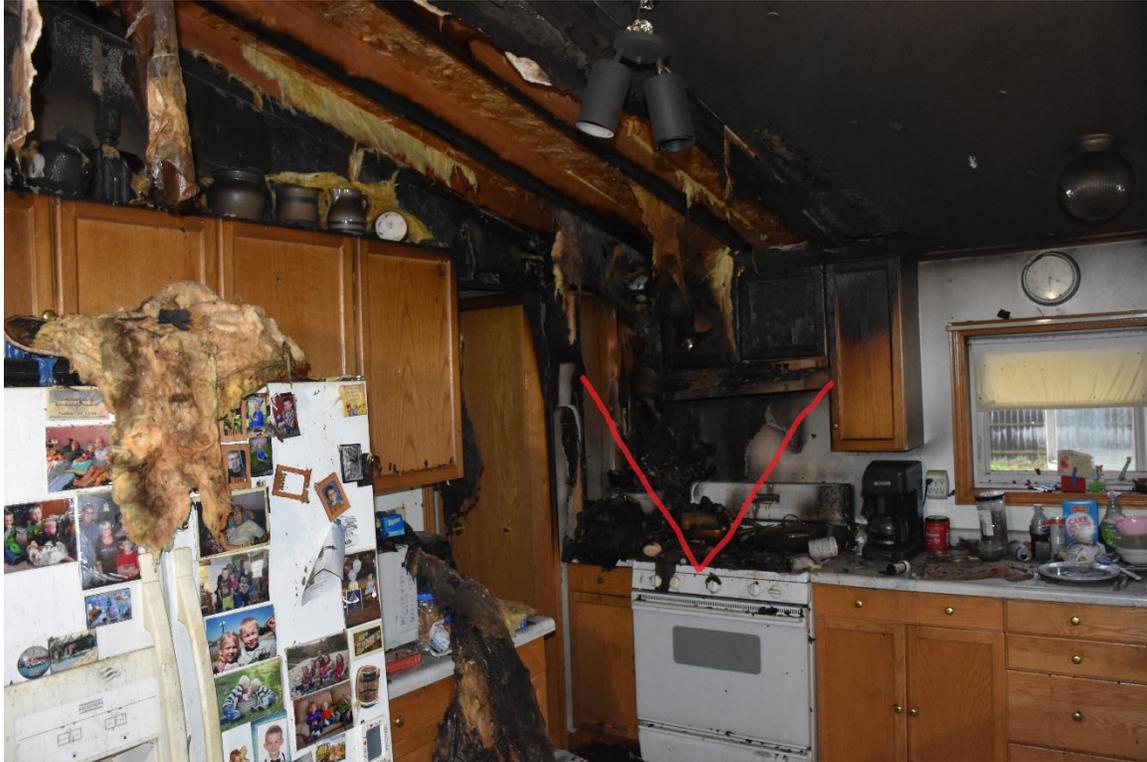
The kitchen going from north to south, the ceiling received smoke staining and received mass loss to the ceiling over the stove in a horizontal line all the way to roof peak. The upper kitchen cabinets over the sink received

smoke staining on the upper half portion while the upper cabinets above the stove received charring with a v pattern observed from the stove top to the ceiling. (See Figure 4)

Figure 4 Photograph NJF\_0071, V pattern over kitchen stove.

- This area sustained the most consumption compared to the rest of the structure.
- The wood framing sustained more charring and mass loss compared to the rest of the structure.
- Top kitchen cabinets received charring in a V pattern.

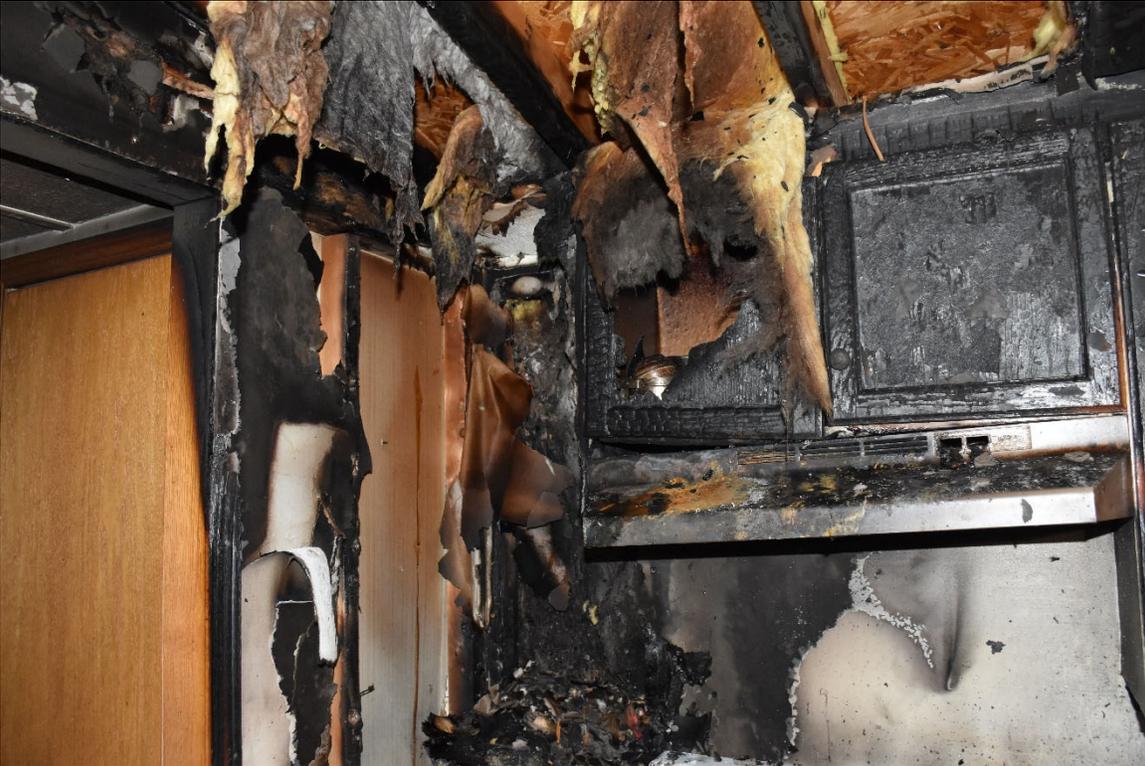
On the upper cabinets above the stove the south cabinet door received mass loss of the door and charring to the interior walls. The south side of the kitchen stove wall received mass loss to the wall stud and electrical outlet housing. The exhaust fan above the stove received oxidation and discoloration more to the south side of the exhaust vent than the north. (See figure 5)

*Figure 5 Photograph NJF\_0085, Kitchen, mass loss of cabinet door, oxidation to exhaust vent.*

- Color changing oxidation to the hood exhaust vent.
- Charring and mass loss to wall studs in the area of the kitchen.
- Charring to wooden rafters in the kitchen area.

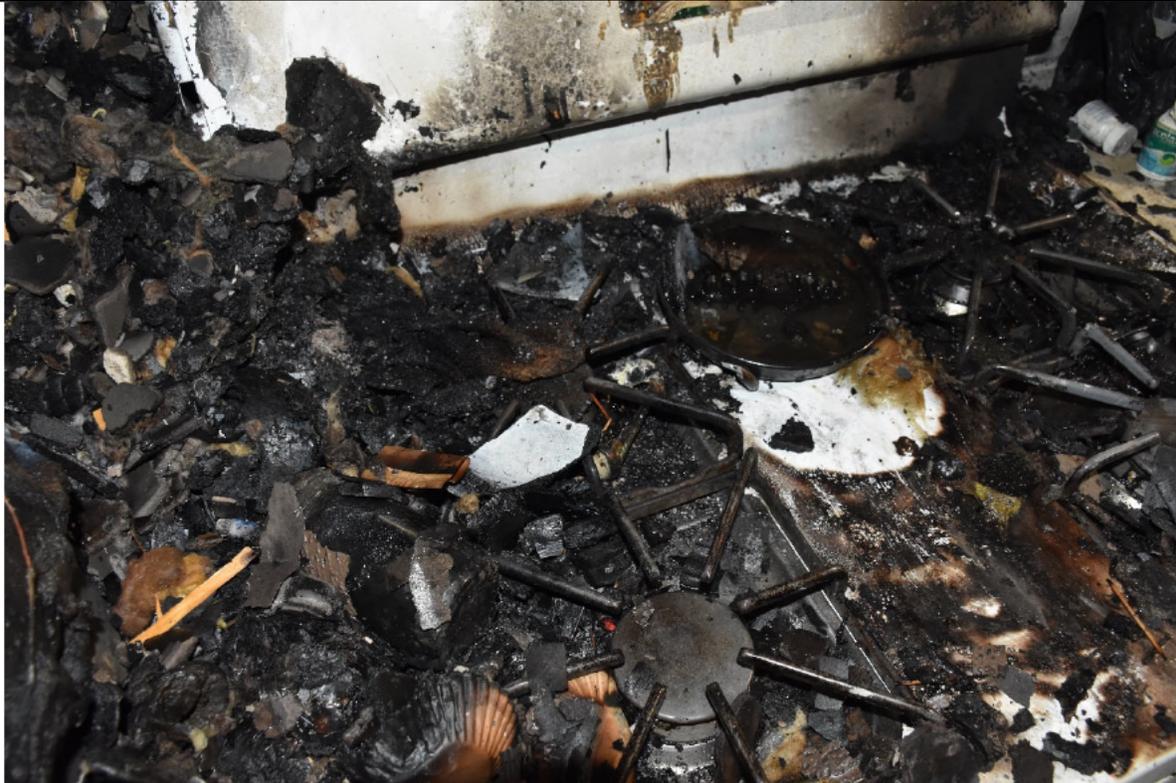
The stove back received heat-induced color change which extended to the outer edge on the south side with melting to the digital clock display. The stove top had an ash tray in the center of the two rear burners which left a protected space underneath the ash tray. Pieces of charred cloth material and wooden tooth picks were discovered across the stove top along with melted plastic materials. Insulation materials were discovered on the stove top on top of and around the two metal cooking pans observed on the on the rear two burners. (See figure 6)

Figure 6 Photograph NJF\_0093, Kitchen stove top

- Cooking appliance activated igniting ordinary combustible materials such as cloth and plastics.
  - FC Shane Thull stated fire crews discovered right front burner switch was on the HI position.
  - Helmet camera video shows right front burner on the HI position.
  - Mass loss of cloth and plastic materials were discovered on stove top.
  - Two pans were discovered on the stove top.
  - This hypothesis could not be eliminated

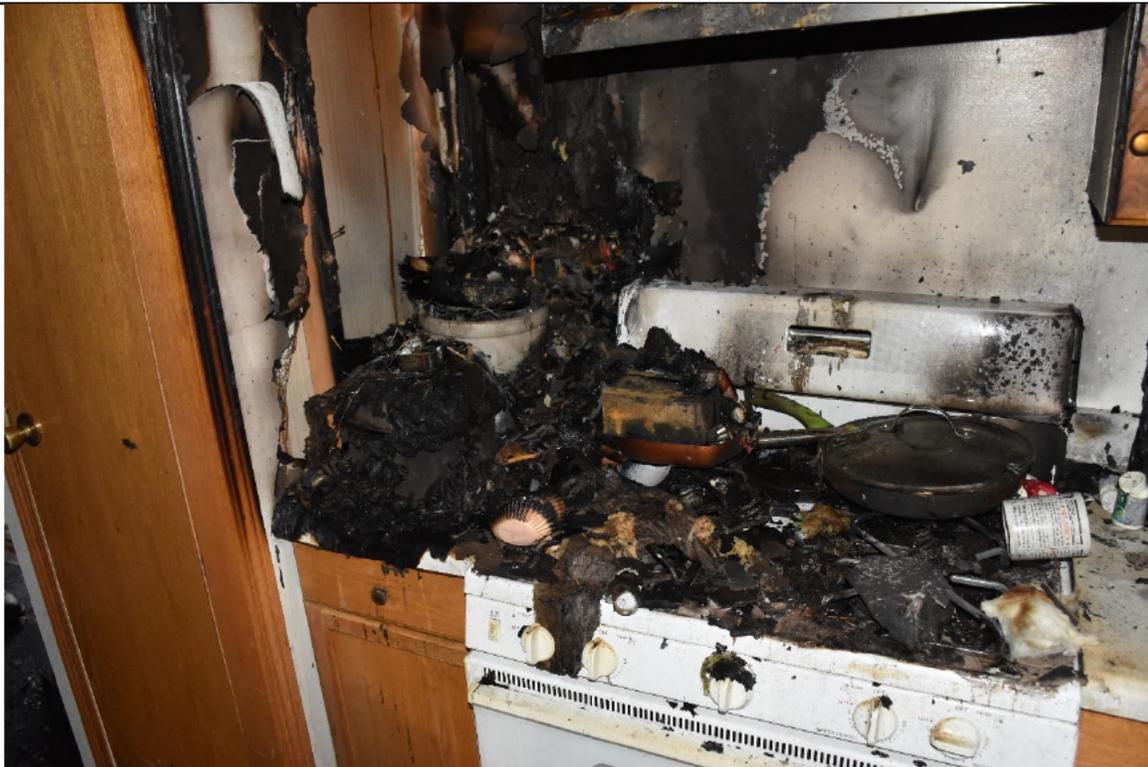
Based on the fire scene examination, witness statements, and other data reviewed, the area of origin was determined to be the stove area of the kitchen. (See figure 7)

Figure 7 Photograph NJF\_0087, Kitchen stove top

Based on the fire scene examination, witness statements, and other data reviewed, the area of origin was determined to be at or near the kitchen stove.

This fire cause remains cooking appliance activated igniting ordinary combustible materials such as cloth and plastics.
