INCIDENT REPORT

Agency Incident ID: NDSFM25-070

Investigation Title: STRASBURG VANBEEK FIRE

North Dakota State Fire Marshals Office (ND)
 INCIDENT ORIGIN & CAUSE NARRATIVE
 Official Law Enforcement Report – Unauthorized Dissemination is Prohibited

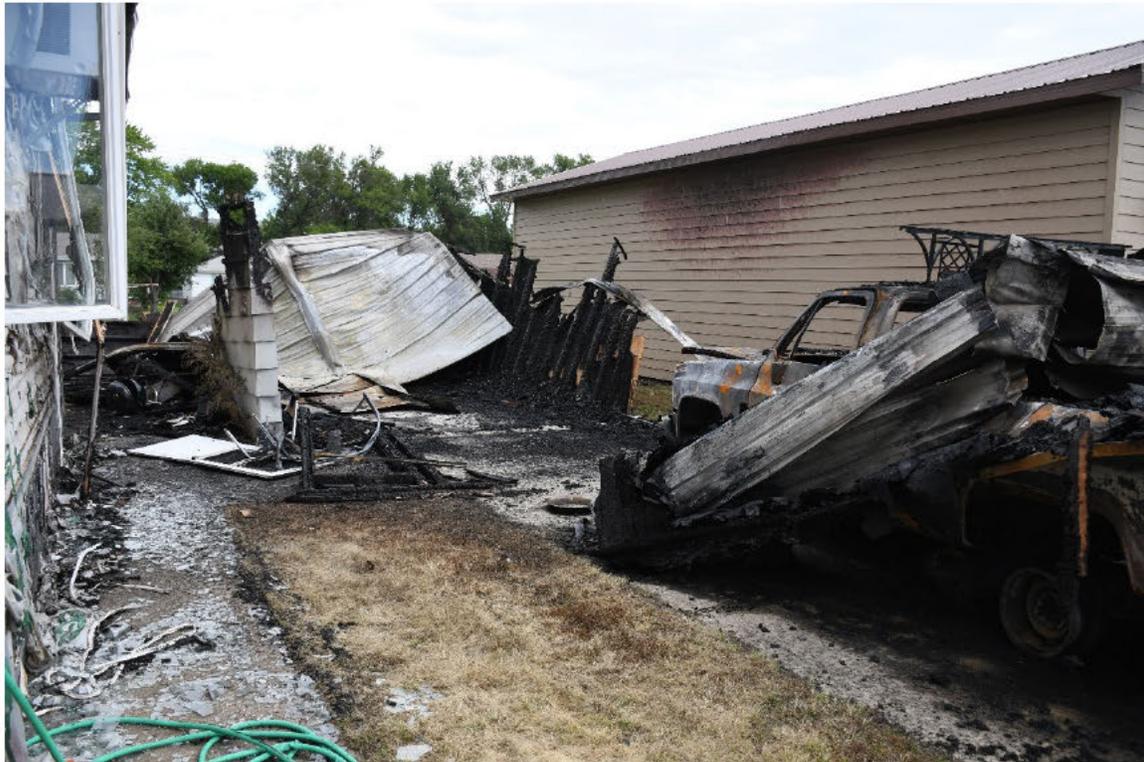
A fire occurred inside a single-stall detached garage at 505 Main St., Strasburg, ND, 58573, on July 4th, 2025, at approximately 11:05 pm. The homeowner, Greg VanBeek, discovered the fire and called 911. No injuries or fatalities were reported. (See Figure 1.)

Figure 1. Photo of the detached garage.

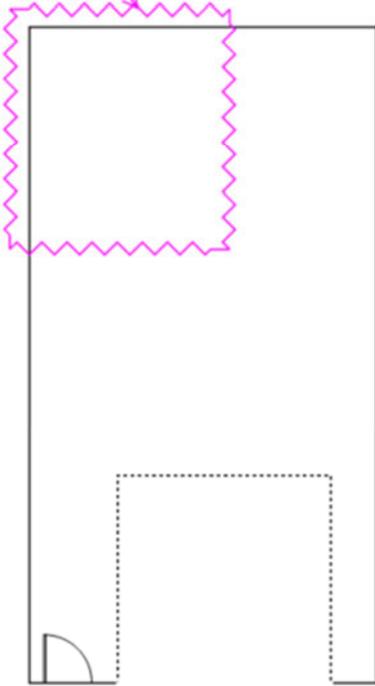
Area of Origin

Case #: NDSFM25-070

Location: 505 Main St. Strasburg, ND 58573

Area of Origin:
 Based on witness statements, fire dynamics, and fire patterns, the area of origin was determined to be on the northwest side of the garage interior.

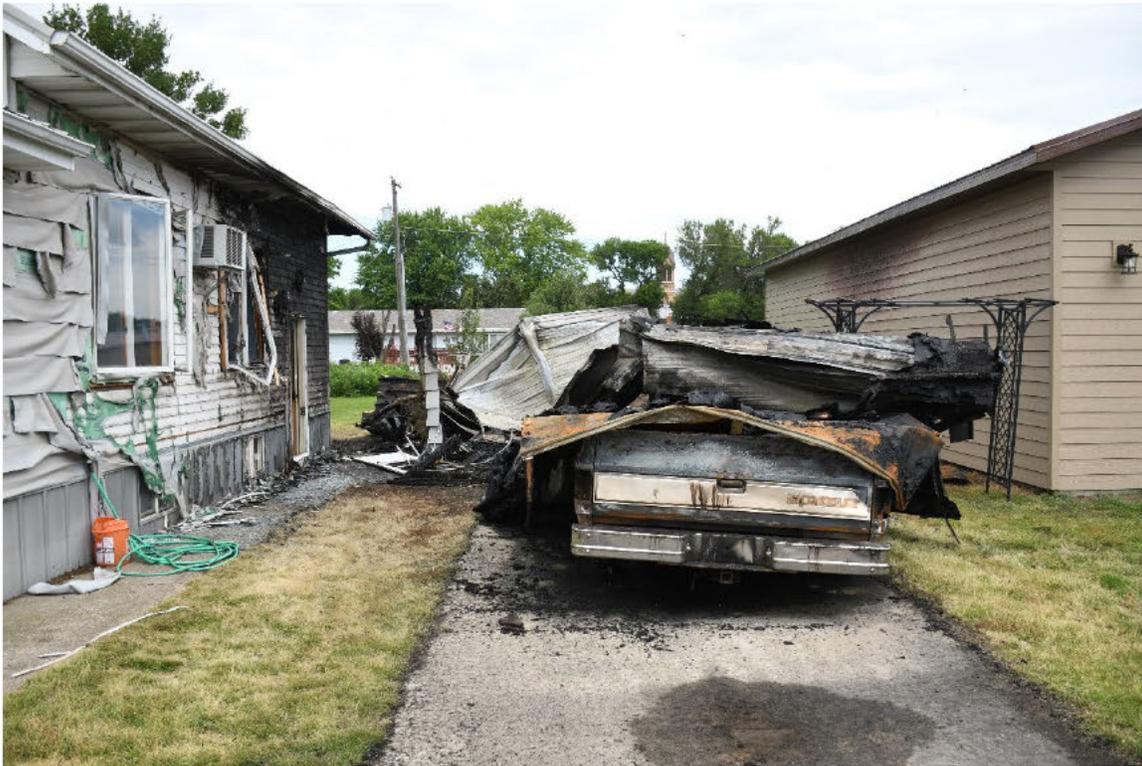
My exterior scene examination started on the south side of the garage facing north. I observed the roof of the garage that had fallen onto a truck that was in the driveway. Also pictured is the observation of melting of the home's vinyl siding caused by radiant heat from the fire in the garage. (See Figure 2.)

Figure 2. Showing the damage to the garage and the radiant heat damage to the home.

The west side of the garage's wall sustained mass loss. The garage's sheet metal roof can be observed to have fallen down into the garage. Exterior burning can be seen on the east side of the home, along with melting of the home's vinyl siding. Exterior radiant heat damage can be seen on the west side of the neighbor's garage as well.

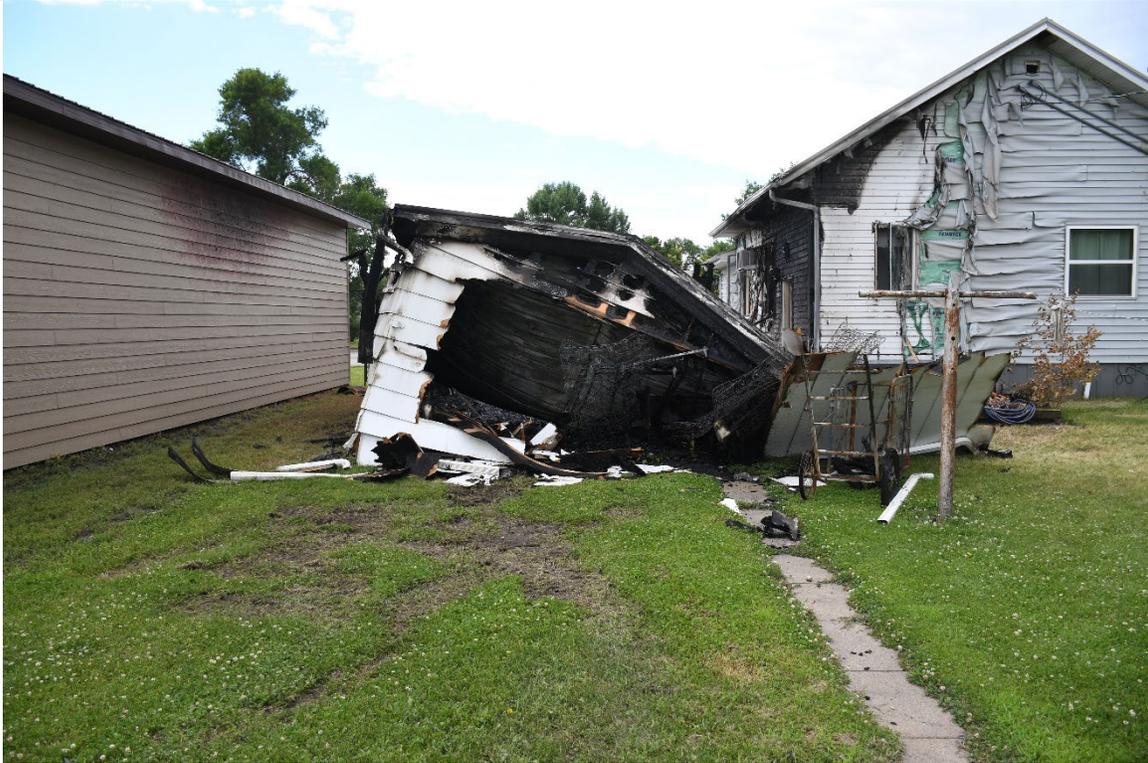
On the north side of the wall, I observed that a portion of the northeast exterior wall was still standing, but the northwest side was primarily consumed with portions that had collapsed to the ground. The north side of the home sustained thermal heat damage to the home's vinyl siding as well as some charring. I also observed the thermal damage sustained to the exterior of the neighbor's garage. (See Figure 3.)

Figure 3. The north side of the garage shows the damage to the northwest side.

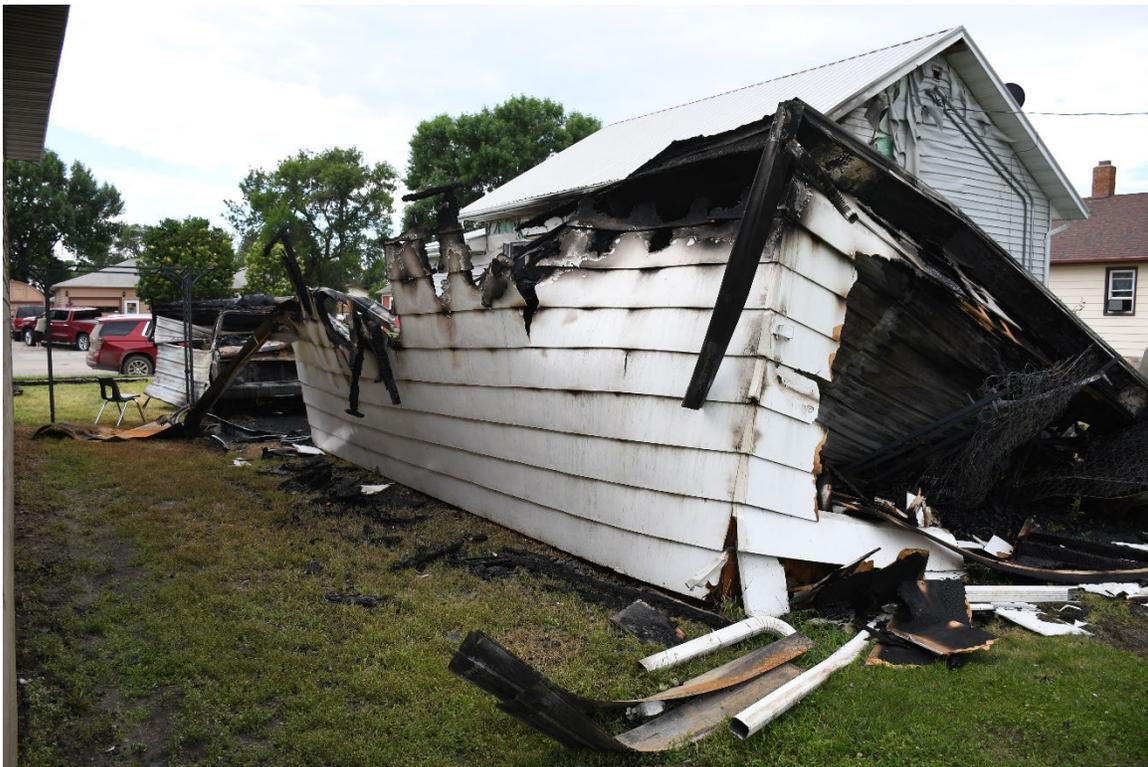
The east side of the garage still had most of its exterior wall standing, and the visible burn patterns show burning from the top of the wall down. The north end of the east wall remained more intact than the south end. (See Figure 4.)

Figure 4. Showing the fire damage sustained to the east side of the garage.

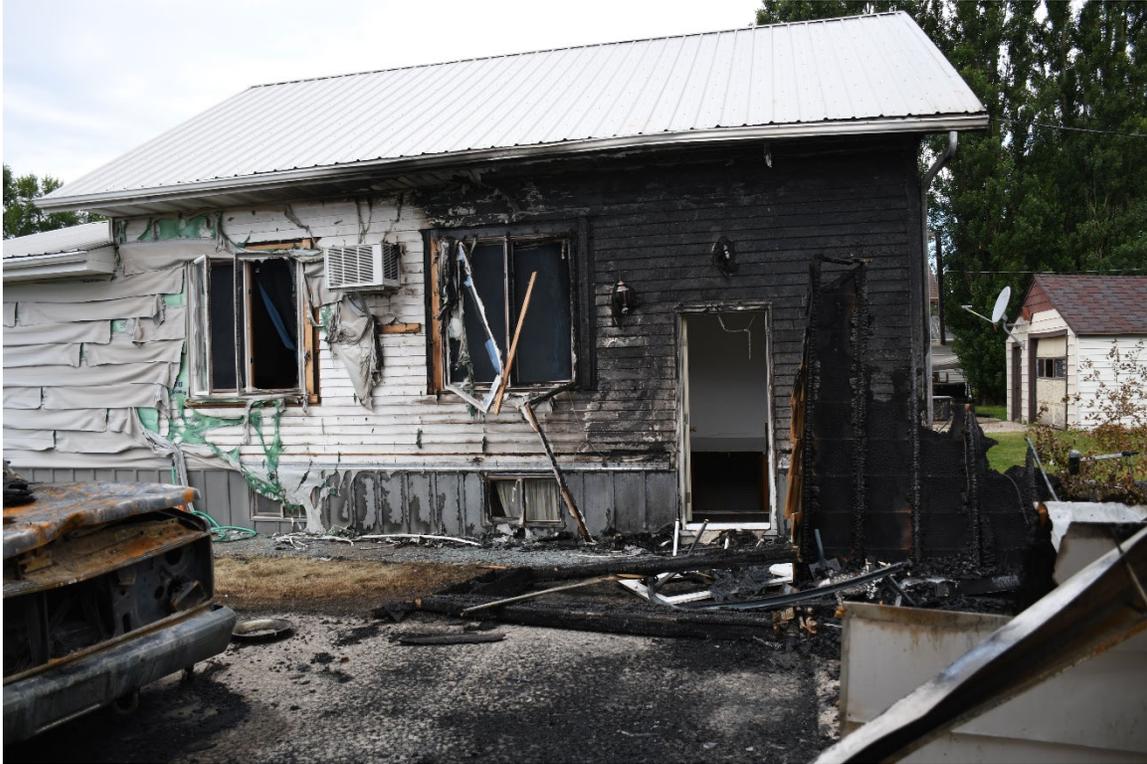
The exterior of the home that was west of the garage sustained thermal damage as well as charring. The windows on the home facing east were gone, and the framing had melted away. The vinyl siding on the north side of the home had been burned away, with more of the vinyl siding still intact on the south side of the home. (See Figure 5.)

Figure 5. Showing the radiant damage sustained to the home next to the garage.

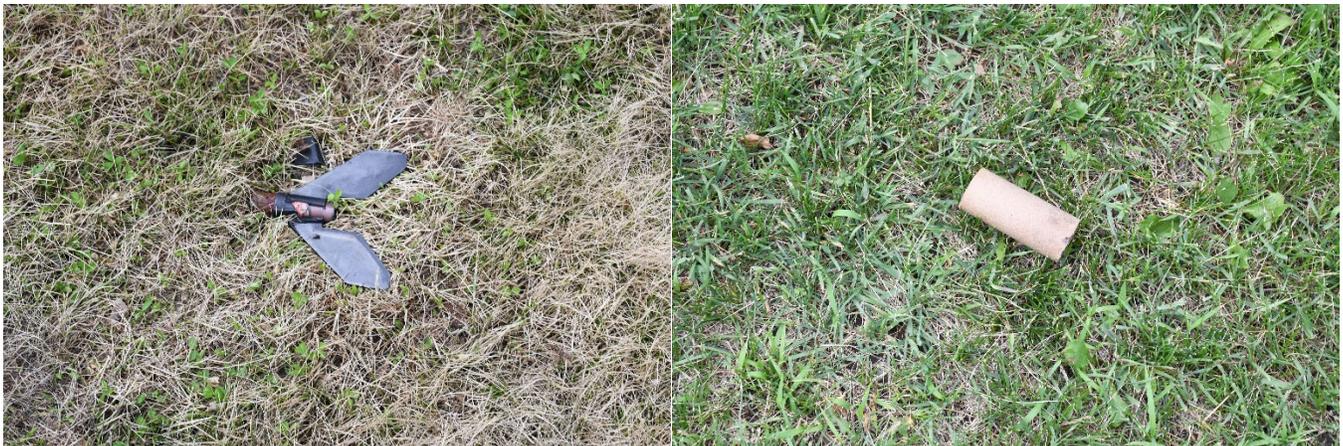
Multiple fireworks were found to the northwest of the garage. (See Figures 6 and 7.)

Figure 6 And 7. The fireworks that were found in the area of the garage.

- Multiple used fireworks were found in the area of the garage.
 - No other sources of ignition were found in the area of origin.
 - This hypothesis could not be eliminated as the potential cause of the fire.

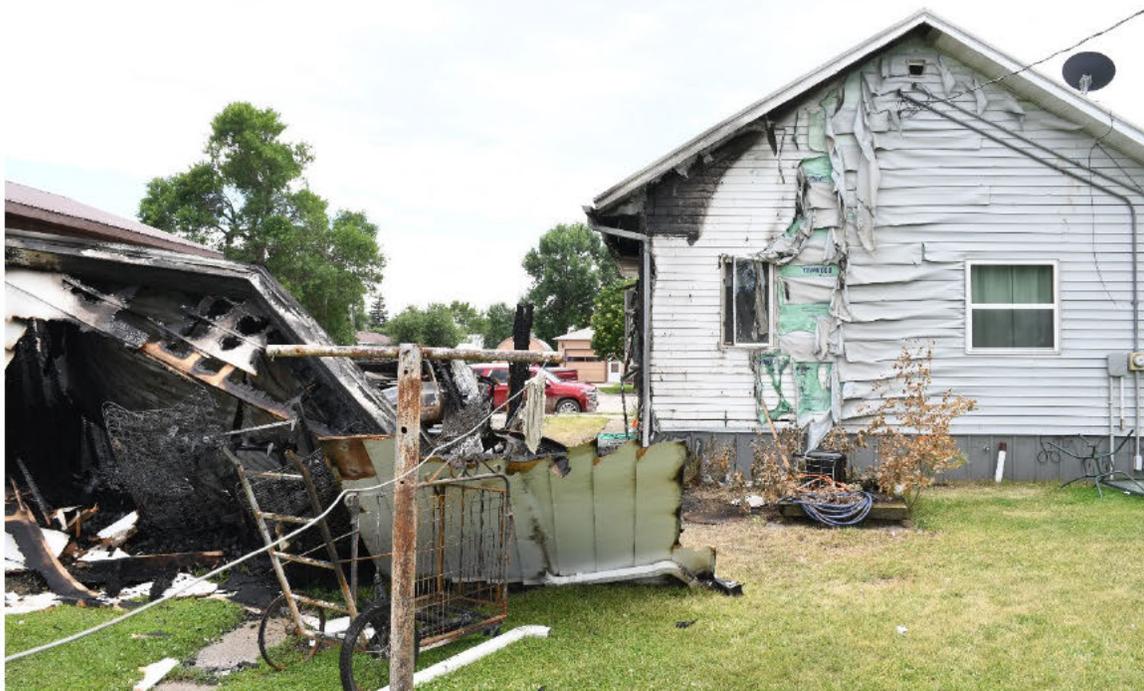
The home was supplied by natural gas that entered on the north side of the house, and the electricity entered from overhead on the north side as well. No electricity or gas was supplied to the detached garage. (See Figure 8.)

Figure 9. the north side of the home where the electricity comes in.

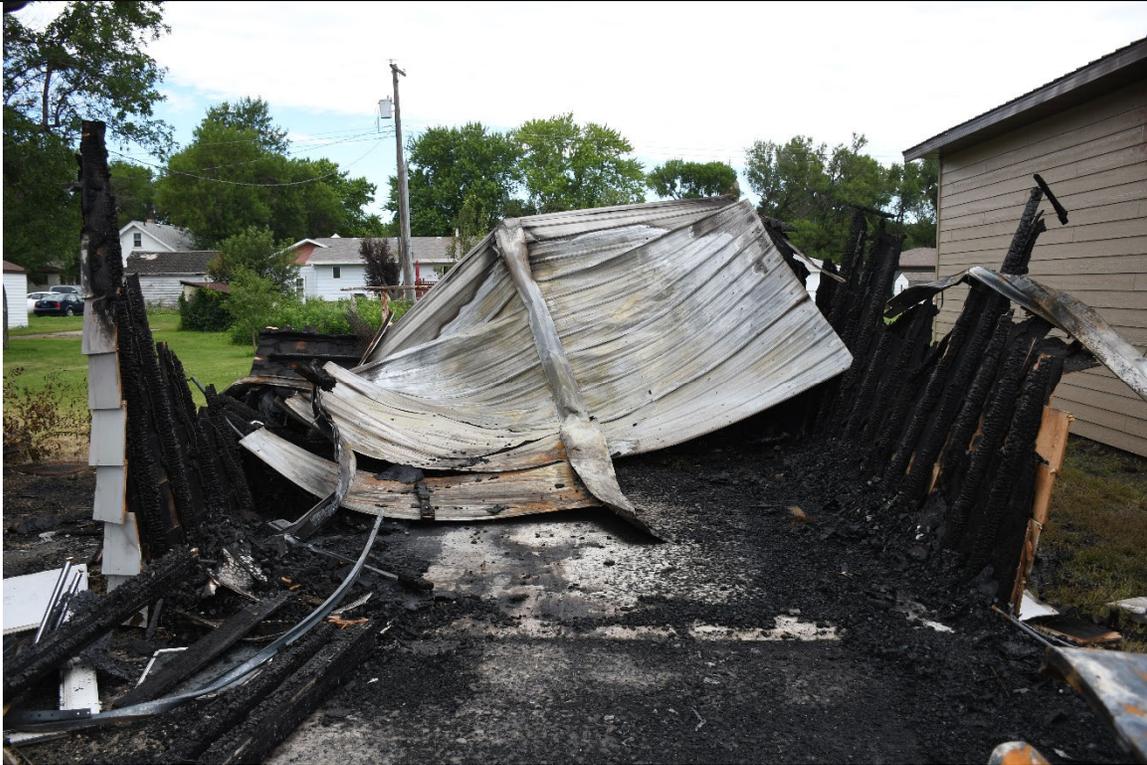
No interior examination was completed for the entire structure due to safety concerns with regard to the stability of the building materials. Exposure to the flames produced heat-induced oxidation on the tin roof, which then collapsed into the interior.(See Figure 10.)

Figure 10. Showing the mass loss to the interior of the garage.

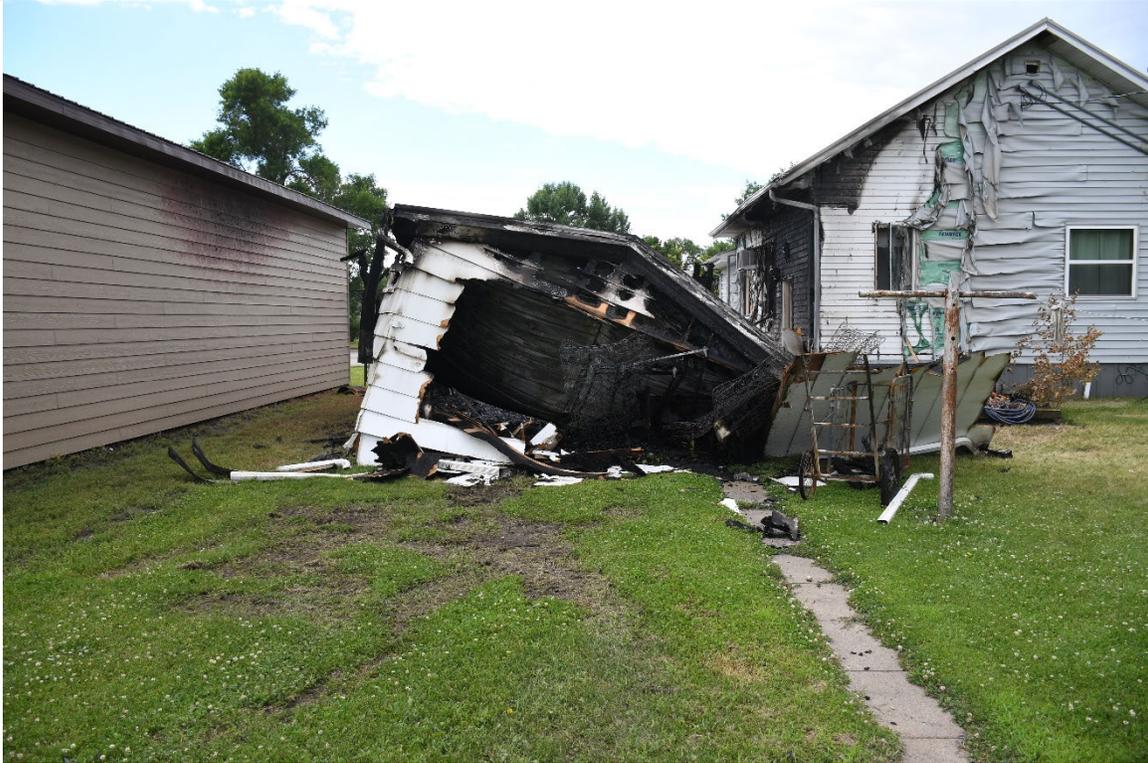
The garage sustained full room involvement. The room and contents within the structure had reached flashover during the fire. Uniformity in fire patterns was observed throughout. The majority of the combustible materials were consumed, and the non-combustible materials sustained oxidation and heat-induced color change. The remaining wood structural members sustained charring from the roof to ground level. Mass consumption occurred in the roof trusses. The area of greater mass consumption and collapse to the structure was in the northwest portion of the garage. (See figure 11.)

Figure 11 The north side of the garage..

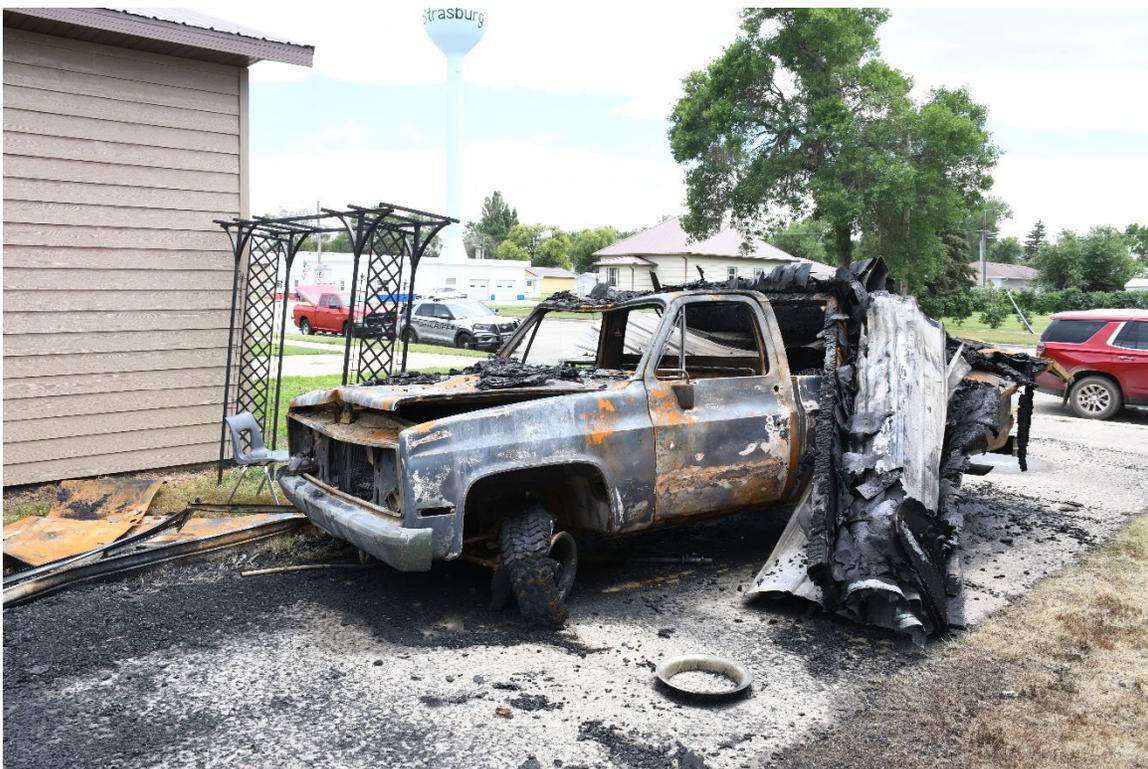
A Pickup was parked inside the garage at the time of the fire and sustained a heat-induced color change. The fire department pulled the truck out of the garage during the firefighting process. (See Figure 12.)

Figure 12. Shows the heat-induced color change and oxidation on the pick-up.
