Investigation Title: JAMESTOWN WAHL FIRE

**North Dakota State Fire Marshals Office (ND)**  
**INCIDENT ORIGIN & CAUSE NARRATIVE**  
**Official Law Enforcement Report – Unauthorized Dissemination is Prohibited**

A fire occurred in a residential structure at 3415 79<sup>th</sup> Ave SE in Jamestown, ND. The fire was reported on July 21, 2025 at approximately 7:10 AM. The Jamestown Rural Fire Department responded and extinguished the fire. The property owners were away on a cruise ship at the time of the fire and had family members who were checking on the property call 911. No injuries or fatalities were reported. (See Figure 1)

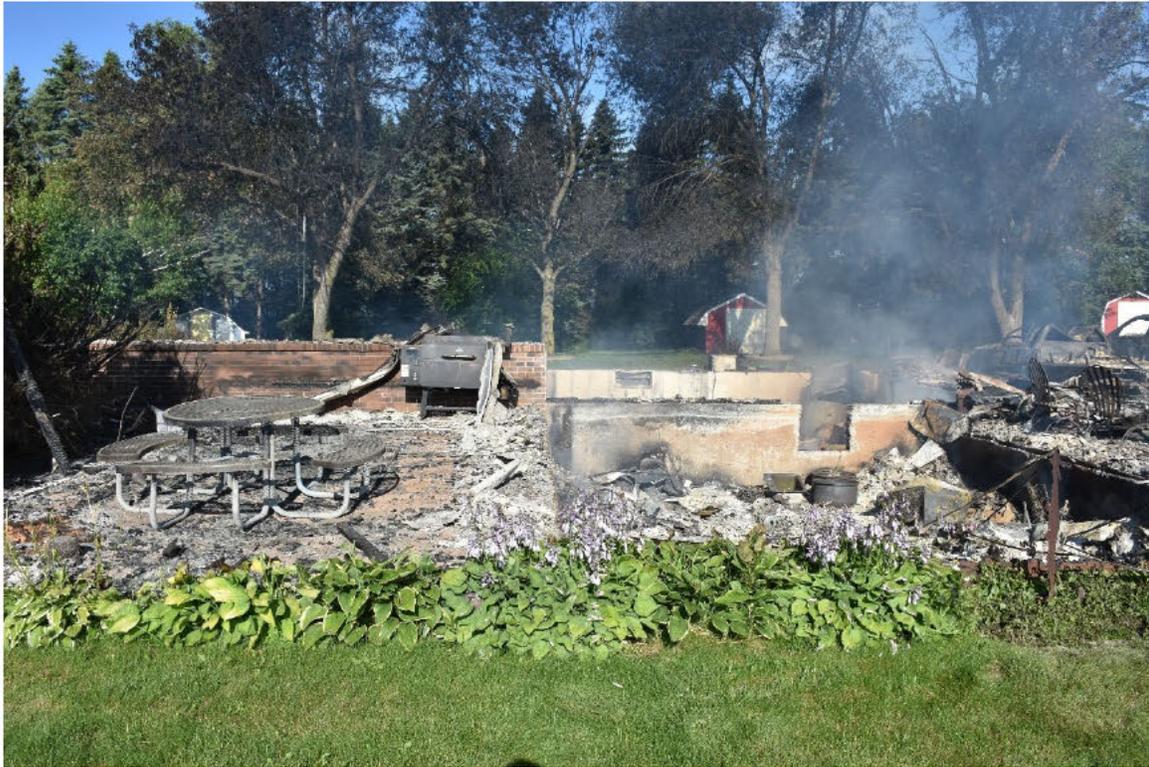
*Figure 1 Photograph NJF\_0005, front yard of structure, facing west.*

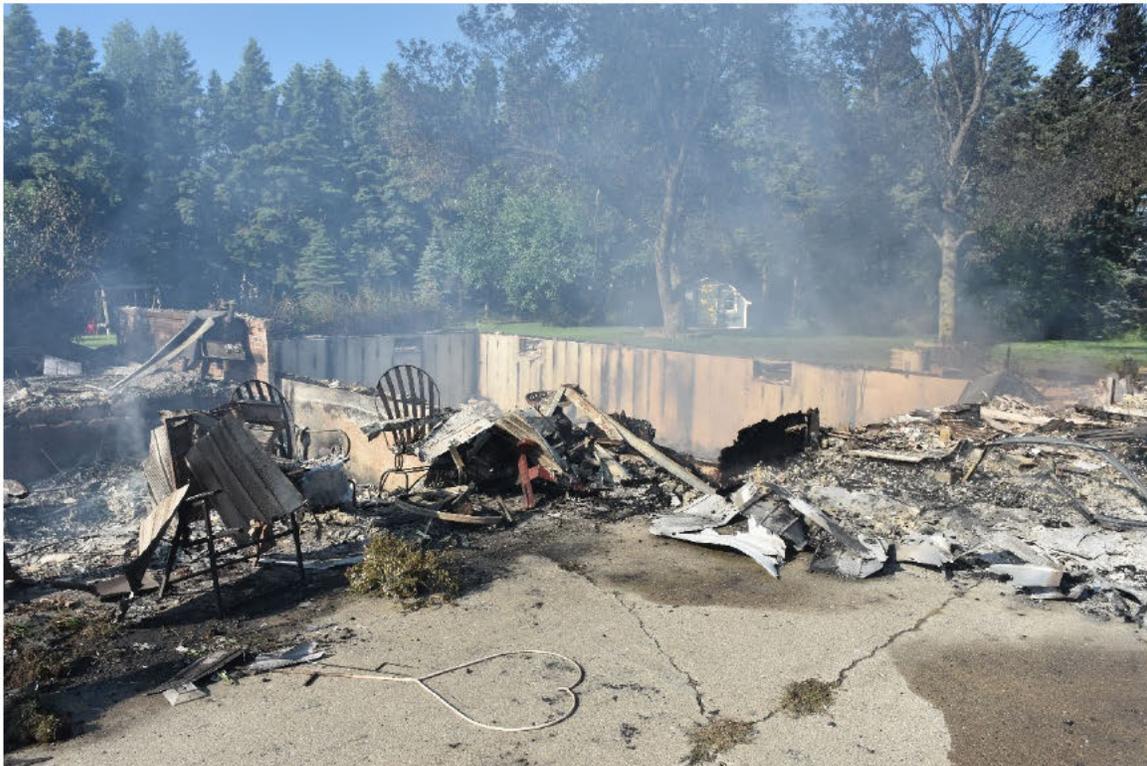
The east side of the structure had all walls missing except an approximately 4 foot tall by 20-foot-long brick and mortar wall. The roof had collapsed inside of the structure. Pieces of metal soffit materials were discovered with deformation and smoke staining. (See Figure 2)

*Figure 2 Photograph NJF\_0007, east side of the structure*

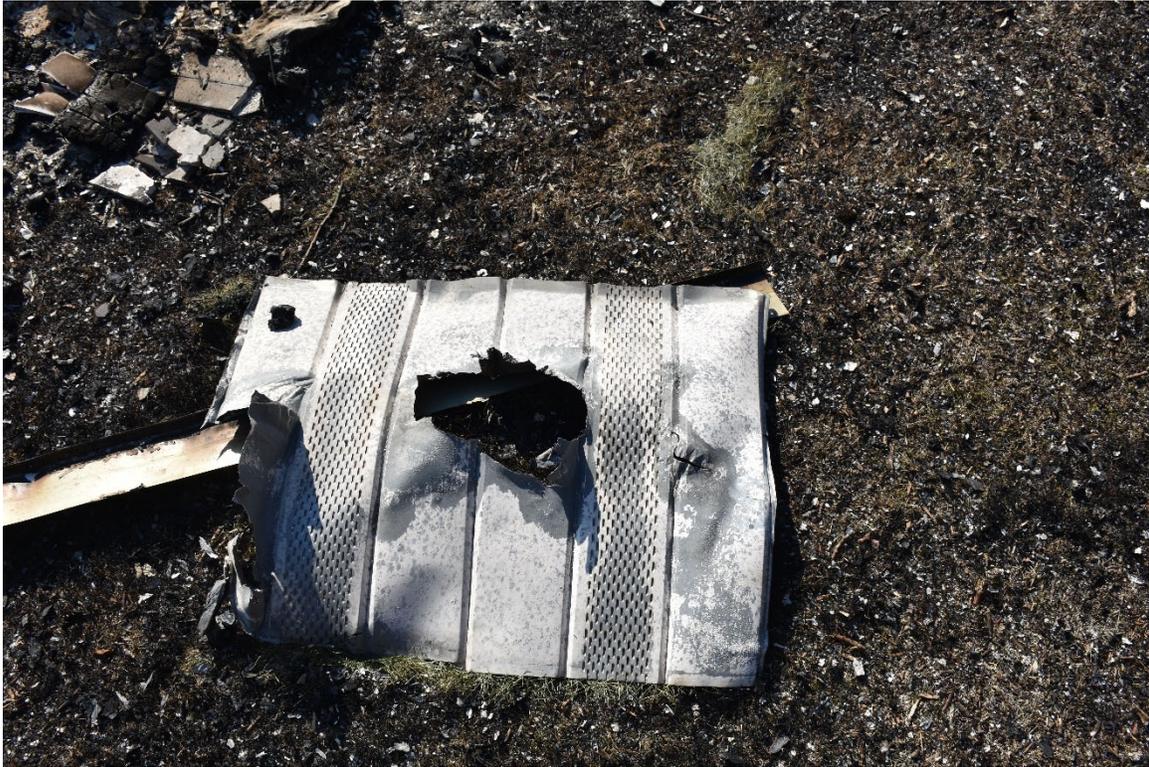
The west side of the structure had all walls and roof missing only standing portion was the basement foundation. Vegetation surrounding the structure was charred and had discoloration. The soffit and gutter materials had discoloration and melting and was found approximately 4 feet west of the structure. One piece of the soffit material was examined that was found to have a large irregular hole with ununiformed ends and melting. (See Figure 3)

*Figure 3 Photograph NJF\_0028, west side of structure, soffit material*

- Lighting strike on or near a structure that caused combustible building material to ignite.
  - Review of the weather showed signs of Thunder storms in the area.
  - National Weather Service showed a lightning strike in the area
    - 546 Meters distance from strike to structure
    - Time of strike 5:27 AM.
  - Soffit material with a large irregular opening.
  - No known witness to the strike or the fire.
    - Amanda Schaffer stated severe thunderstorm with lightning.
  - Service hole in west yard had melted and mass loss of wiring with the cover and dirt and grass material removed.
  - Crater was discovered in the west yard.
  - This hypothesis could not be eliminated.

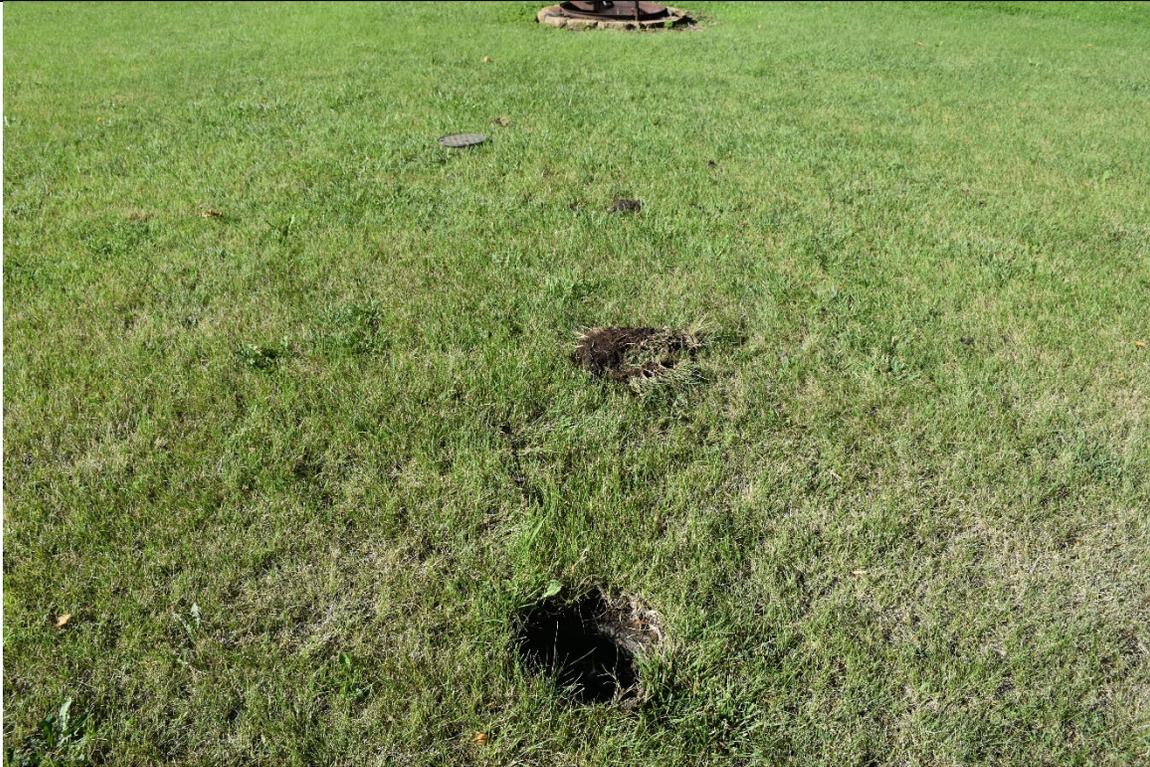
In the yard of the west side of the structure approximately 15 feet away from the structure a service hole was discovered. The area around the service hole had dirt and grass material removed and was discovered in clumps approximately 2 feet west of the service hole. The interior of the service hole had melted and mass loss of electrical wiring for an underground sprinkler system. The cover for the service hole was discovered approximately 10 feet west from the service hole. (See Figure 4)

*Figure 4 Photograph NJF\_0037, service hole for sprinkler system, west yard*

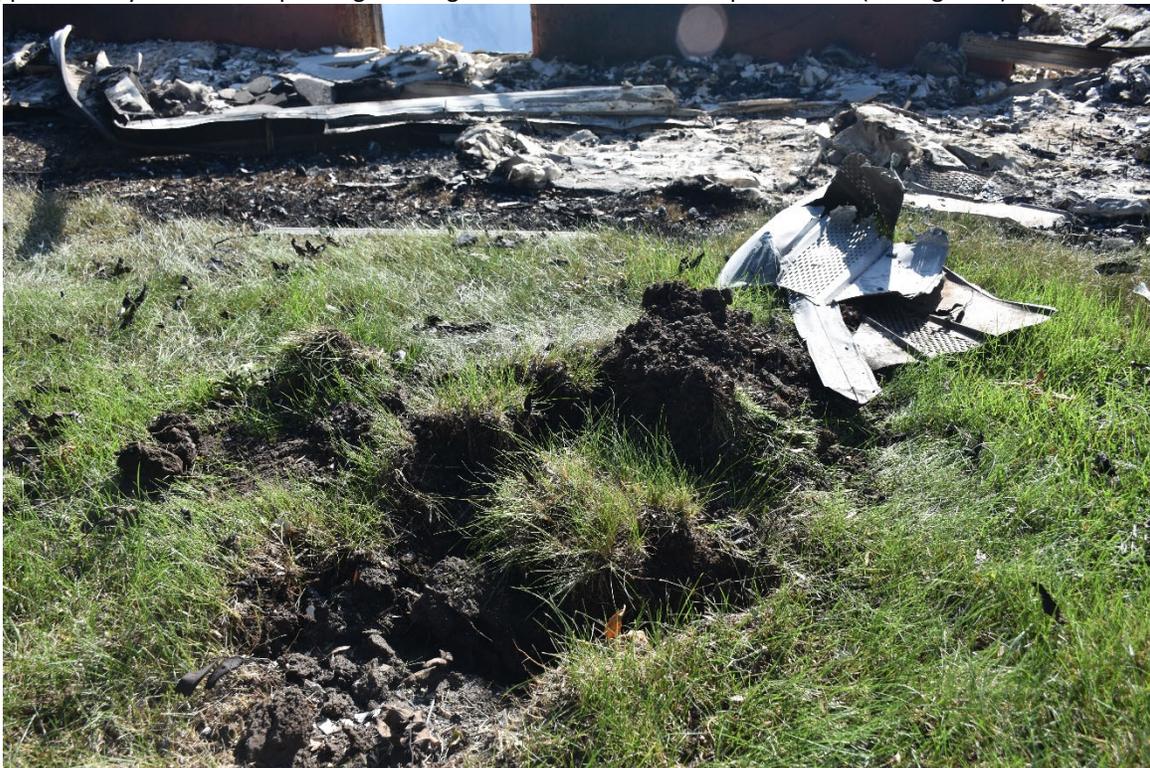
Also, in the west portion of the yard a crater in the ground was discovered approximately 10 feet away from the structure. The crater was approximately 6 inches deep with green vegetation and had non compacted dirt. (See Figure 5)

*Figure 5 Photograph NJF\_0033, ground crater west yard*

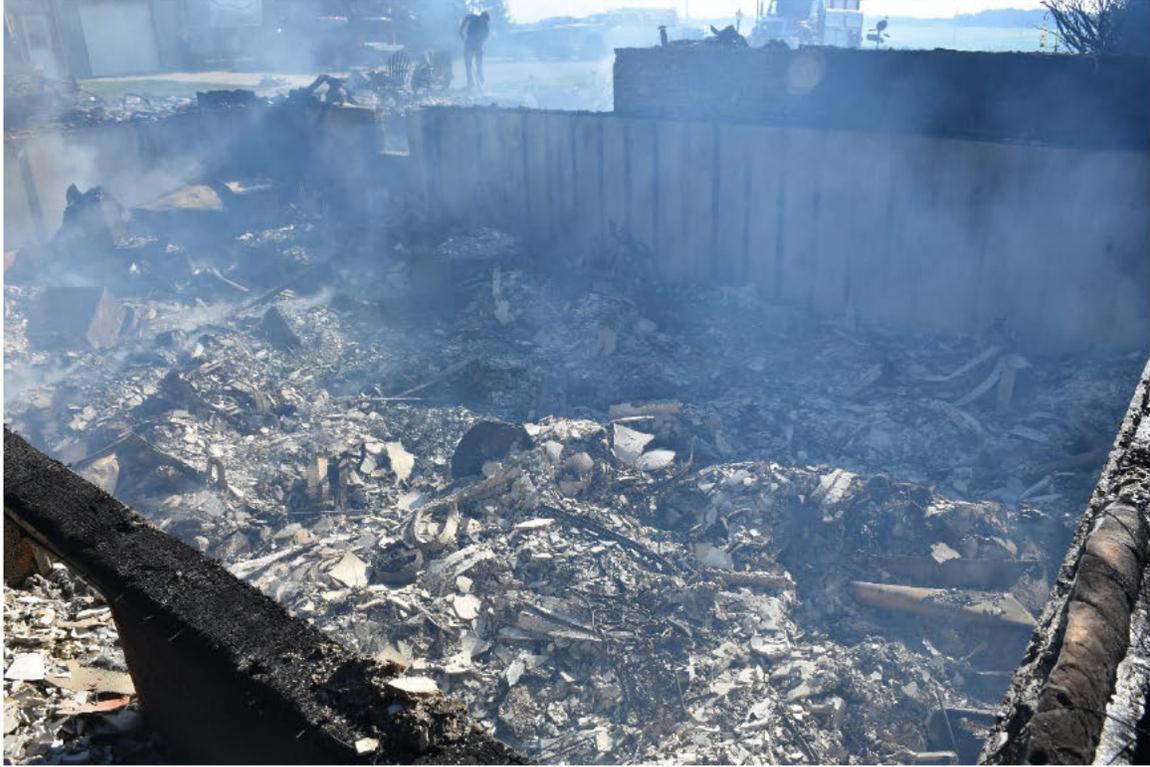
My interior inspection was limited to the exterior due to the only portion of the structure left was the basement foundation. Due to active fires at the time of the investigation no access was made to enter the structure. (See Figure 6)

*Figure 6 Photograph NJF\_0042, basement foundation*

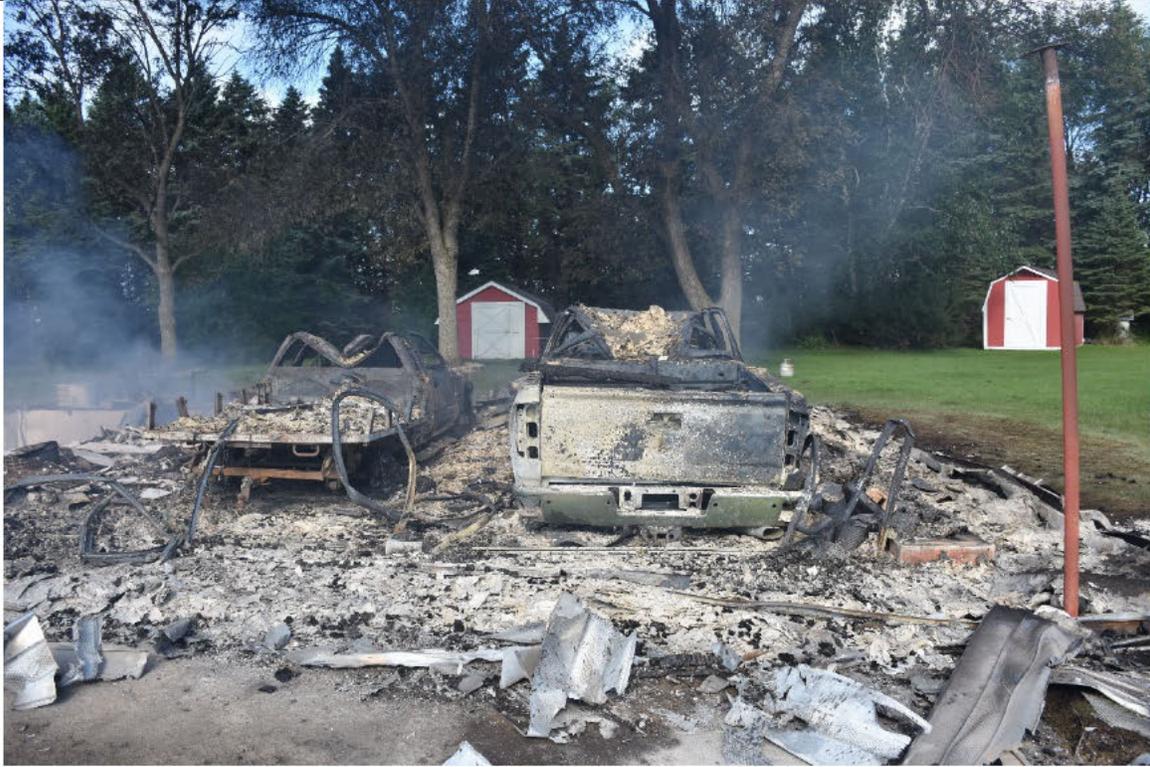
The garage portion of the structure had two vehicles that had mass loss to the wheel and rims of the vehicles along with mass loss of cloth and plastic materials in the cabs. The exterior rooflines of both vehicles received caved in roofs with charred wooden lumber materials on top. Both vehicles received discoloration and all glass materials missing. (See Figure 7)

Figure 7 Photograph NJF\_0049, garage area of structure.

The ground level of the garage area had mass loss and charring of wooden materials with oxidation and color change of metal cans.

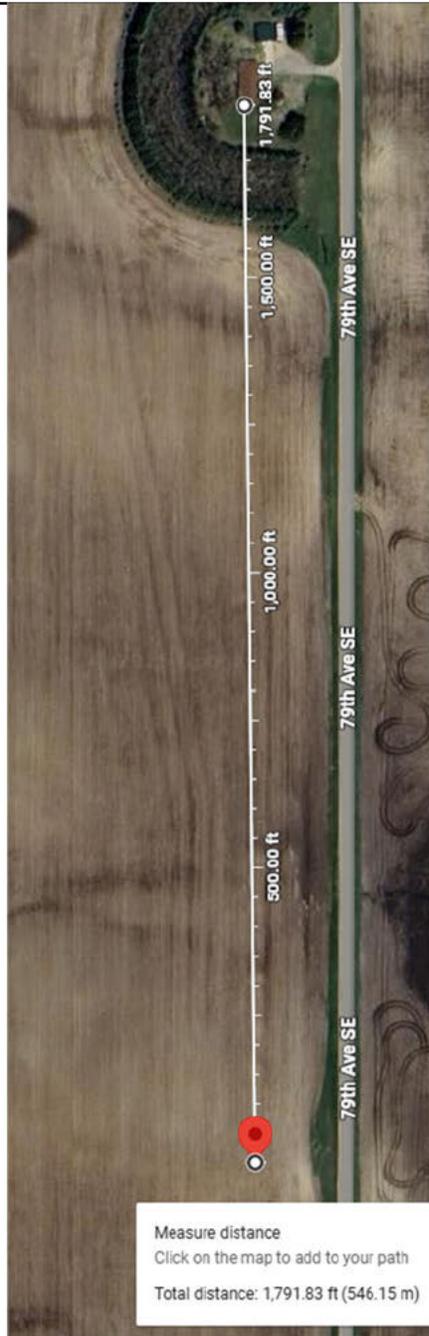
- (NWS) National Weather Service, Report ID 873b3d11-6607-4a13-bb72-c448dd87088f
  - Confirmed coordinates of lightning strike
  - Latitude 46.915407, Longitude -98.798604
  - Time of lightning strike was 5:27 AM
  - 500 meter +or – accuracy (See Figure 8)

*Figure 8 google maps snip it*

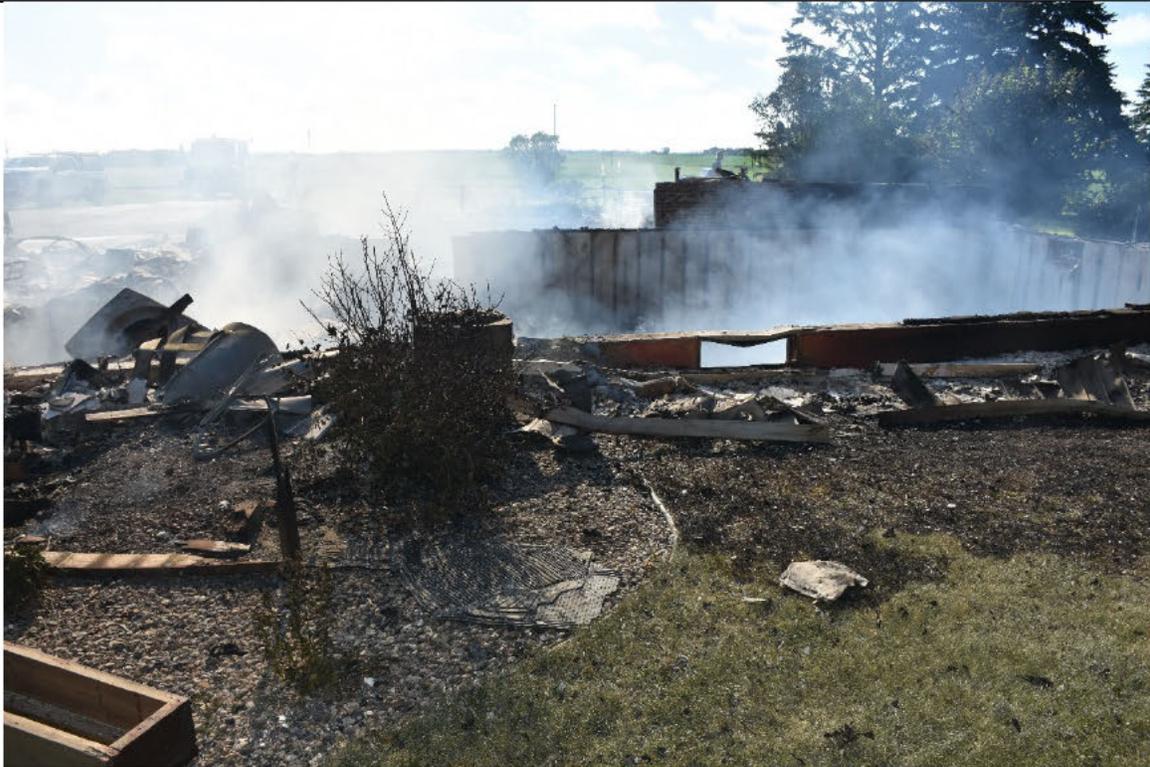
Based on the fire scene examination, witness statements, and other data reviewed, the area of origin was determined to be at or on the exterior of the structure. (See Figure 9)

Figure 9 Photograph NJF\_0026, direction east

Based on the fire scene examination, witness statements, and other data reviewed, the area of origin was determined to be near or on the exterior of the structure. The fire cause was lighting strike on or near the structure that caused combustible building material to ignite.
