INCIDENT REPORT

Investigation Title: KILLDEER PIPE BAR & GRILL FIRE

INCIDENT ORIGIN & CAUSE NARRATIVE

On August 1, 2025, a fire occurred at a commercial bar and restaurant at 355 Hwy 22, Killdeer, ND. See Figure 1.

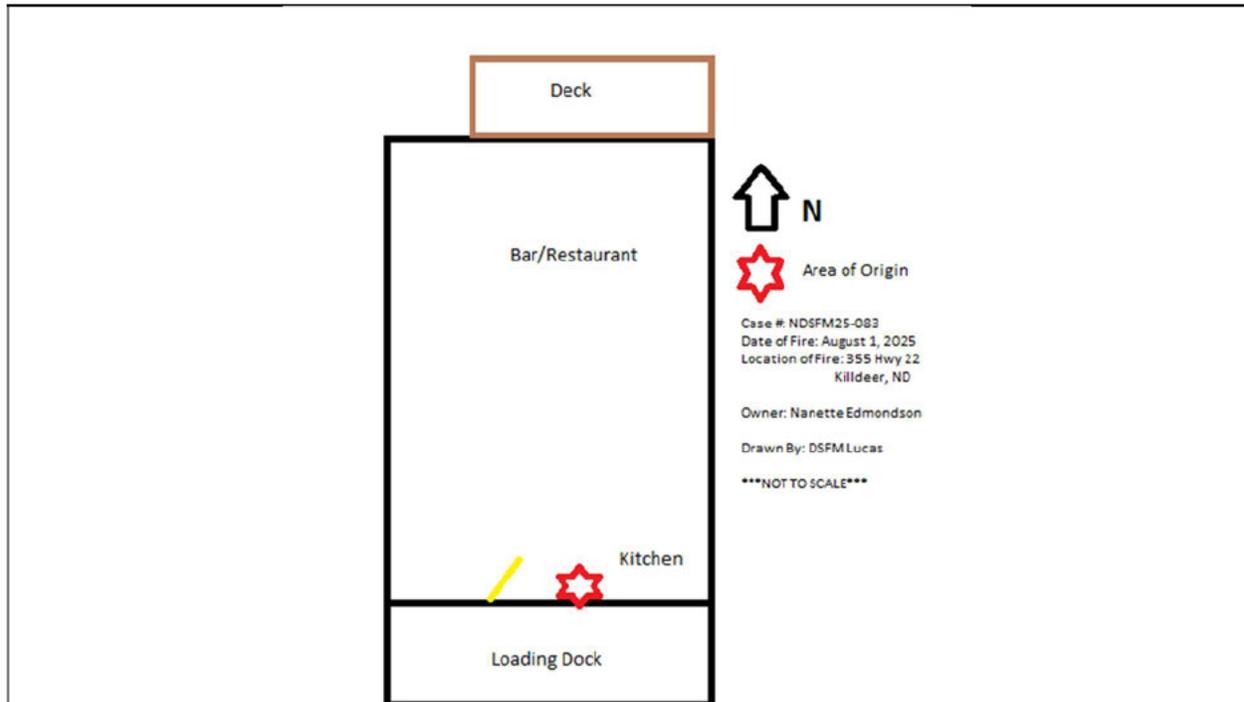
The following basic rendition was drawn by DSFM Kaylyn Lucas and was not to scale.

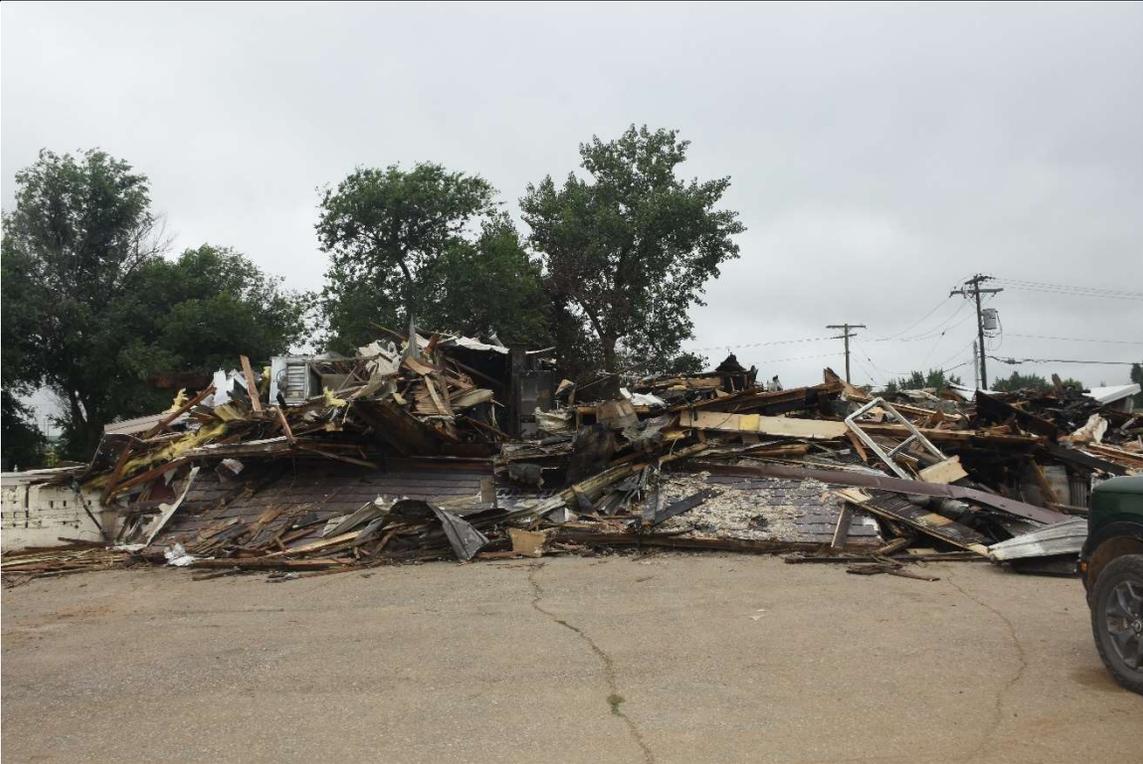
Figure 2: Photograph 7 - East View of Structure

Th examination began with a 360° walk around that started on the north side and went in a counterclockwise direction. The structure sustained mass loss and charring at the south end and smoke and soot deposition on the building construction that was visible. The building was collapsed into the interior. The deck, railing, and fence at the north end were intact. See Figure 2.

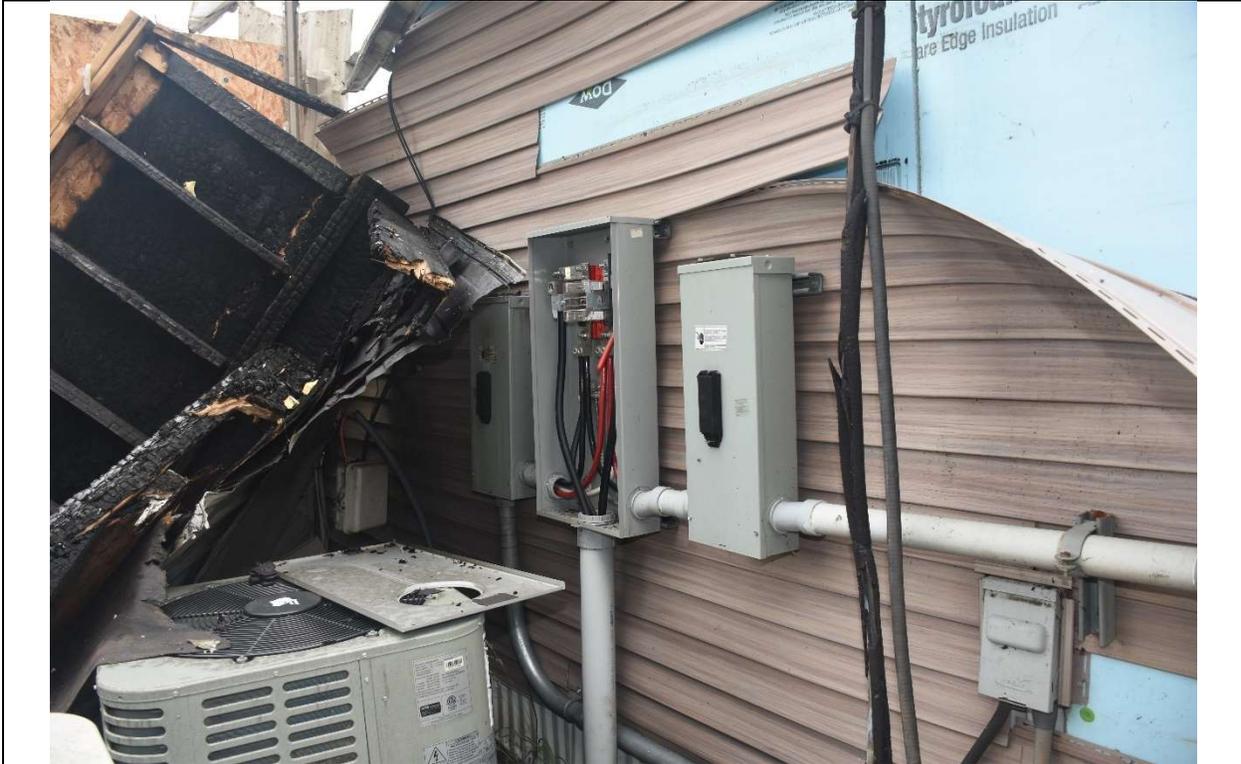
Figure 3: Photograph 19 - Electrical Boxes

The electrical service to the building was located on the west side of the structure, near the approximate middle, entering the building via later underground lines. An electrical pole, meter pedestal (with meter in place), and green metal electrical box were located to the northwest of the structure. No fire or thermal damage was witnessed on the pole, pedestal (meter), or green metal box. Attached to the west wall was a meter box and two adjacent electrical boxes. The cover of the meter box was removed at the time of the scene examination, and no meter was in place. No fire or heat damage was viewed upon the electrical boxes. See Figure 3.

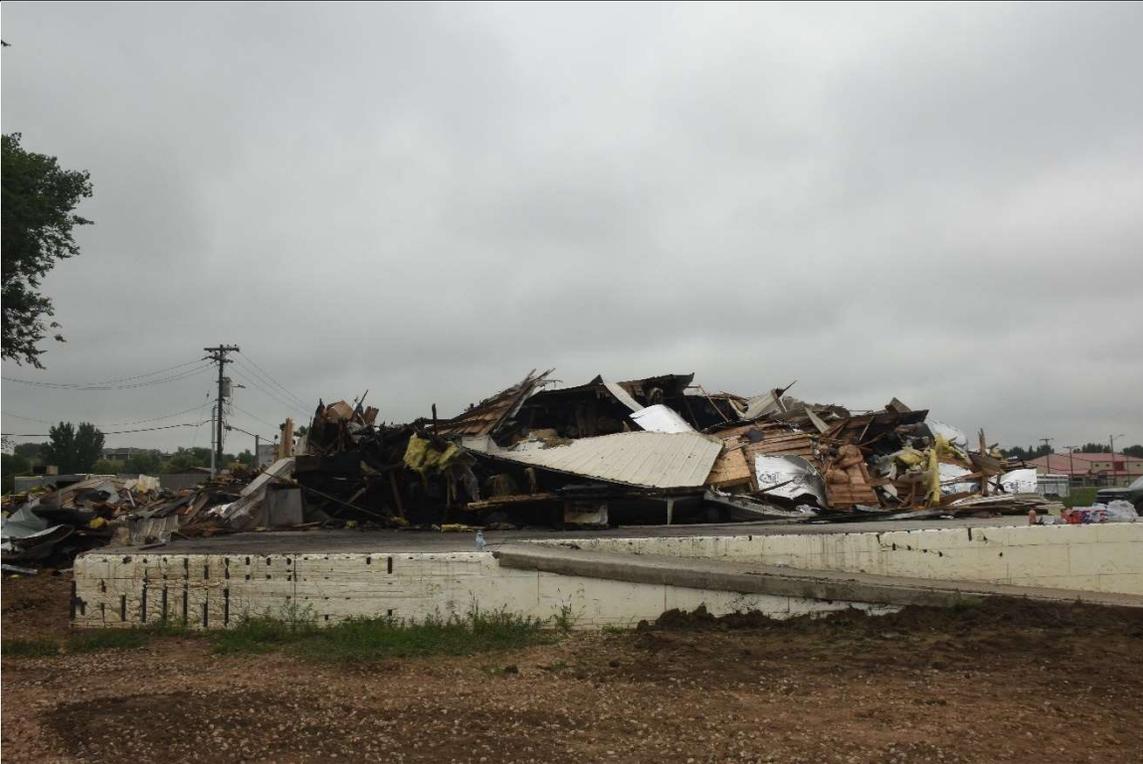
Figure 4: Photograph 9 - South View of Structure

The south side of the structure was collapsed to the interior with portions of the wall in a more upright position than compared to the north and east sides of the building. Building materials throughout the area showed signs of charring, smoke and soot deposition, and mass loss. See Figure 4.

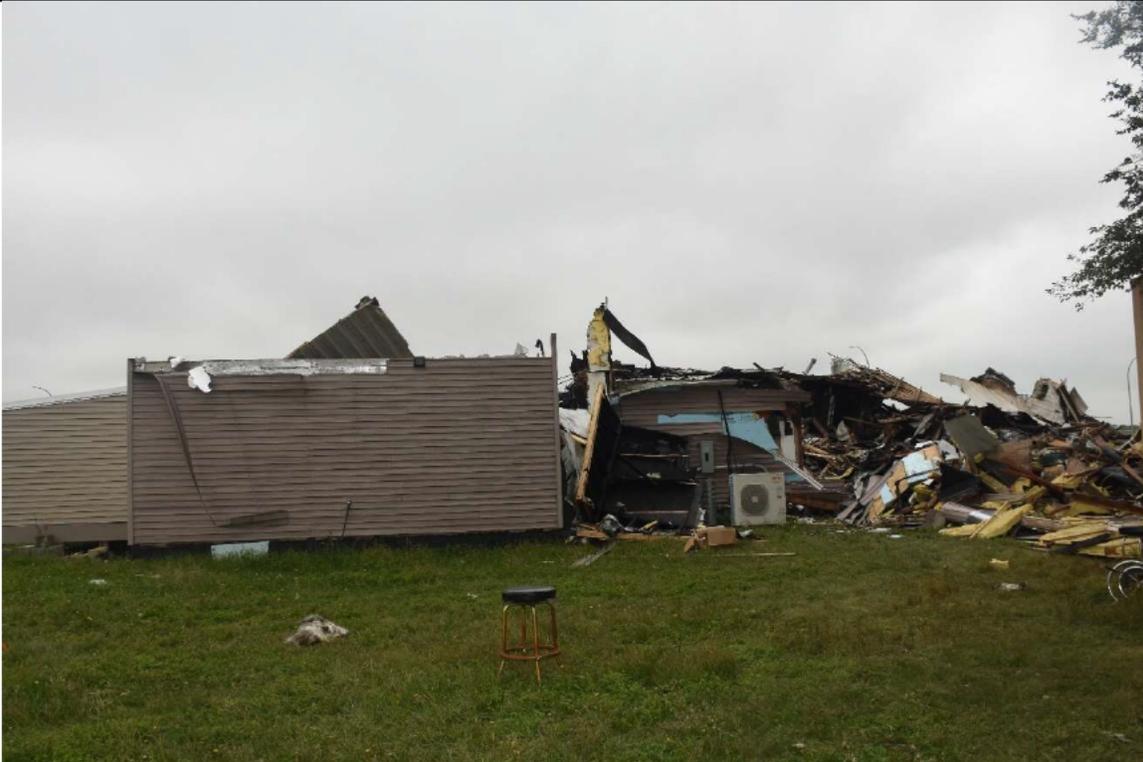
Figure 5: Photograph 14 - West View of Structure

The west walls of the northern west rooms were not collapsed to the interior; the roof was collapsed to the interior. The upright walls did not exhibit any exterior signs of charring, oxidation, mass loss, or smoke and soot deposition. See Figure 5.

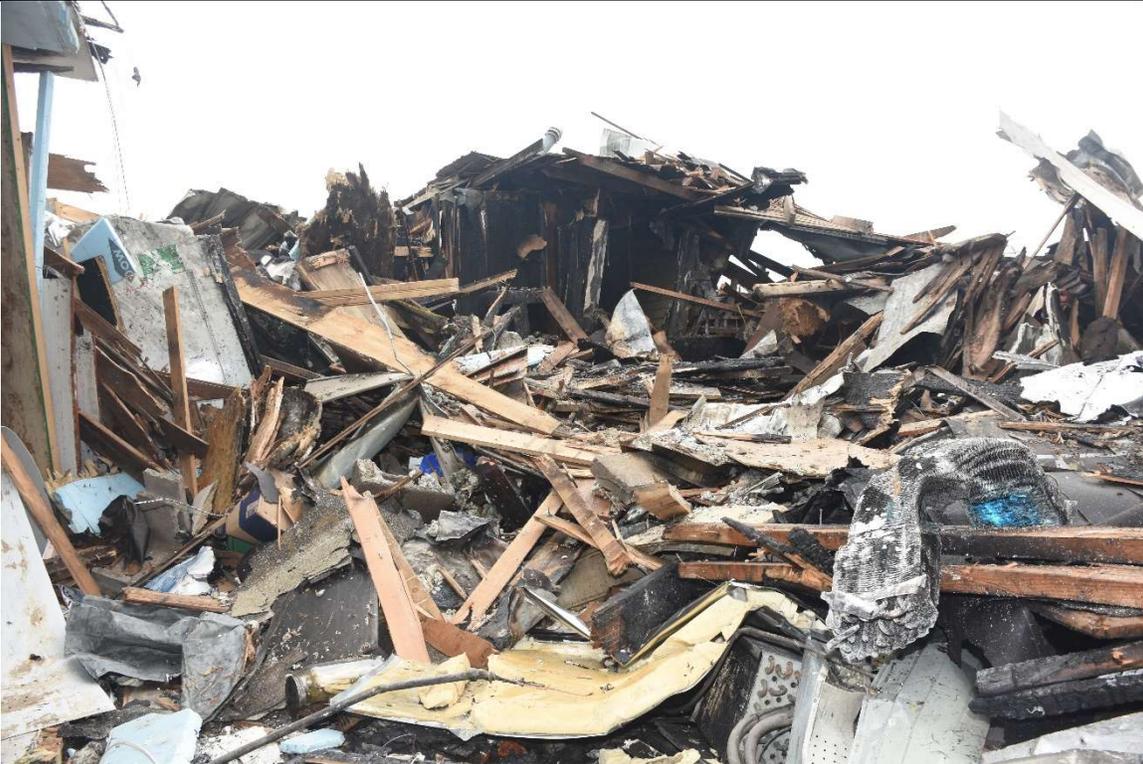
Figure 6: Photograph 32 - Northeast View of Interior

No interior examination was completed for the entire structure due to safety concerns with regard to the stability of the remaining upright building materials, unknown floor structural soundness, and the majority of the building had collapsed to the interior. See Figure 6.

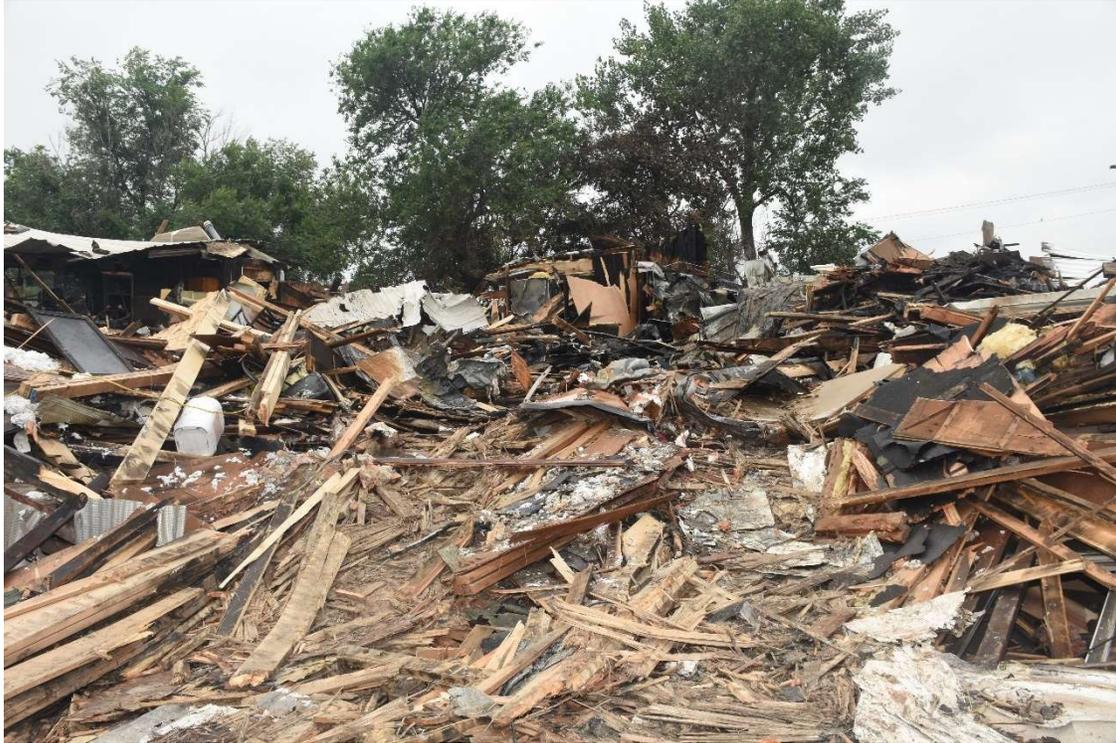
Figure 7: Photograph 35 - West View of Center Interior

The interior scene examination of the north and center area of the building were completed photographically from the exterior of the structure. See Figure 7.

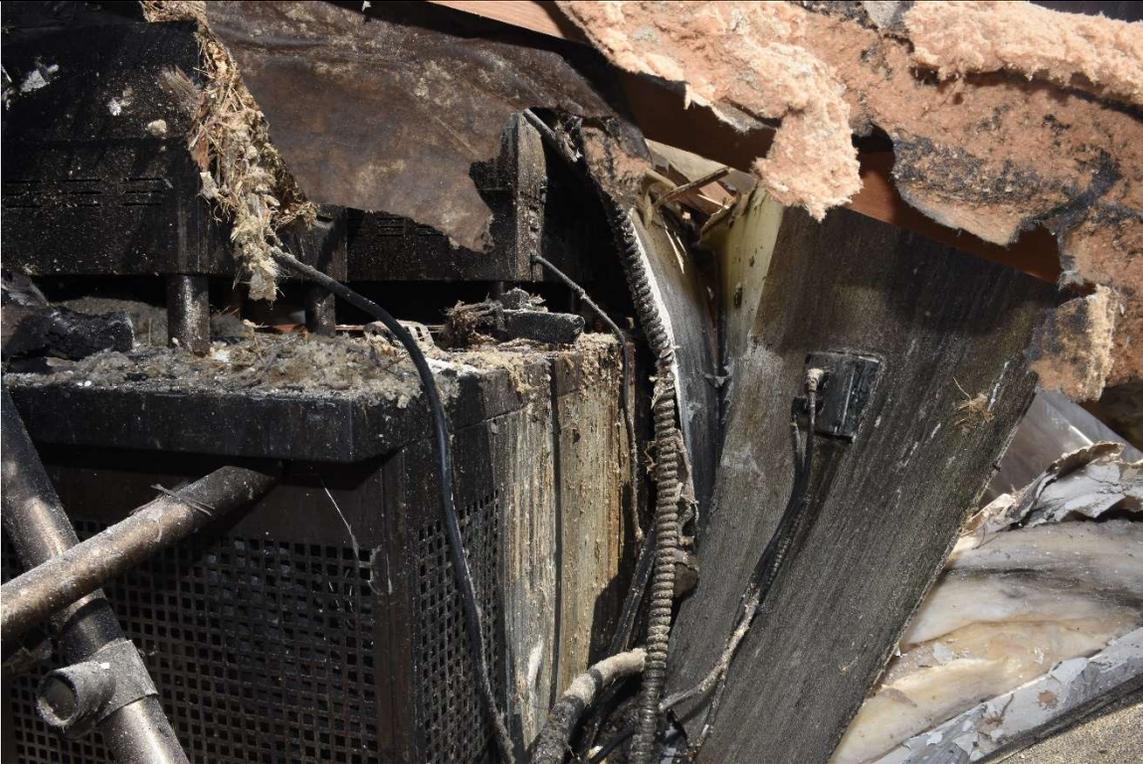
Figure 8: Photograph 81 - Freezer & Pizza Ovens

Along the south wall of the building, a prep station was located and adjacent to the east, was a freezer with a pizza oven sitting on top. A second pizza oven was located to the east. The line cords for the appliances were located, traced, and found intact. The wall mounted receptacle on the south wall behind the freezer had two appliances plugged in. The receptacle and plugs were intact. A third line cord for the appliances was located, traced, and found intact with no damage to the blades. The freezer and pizza ovens sustained heat induced color change on the rear of the appliances and soot deposition on the west sides. See Figure 8.

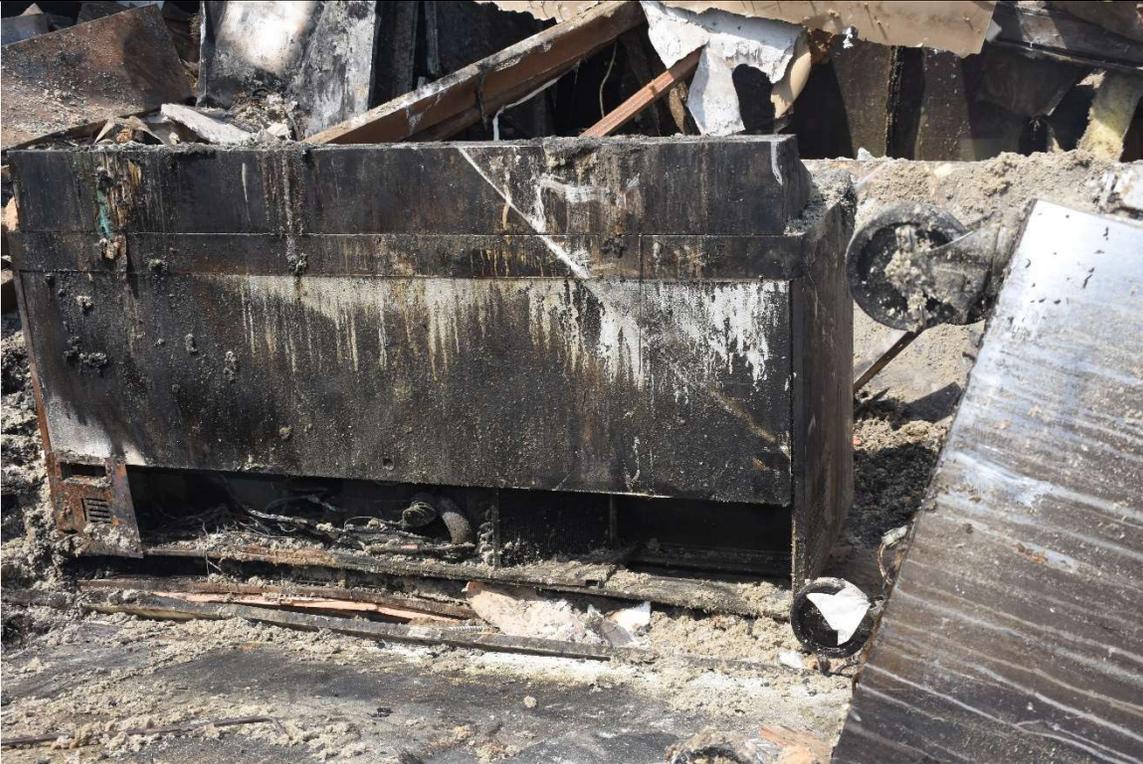
Figure 9: Photograph 152 - Rear of Prep Station

The rear of the prep station had visible oxidation, clean burn, heat induced color change, and smoke and soot deposition. The lower west corner sustained more clean burn than the rest of the rear of the prep station. Greater heat induced color change was viewed upon the west side compared to the east side of the prep station, with greater viewed at the rear versus the front of the sides. See Figure 9.

- Greater oxidation and clean burn was viewed on west side of the rear of the prep station than the east side.
 - Correlating damage was viewed upon the wall behind the prep station.

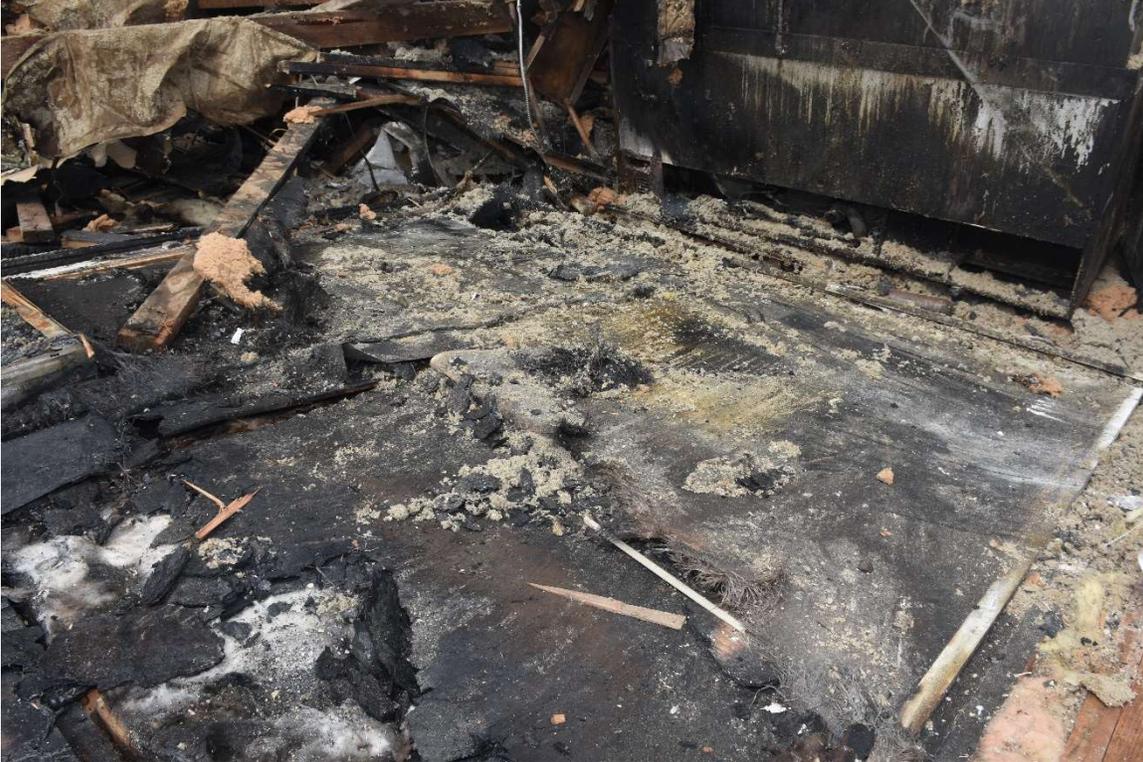
Figure 10: Photograph 58 - Correlating Damage on Wall Behind Prep Station

Correlating damage was viewed upon the south wall that was behind the prep station. The wall was viewed upon the ground at the time of the examination. Greater damage to the lower portion of the wall, nearest to the lower west area on the rear side of the appliance. See Figure 10.

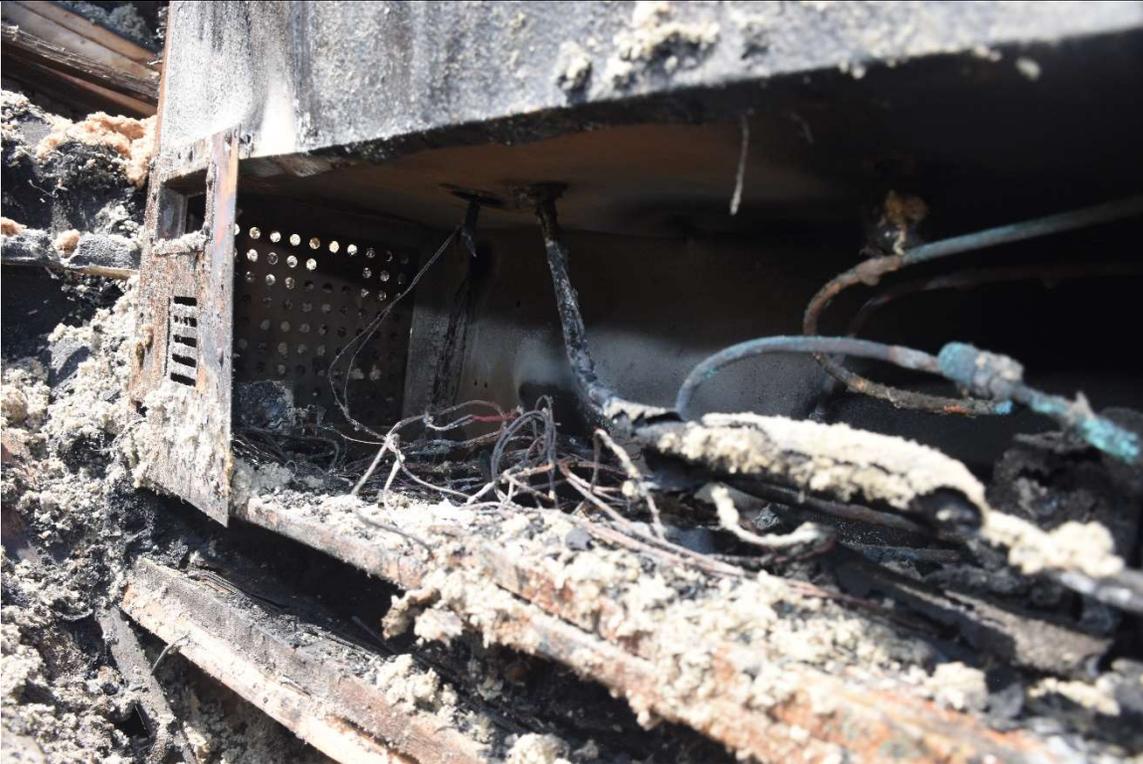
Figure 11: Photograph 108 - Electrical Components of the Prep Station

In the rear of the prep station, near ground level were electrical components for the electric appliance. The combustible materials, such as wiring insulation and lightweight plastic components were charred and melted. Greater charring, melting, and mass loss was viewed in the west half compared to the east half. The non-combustible materials sustained oxidation and heat induced color change. See Figure 11.

Based upon the systematic examination of the fire scene, fire patterns, witness statements, and physical evidence the cause of the fire was overheating of an electrical component or wiring of the prep station appliance resulting in sufficient heat for a duration capable of igniting available combustible materials, such as lightweight plastic material or wire insulation.

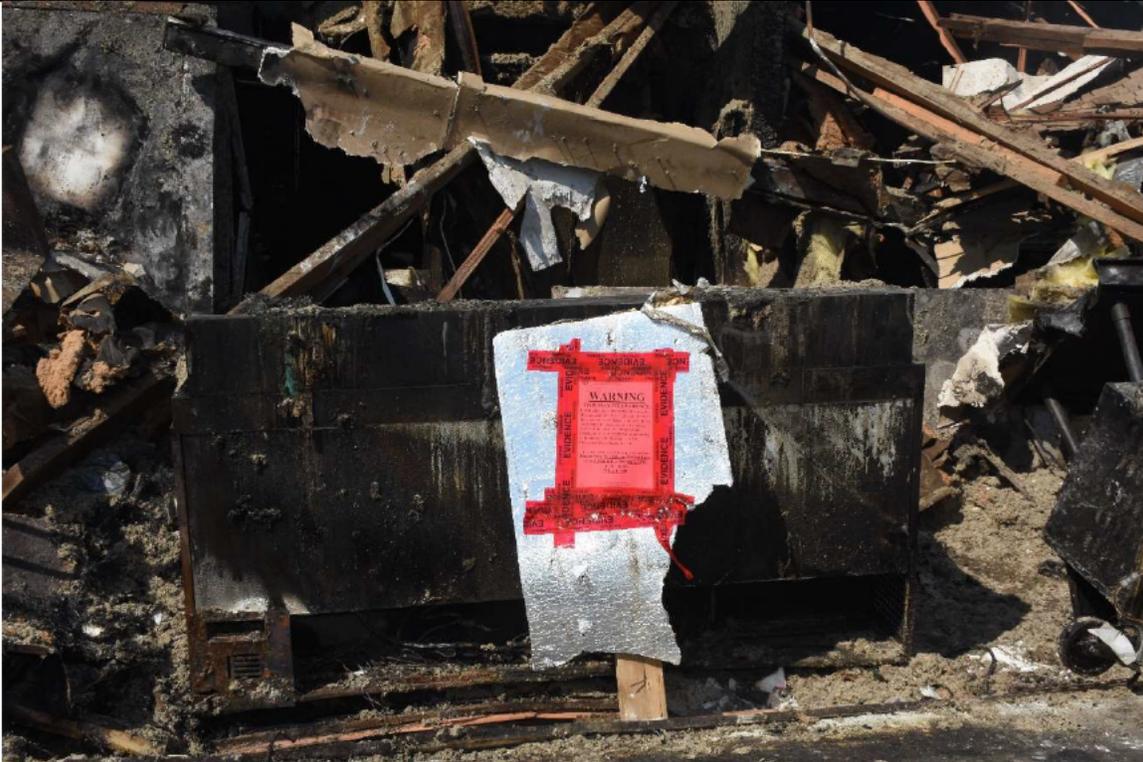
Figure 12: Photograph 153 - Prep Station

The prep station was labeled with 'Warning, This May Be Evidence', and left at the scene. See Figure 12.

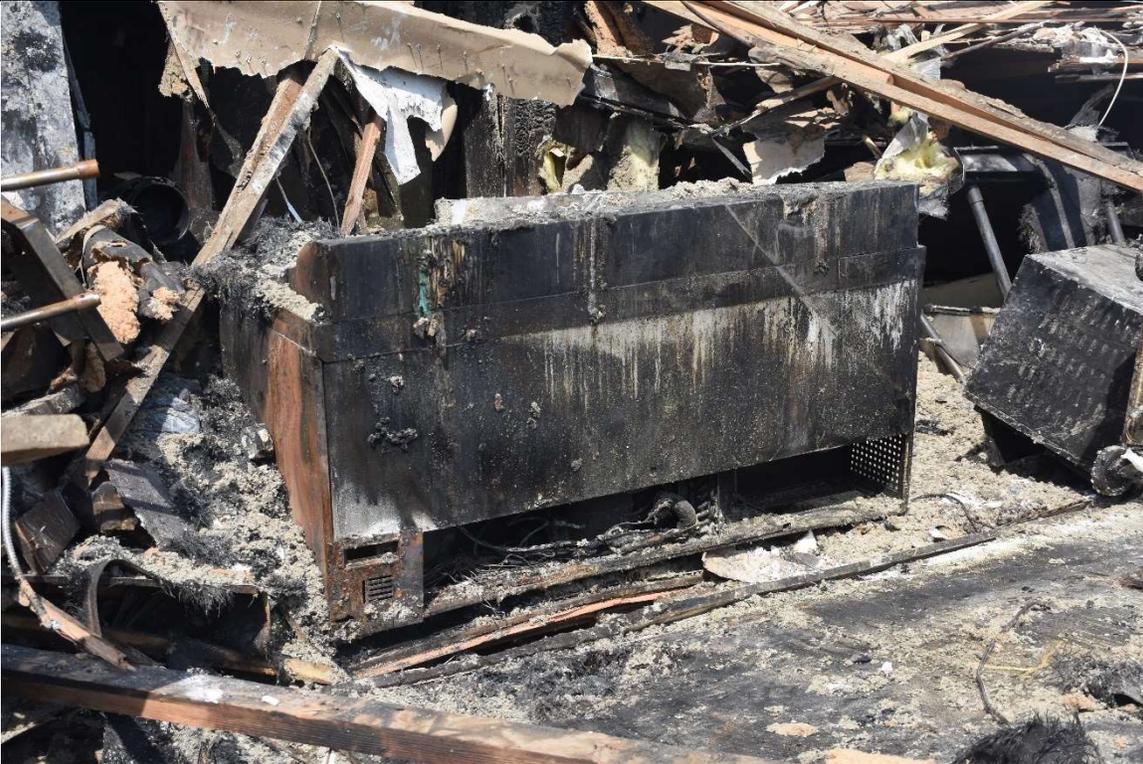
Figure 13: Photograph 151

Fire Effects

- Greater amount of oxidation and heat induced color change to the rear side of the prep station compared to the front.
- Greater amount of clean burn to the rear west side than the east side of the prep station.
- Greater heat induced color change on the west side than the east side of the prep station.
- More charring and melting of wire insulation and plastic materials on the electrical components on the west than the east lower area of the prep station.
