# North Dakota Office of the State Fire Marshal (ND)

## INCIDENT REPORT

Investigation Title: RUGBY DECOTEAU FIRE

**North Dakota State Fire Marshals Office (ND)**  
**INCIDENT ORIGIN & CAUSE NARRATIVE**  
**Official Law Enforcement Report – Unauthorized Dissemination is Prohibited**

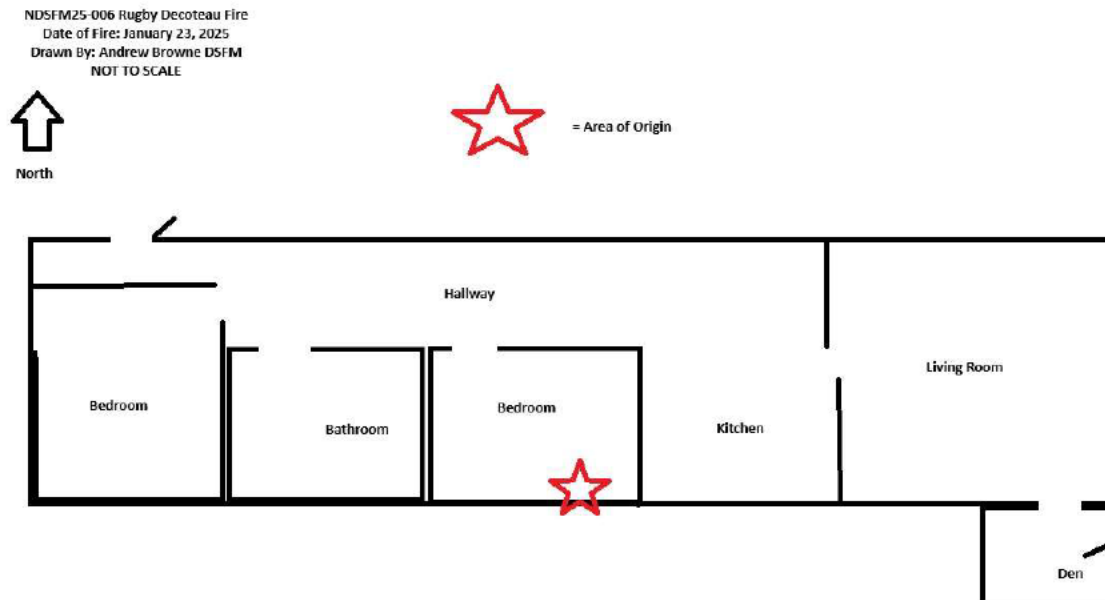
Sketch was drawn by Deputy State Fire Marshal Andrew Browne. Sketch as not drawn to scale. The sketch will remain with the file.
