INCIDENT REPORT

Investigation Title: SAWYER RICHARDSON FIRE

INCIDENT ORIGIN & CAUSE NARRATIVE

A fire occurred in a two-story residential structure with a basement at 120 Central Ave E in Sawyer, ND. The fire was reported on February 26, 2025, at approximately 8:53 AM. The Sawyer Fire Protection District responded and extinguished the fire. The property tenant was not home at the time of the fire and a passerby called 911. (See Figure 1)

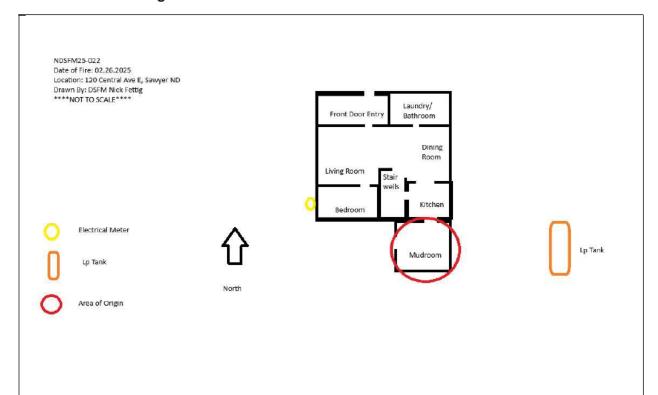
During my initial 360°walk around of the structure a Scene Safety Form was completed. The form will remain with the file. The structure was a two-story residential structure home with a basement. The structure had wood siding and asphalt shingles. The electrical meter was mounted on the west side of the structure and the electrical meter was removed. The Lp tank was located in the south side of the yard with regulator mounted to the tank. The Lp tank gauge read approximately 40% full and the shutoff valve was in the closed position. No fire or smoke damage was observed to the electrical meter and the Lp tank or regulator.

The north side of the structure did not have any signs of fire or heat damage.
