INCIDENT REPORT

Agency Incident ID: NDSFM25-031

Investigation Title: CARRINGTON MARLOW FIRE

North Dakota State Fire Marshals Office (ND)
INCIDENT ORIGIN & CAUSE NARRATIVE
Official Law Enforcement Report – Unauthorized Dissemination is Prohibited

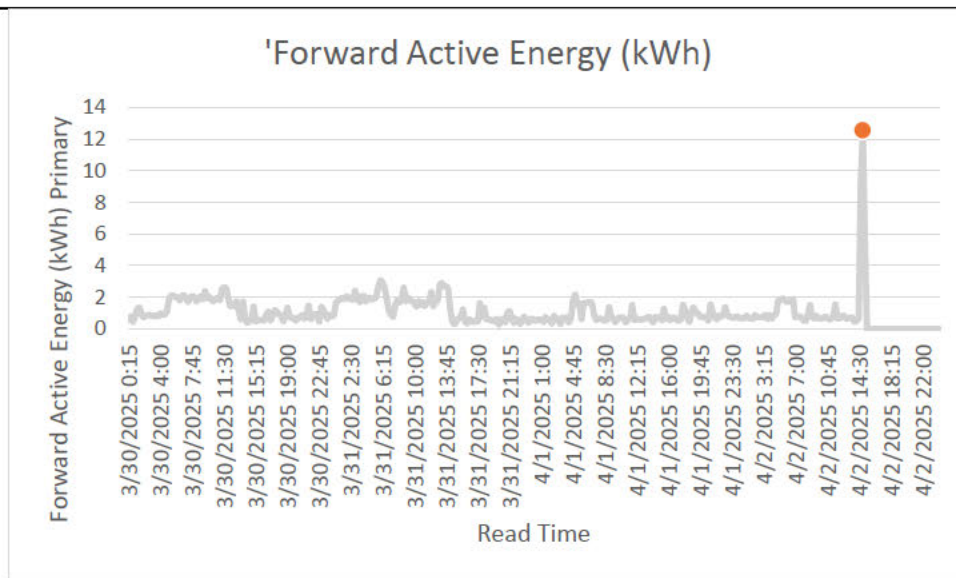
Ottetail Power Company Smart Meter Data

- Data request via email from smart meter of the structure.
- Ottetail Power Company was the provider of power for the structure.
- Provided an excel file of the data from March 30, 2025, at midnight until April 2, 2025, at midnight.
- On April 2, 2025, the following kilowatts per hour were read with an above normal reading of 9.04189 kWh at 2:45 pm, 12.55722 kWh at 3:00 pm, and 4.93099 kWh at 3:15pm.
- Chart below shows the range of the data obtained from the excel file provided from Ottetail Power Company.
