## INCIDENT REPORT

Agency Incident ID: NDSFM25-075

Investigation Title: RYDER JOHANSEN FIRE

**North Dakota State Fire Marshals Office (ND)**  
**INCIDENT ORIGIN & CAUSE NARRATIVE**  
**Official Law Enforcement Report – Unauthorized Dissemination is Prohibited**

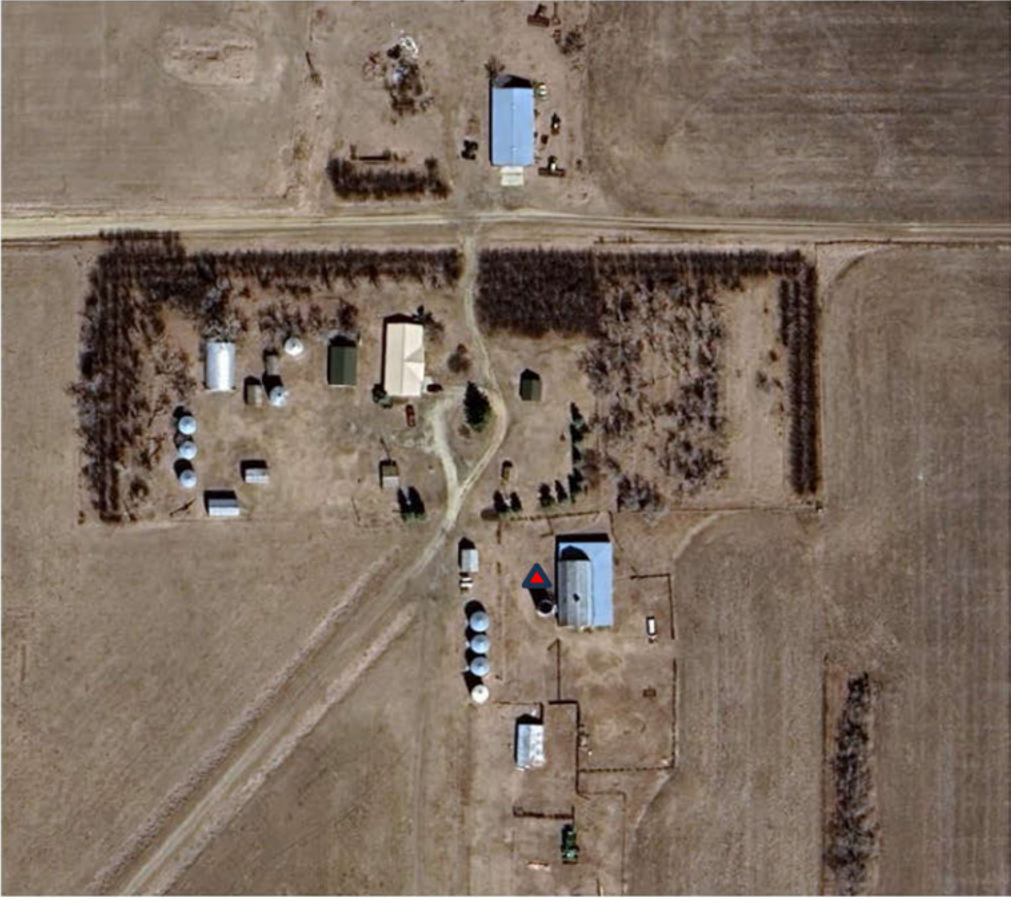
| Drawings/Sketches: |
|---|
| <p>Due to the size of the fire and its complexity no drawing or sketch was completed. The photograph was a snip from google.earth.com. The red triangle represents the approximate location of the John Deere 2420 Swather. The barn in proximity to the red triangle was known as the dairy barn. An adult male victim was located in the dairy barn. (See Figure 2)</p> <p>The photograph is an aerial view of a farm. It shows several buildings, including a large blue-roofed barn and a smaller white building. There are several large white storage tanks. A red triangle is placed on the ground near the blue-roofed barn. The surrounding area is mostly bare, brownish ground with some patches of vegetation.</p> <p><i>Figure 2 Snip from google.earth.com</i></p> |
