INCIDENT REPORT

Incident Type: Fire / Undetermined

ROGERS JONES FIRE

INCIDENT ORIGIN & CAUSE NARRATIVE Official Law Enforcement Report – Unauthorized Dissemination is Prohibited

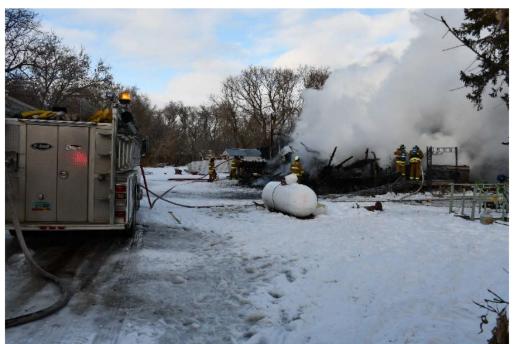
On Thursday, January 23, 2025, at 11:21 am, the Dazey Fire Department was dispatched to a single-family residential structure fire at 2251 109th Ave SE, Rogers, ND. Upon arrival of the fire department the structure was fully involved, and the roof had collapsed. (See Figure 1)

Figure 1 Photograph DSC_0004.JPG South Exterior Wall From Driveway Facing North

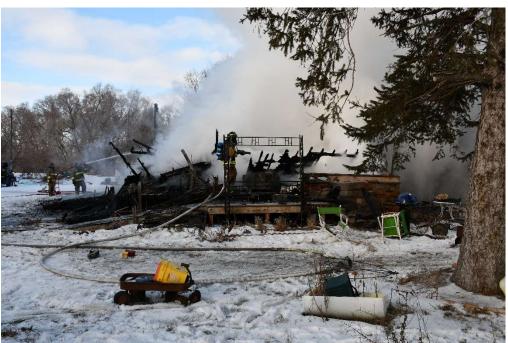
Most of the south wall was consumed and collapsed. The lower brick skirting of the wall was intact. Noncombustible remains of stored items were visible along the south wall. The noncombustible remains of household items were warped and oxidized. There was active fire and smoldering visible. There was a wooden deck that extended from the south exterior wall with a wooden ramp that extended from the west of the deck that was intact. (See Figure 2)

Figure 2 Photograph DSC_0005.JPG South Exterior Wall Facing North

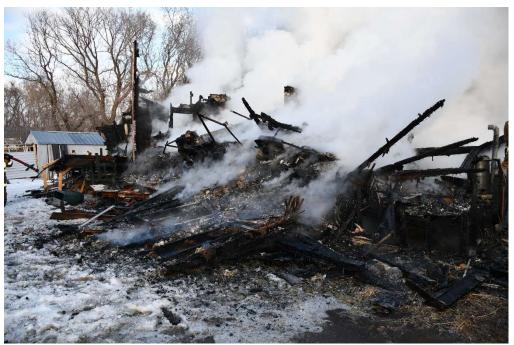
Most of the west wall had collapsed to the exterior. The structural remains had comparable charring throughout. Most of the combustible material contents were consumed. Noncombustible remains of household items were visible along the west wall. The noncombustible remains were warped and oxidized. There was active fire and smoldering visible. In the northwest corner of the west wall was a wooden deck that extended from the west wall. The wooden deck was still intact. (See Figure 3)

Figure 3 Photograph DSC_0008.JPG West Exterior Wall Facing Northeast

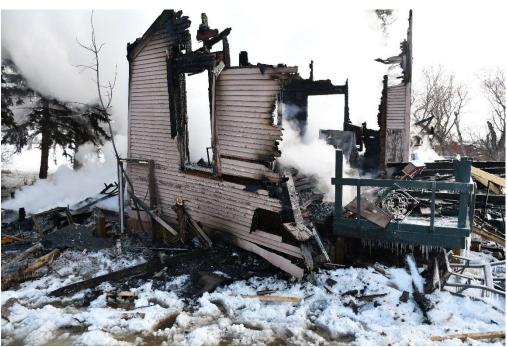
Most of the north wall was upright with the mass loss along the west wall, area closet to the deck/steps extending up to the roof peak. There was a window in approximately the center of the wall. The glass was no longer in place and the wood frame had charring on the upper portion. There was active fire and smoldering visible. Most of the combustible materials of stored items were consumed. The noncombustible materials of household items were oxidized and warped. (See Figure 4)

Figure 4 Photograph DSC_0012.JPG North Exterior Wall Facing South

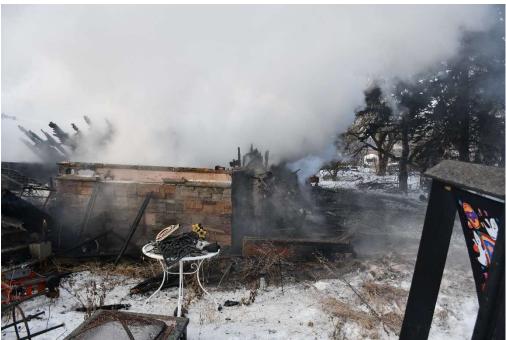
Most of the east wall was consumed. Most of the combustible materials were consumed. Noncombustible remains were visible along the east wall. The noncombustible remains were warped and oxidized. There was active fire and smoldering visible. (See Figure 5)

Figure 5 Photograph DSC_0016.JPG East Exterior Wall Facing North
